MILL POND DAM

MA. 00161

PHASE I INSPECTION REPORT
NATIONAL DAM INSPECTION PROGRAM

DECEMBER 1980

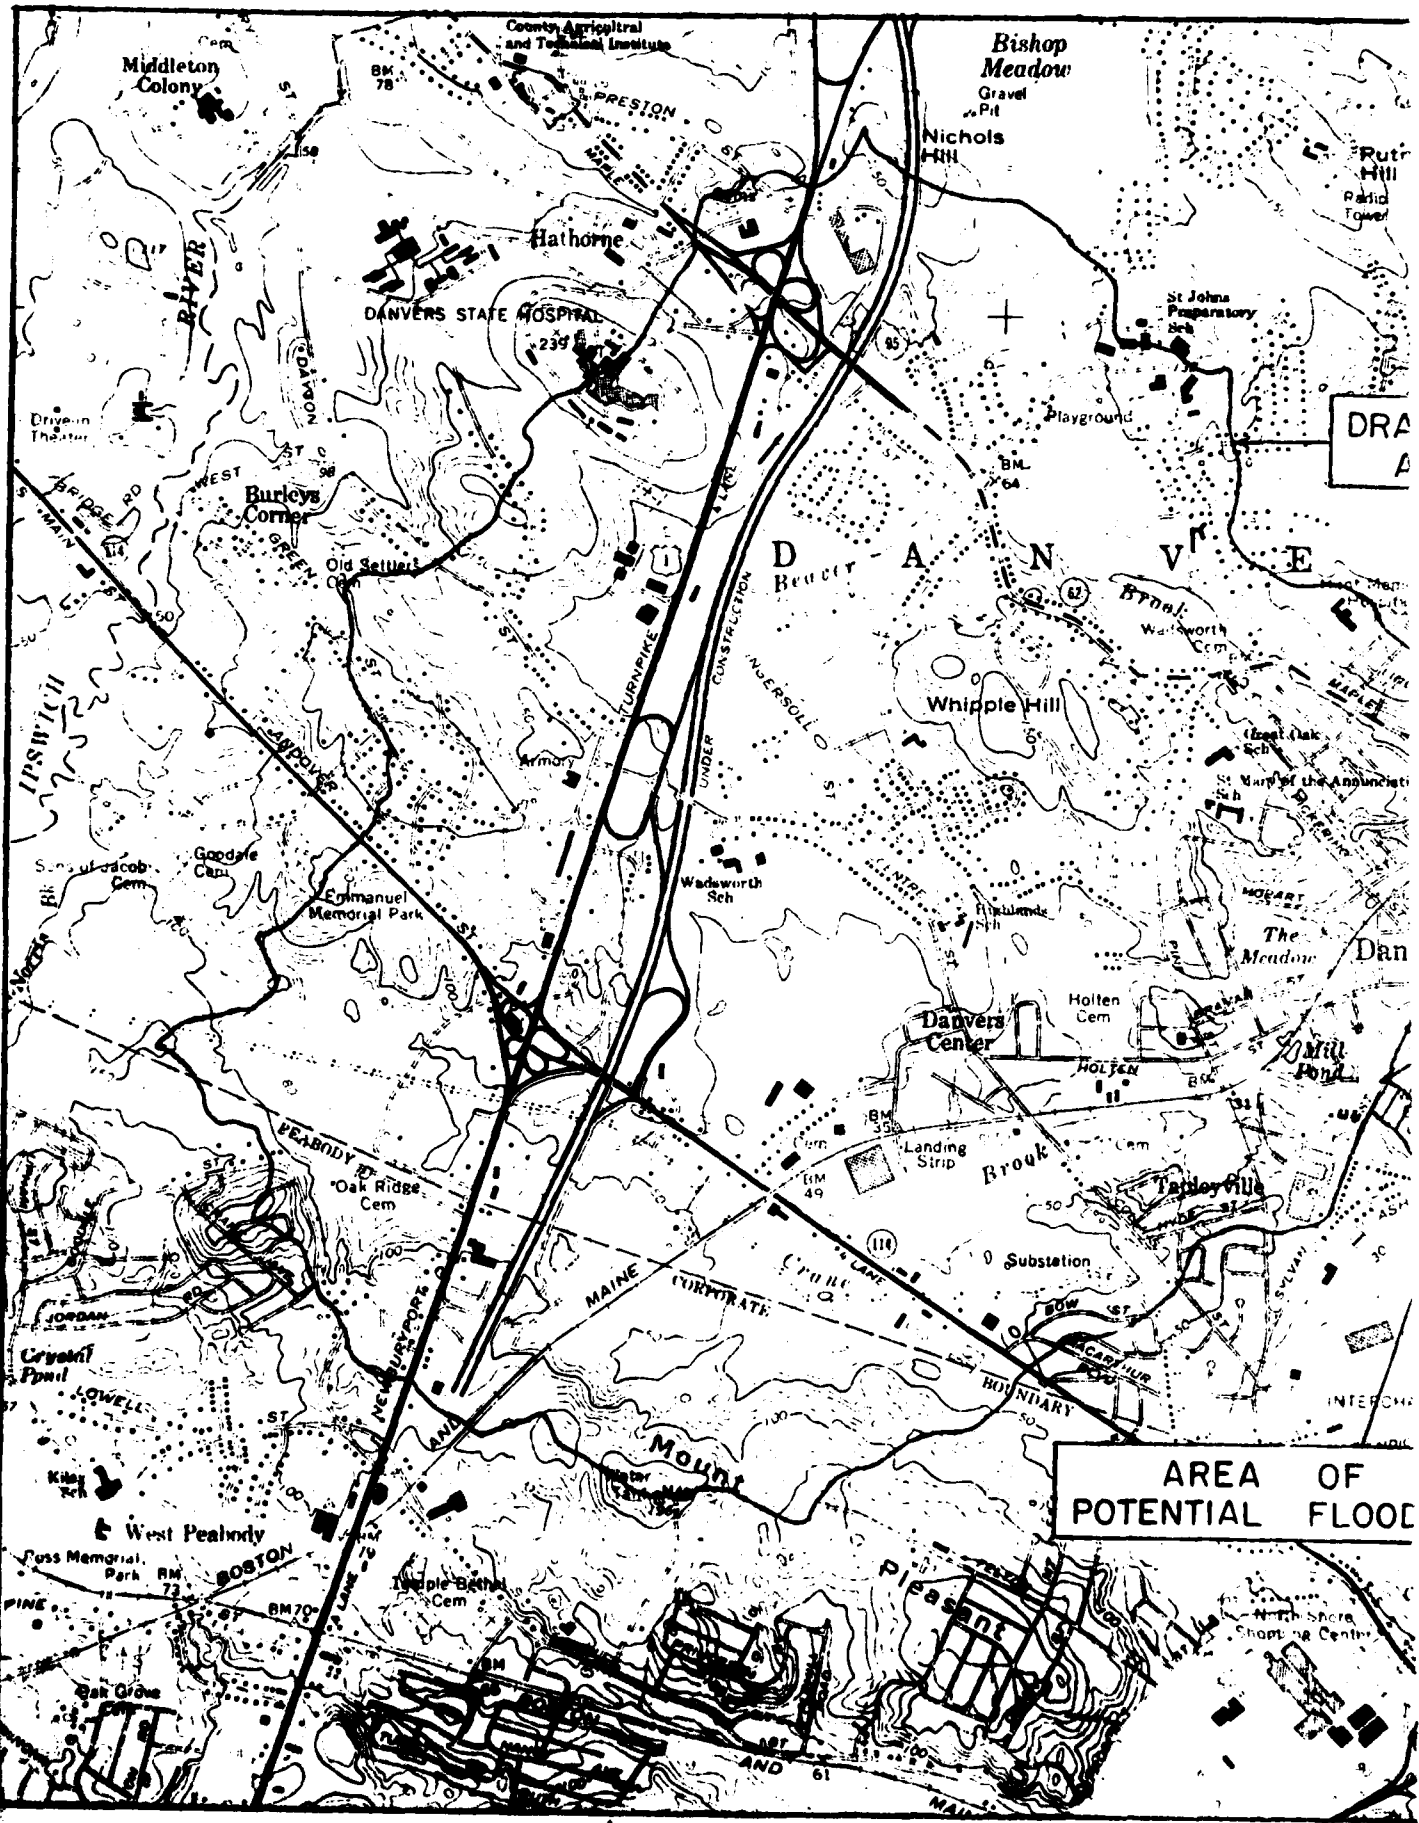
AREA OF
POTENTIAL FLOOD

- 1) LOSS OF SYLVAN ST DUE TO BREACH
- 2) 5 HOODES 3 FT FLOODING
- 3) 1 APT HOODE 1ST WATER
- 4) 2 LOCAL STS TO 5 FT.
