MASSACHUSETTS COASTAL BASIN  
GLOUCESTER, MASSACHUSETTS

FERNWOOD LAKE DAM  
MA 00184

PHASE I INSPECTION REPORT  
NATIONAL DAM INSPECTION PROGRAM

APRIL, 1979

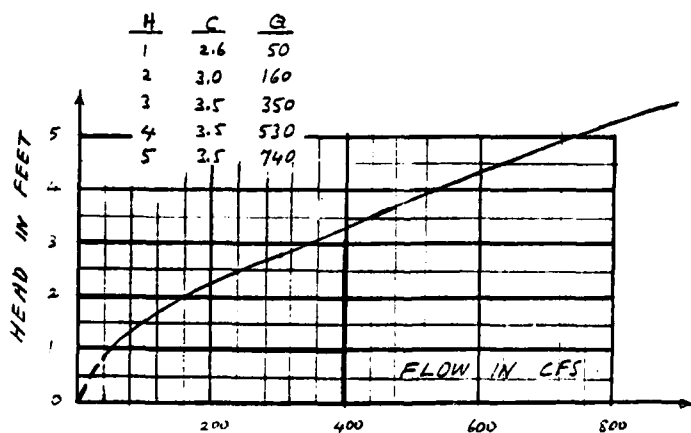
HEAD-CAPACITY CURVE  
 SPILLWAY  
 (No Flashboards)

The spillway head-capacity curve for this condition would be somewhat different because of the crest shape; 160 cfs would flow over the spillway and the remaining 140 cfs over the east and south drains - The required head at the spillway: 1.8 ~ 2.0 feet.
