MULTIPLE-PURPOSE PROJECT OSAGE RIVER BASIN OSAGE RIVER  
MISSOURI HARRY S T. (U) CORPS OF ENGINEERS KANSAS CITY  
MO KANSAS CITY DISTRICT R F GRIFFITH ET AL. 1984

| REPORT DOCUMENTATION PAGE | | READ INSTRUCTIONS<br>BEFORE COMPLETING FORM | |
|---|--|---|--|
| 4. TITLE (and Subtitle)<br>MULTIPLE-PURPOSE PROJECT<br>OSAGE RIVER BASIN<br>OSAGE RIVER, MISSOURI<br>HARRY S. TRUMAN DAM & RESERVOIR<br>OPERATION AND MAINTENANCE MANUAL<br>APPENDIX VIII, VOLUMES ONE AND TWO<br>CONSTRUCTION FOUNDATION REPORT | | 5. TYPE OF REPORT & PERIOD COVERED<br>Construction Foundation<br>Report from September 1966<br>November 1979 | |

APPENDIX VII  
CONSTRUCTION FOUNDATION REPORT

1-03. Purpose and Scope: The purpose of this report is to provide a record of foundation conditions encountered during construction and methods used to adapt to these conditions during construction. This information is a part of the permanent collection of project engineering data required by Appendix A to ER 1120-2-100 and ER 1110-1-1801, dated 15 Dec 81. This report deals with construction of the main embankment, the Sterett Creek Dike and the Spillway-Powerhouse.

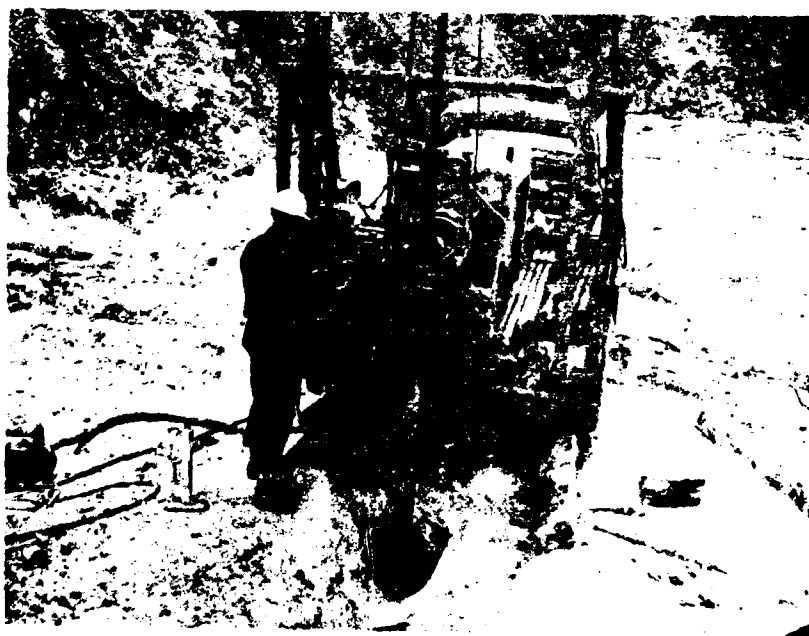
28. Harry S. Truman Dam, 27 September 1966, Neg. No. 82494.  
Cutoff Trench Sta. 22+90 drilling exploratory holes  
near chimney between Sta. 22+00 and Sta. 23+00.

5. Dental Concrete and Guniting. Several areas in the Spillway-powerhouse excavation were overexcavated and dental concrete was required. On the 1H downstream slope of the powerhouse foundation notch required fill concrete. See Plate 64. The left wall and floor of erection bay 1H required backfill concrete. See Plate 63. Guniting and wire mesh were required on the upstream side of the left wall of the spillway foundation. See Plate 70. Backfill concrete was required at outside corners of excavated rock walls and at the junction or top of rock and the spillway powerhouse training walls. See Plates 73 and 74. Concrete and guniting were required to repair overbreaks and damaged corners on the 1V on .75H at El. 634 bench and El. 632 bench on the upstream side of Monoliths 9 and 13. See Photos 165 and 166. In the cutoff trench from Sta. 22+50 to Sta. 24+00, Karst features on the bedrock surface were cleaned out and grouted. See Plate 116. Caves on the sides of the cutoff trench were cleaned out and backfilled with concrete. See Photos 26 thru 32.

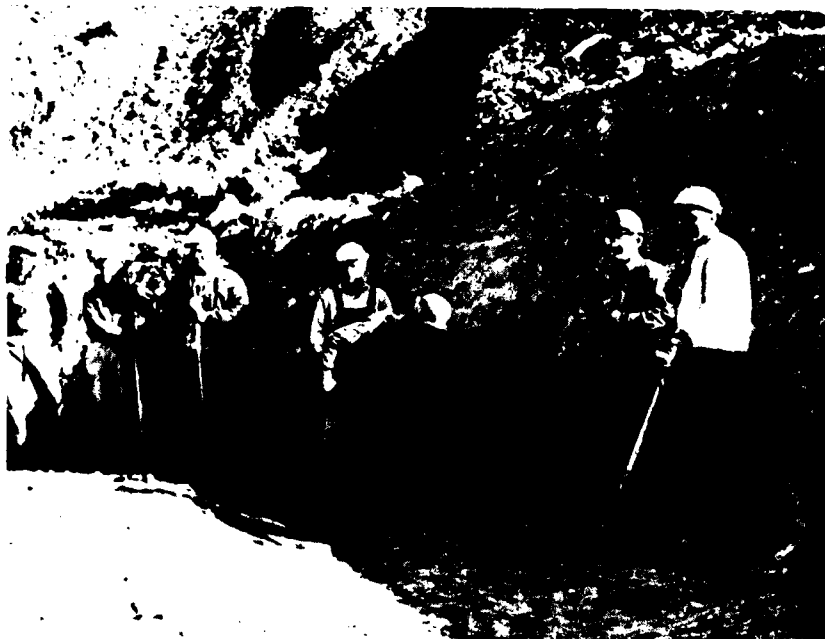
29. Harry S. Truman Dam, 10 November 1966, Neg. No. R-262-3.  
Cutoff Trench Sta. 23+33 to Sta. 23+50 looking upstation.  
Caves on downstream side.

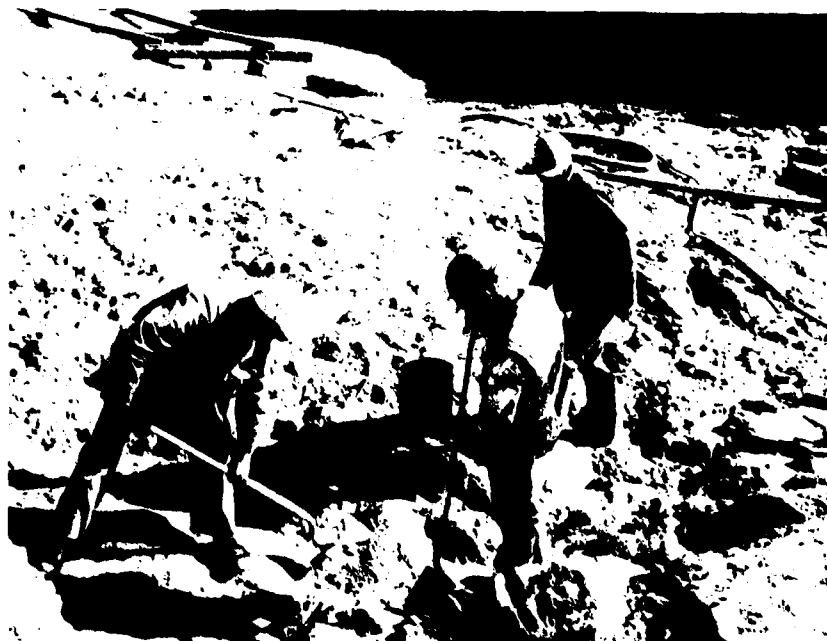
35. Harry S. Truman Dam, 19 November 1966, Neg. No. 82928.  
Cutoff Trench Sta. 27+25 to Sta. 27+75 Breccia Contact.  
Looking downstream and upstation.
