NATIONAL PROGRAM FOR INSPECTION OF NON-FEDERAL DAMS  
PALMER BROOK DAM MA 0 (U) CORPS OF ENGINEERS WALTHAM  
MA NEW ENGLAND DIV MAR 81

| REPORT DOCUMENTATION PAGE | | READ INSTRUCTIONS<br>BEFORE COMPLETING FORM |
|---|---|---|
| 4. TITLE (and Subtitle)<br><br>Palmer Brook Dam<br>NATIONAL PROGRAM FOR INSPECTION OF NON-FEDERAL DAMS | | 5. TYPE OF REPORT & PERIOD COVERED<br>INSPECTION REPORT |
| 20. ABSTRACT (Continue on reverse side if necessary and identify by block number)<br><br>- Palmer Brook Dam is an earthen embankment structure 33.5 feet high and 290 feet long. Based on visual inspection the dam is judged to be in good condition. It is classified as "intermediate" in size with a "high" hazard potential. | | |

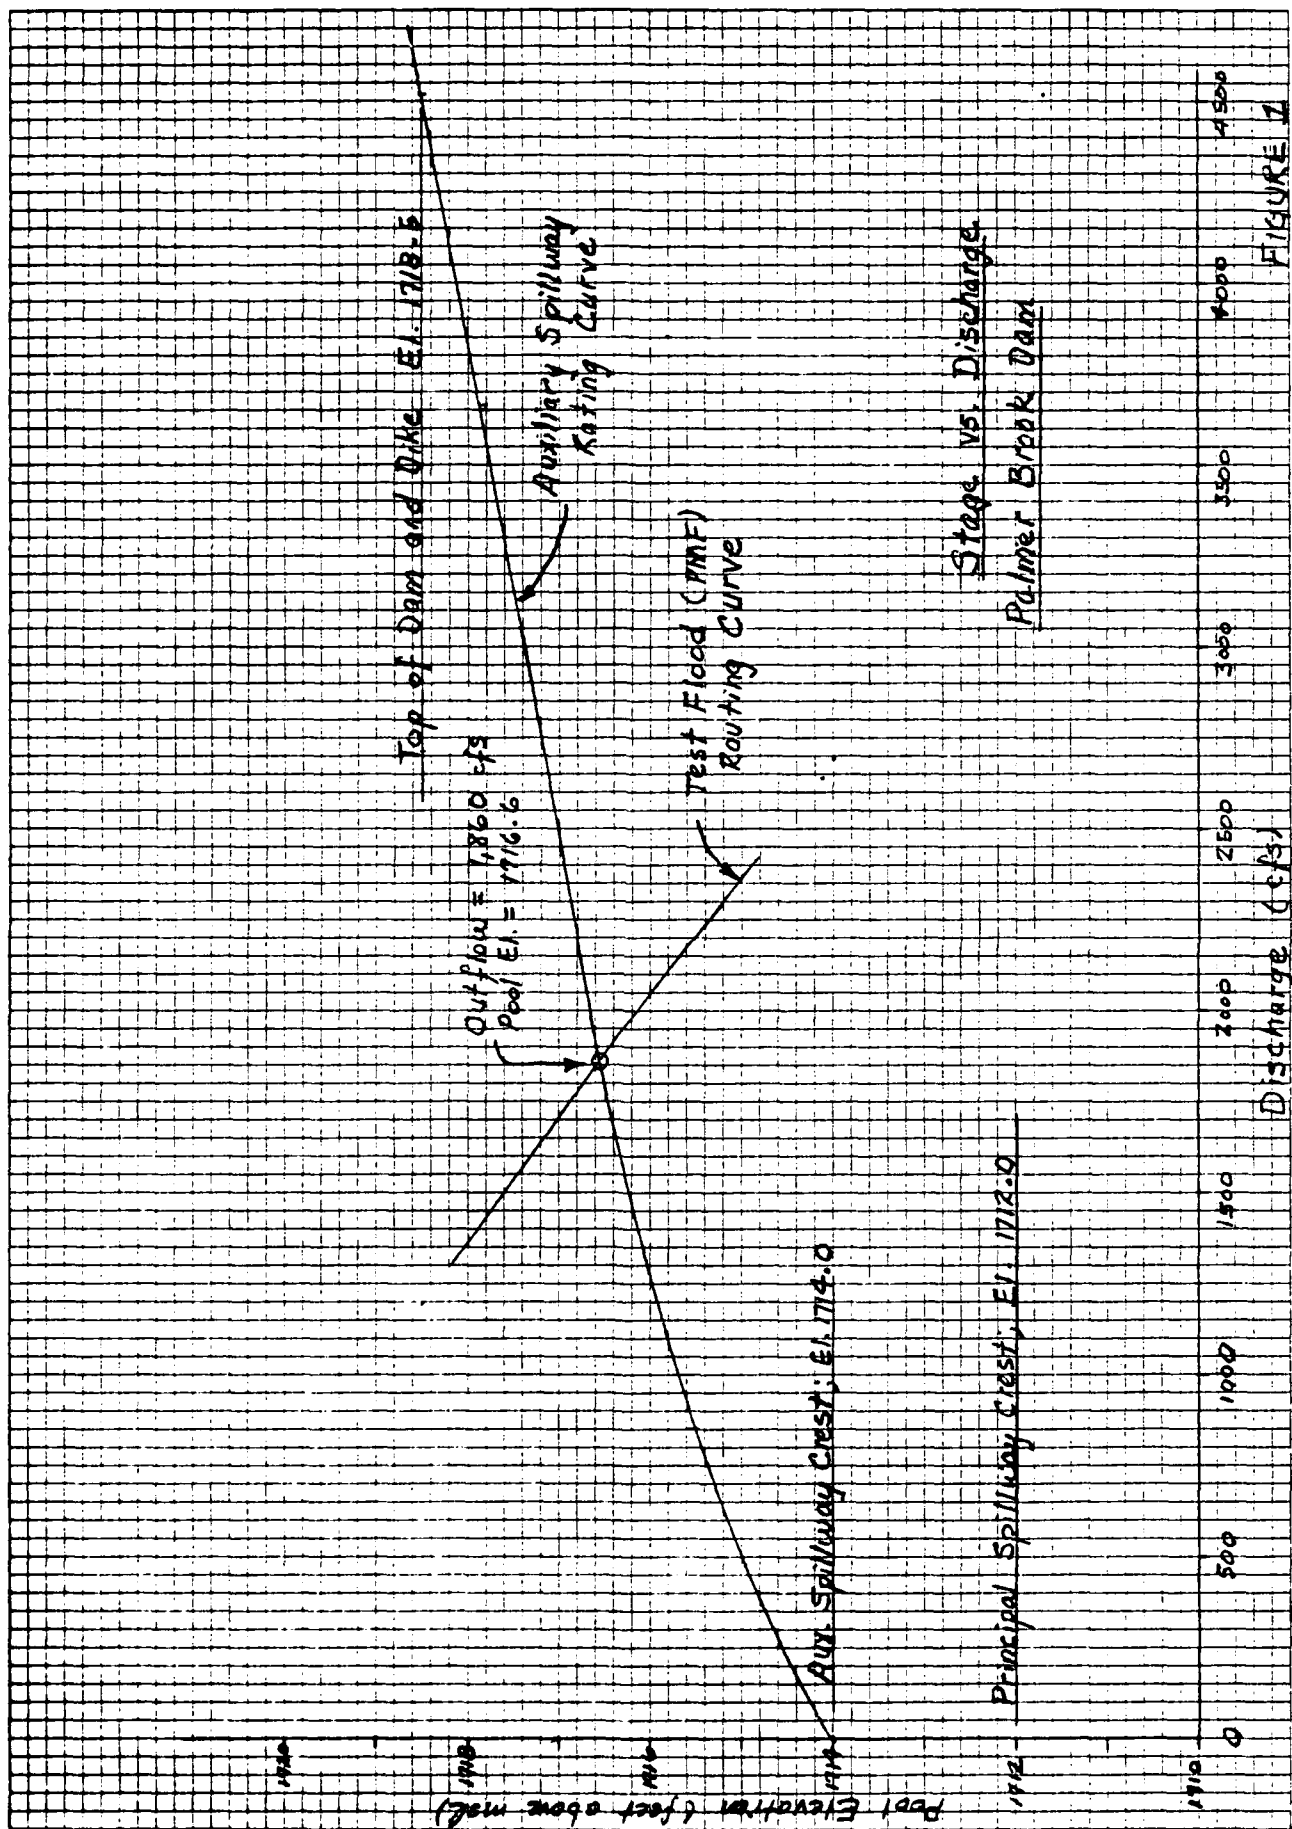
FIGURE 1

From Results Shown on Figure 1 (next sheet):
