HOUSATONIC RIVER BASIN
HINSDALE, MASSACHUSETTS

BELMONT RESERVOIR DAM
MA 00224

PHASE I INSPECTION REPORT
NATIONAL DAM INSPECTION PROGRAM

MARCH 1980

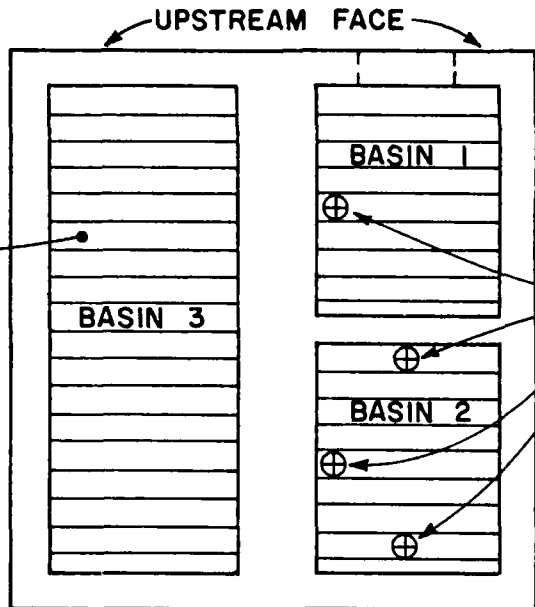
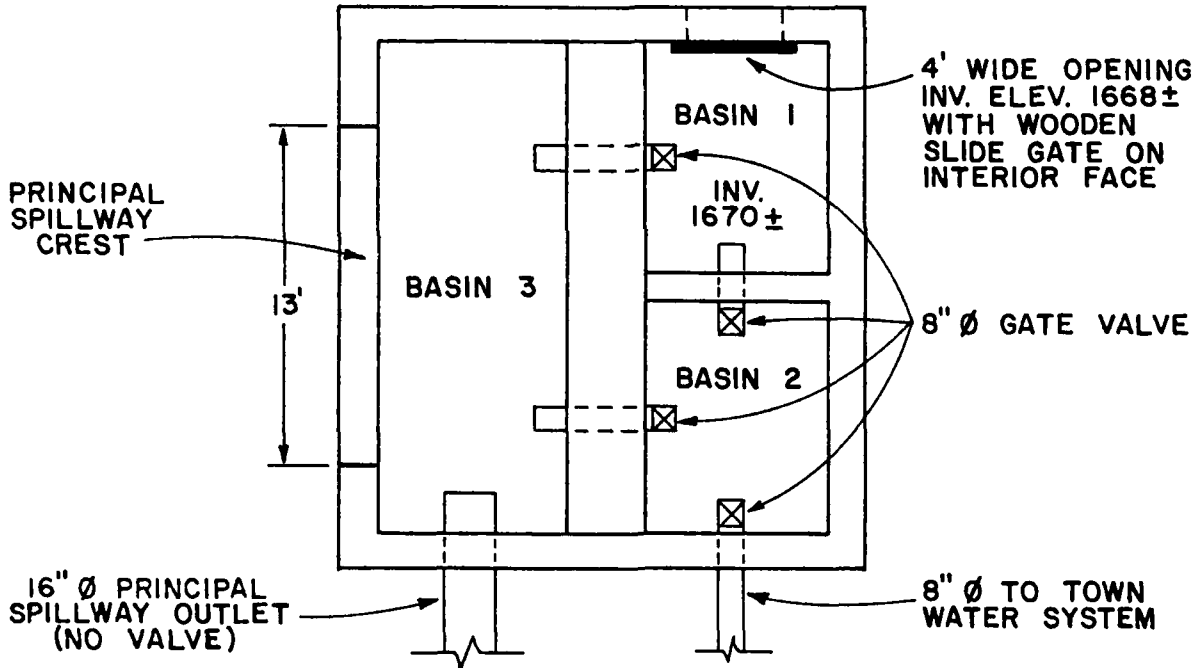
section. There is some minor cracking in the joints of the stone masonry riser section. There is a walkway to the gate house which is constructed of railroad track and wooden planking. The walkway extends into the foundation of the gate house and into the upstream face of the embankment. There is no handrail associated with this walkway.

Inside the gate house there are loose wooden planks that are laid across the openings to the basins. This planking comprises the floor of the gate house. Inspection of the basins is done by lifting one or more of the planks.

The gate house is a 23 foot by 21 foot wooden structure which is located to the right of the left abutment. It is in relatively good condition for this type of structure. The foundation of the gate house is the stone masonry riser
