HOUSATONIC RIVER BASIN  
BECKET, MASSACHUSETTS

GREENWATER POND DAM  
MA 00204

PHASE I INSPECTION REPORT  
NATIONAL DAM INSPECTION PROGRAM

MARCH, 1981

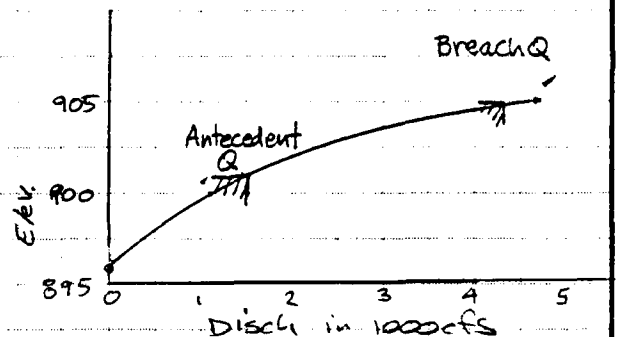
Note - Some large  
boulders in channel  
say water 1' higher due to  
this factor

Note - Breach flow would not flood houses but  
could cause streambank erosion - mill (Clark Aiken)  
near stream -  $V = 10$  fps
