HOUSATONIC RIVER BASIN  
MONTEREY, MASSACHUSETTS

LAKE GARFIELD DAM  
MA 00249

PHASE I INSPECTION REPORT  
NATIONAL DAM INSPECTION PROGRAM

MARCH 1980

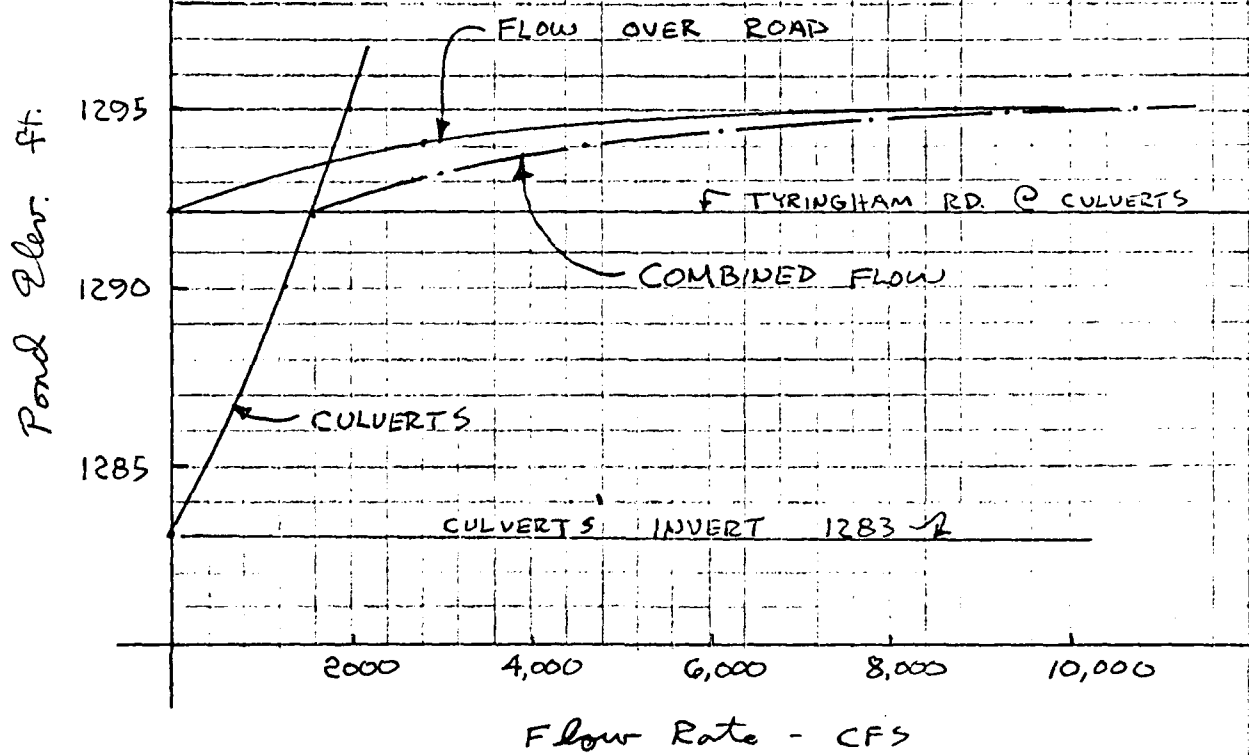
Figure 5

Tyringham Rd. Culvert Capacities.

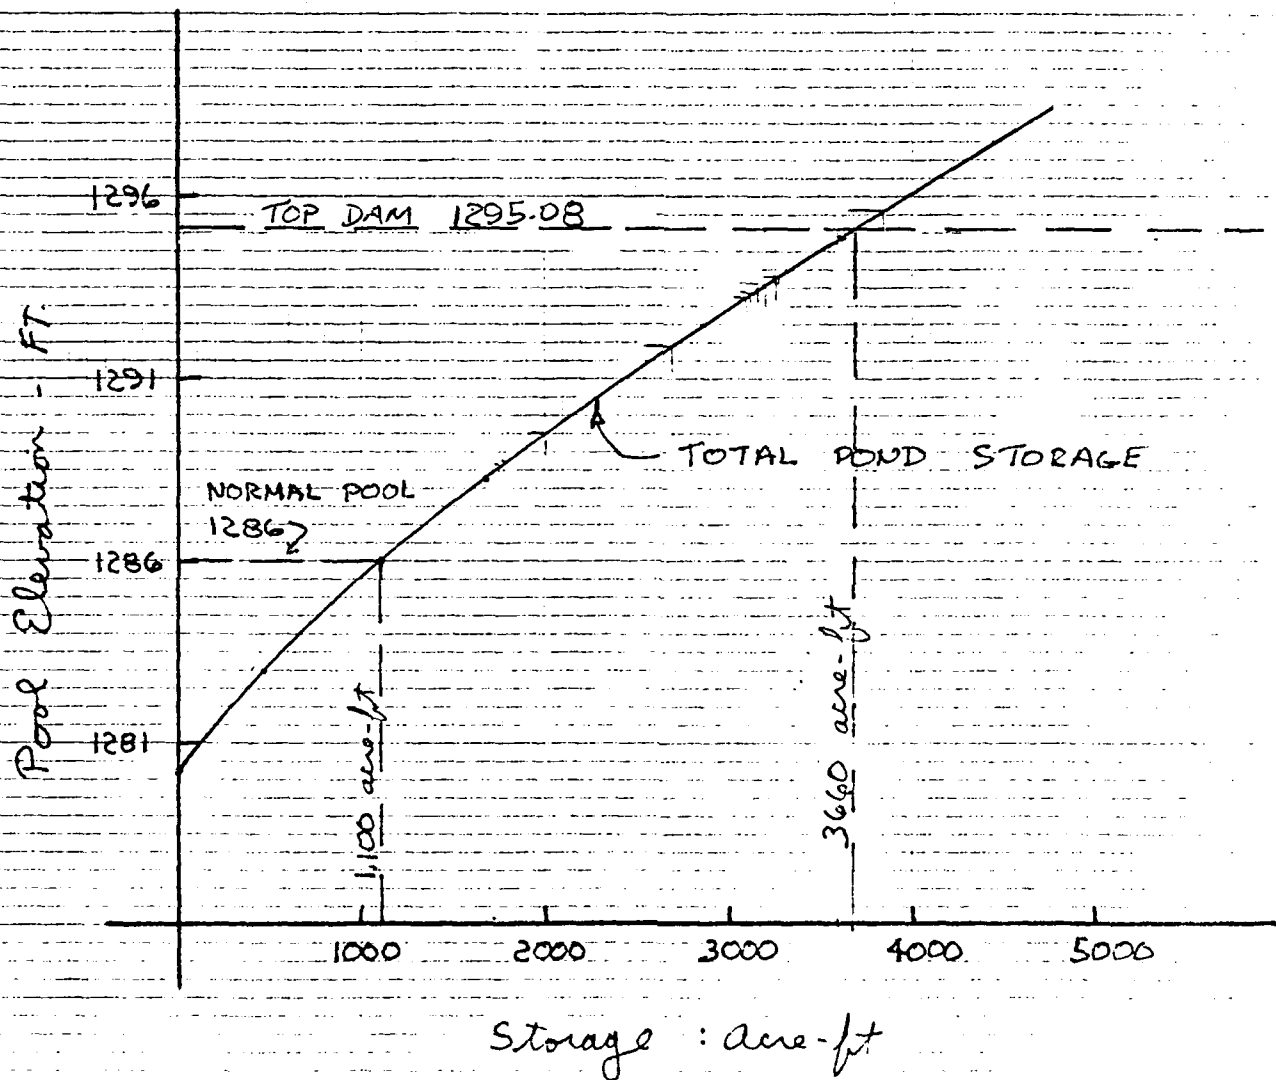
Figure 7

Pool Elev. vs. Storage
