NATIONAL PROGRAM FOR INSPECTION OF NON-FEDERAL DAMS
SEBAGO LAKE DAM (ME-0... (U) CORPS OF ENGINEERS WALTHAM
MA NEW ENGLAND DIV SEP 78

ME-00071
DOCUMENT IDENTIFICATION

Sep 1978

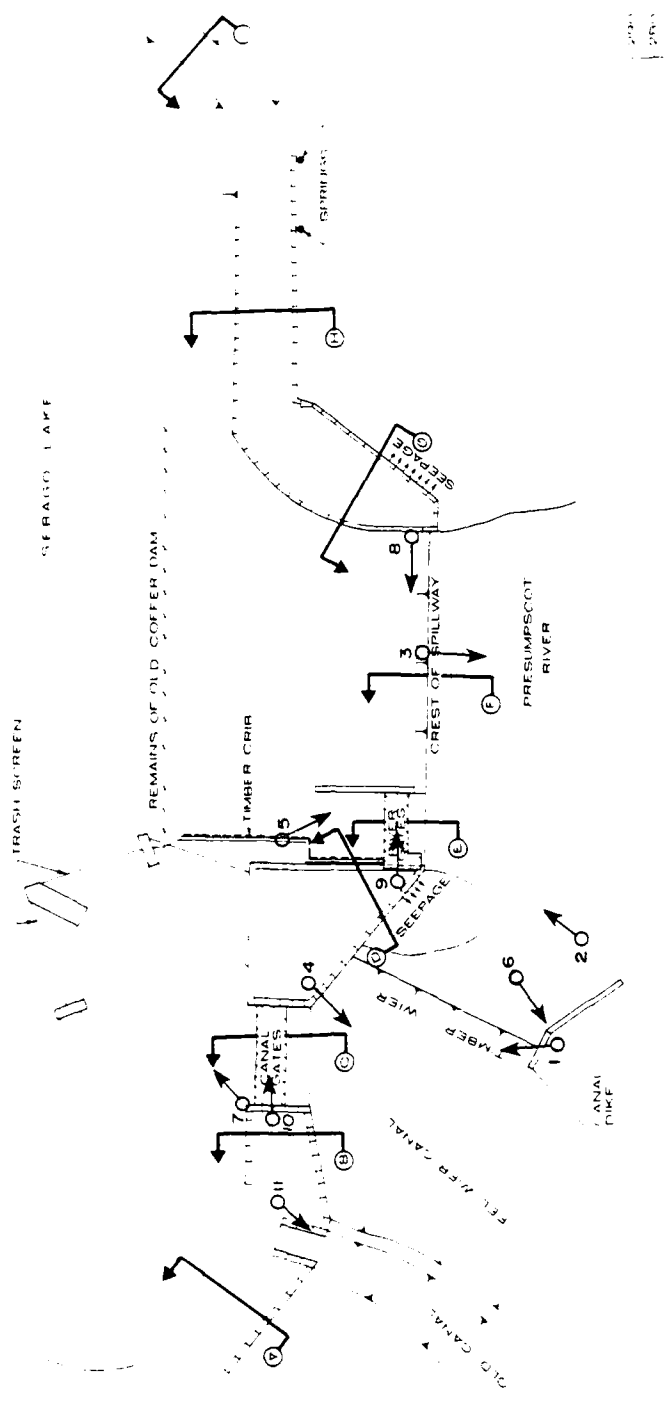
B-1.2

Seepage was also observed along the toe of the downstream masonry wall of the north wing wall of the dam. In two areas, see plan, springs have developed and moderate seepage (probably less than 10 gpm) is occurring.
