CHARLES RIVER BASIN  
HOLLISTON, MASSACHUSETTS

HOUGHTON POND DAM  
MA 00444

PHASE I INSPECTION REPORT  
NATIONAL DAM INSPECTION PROGRAM

JULY 1979

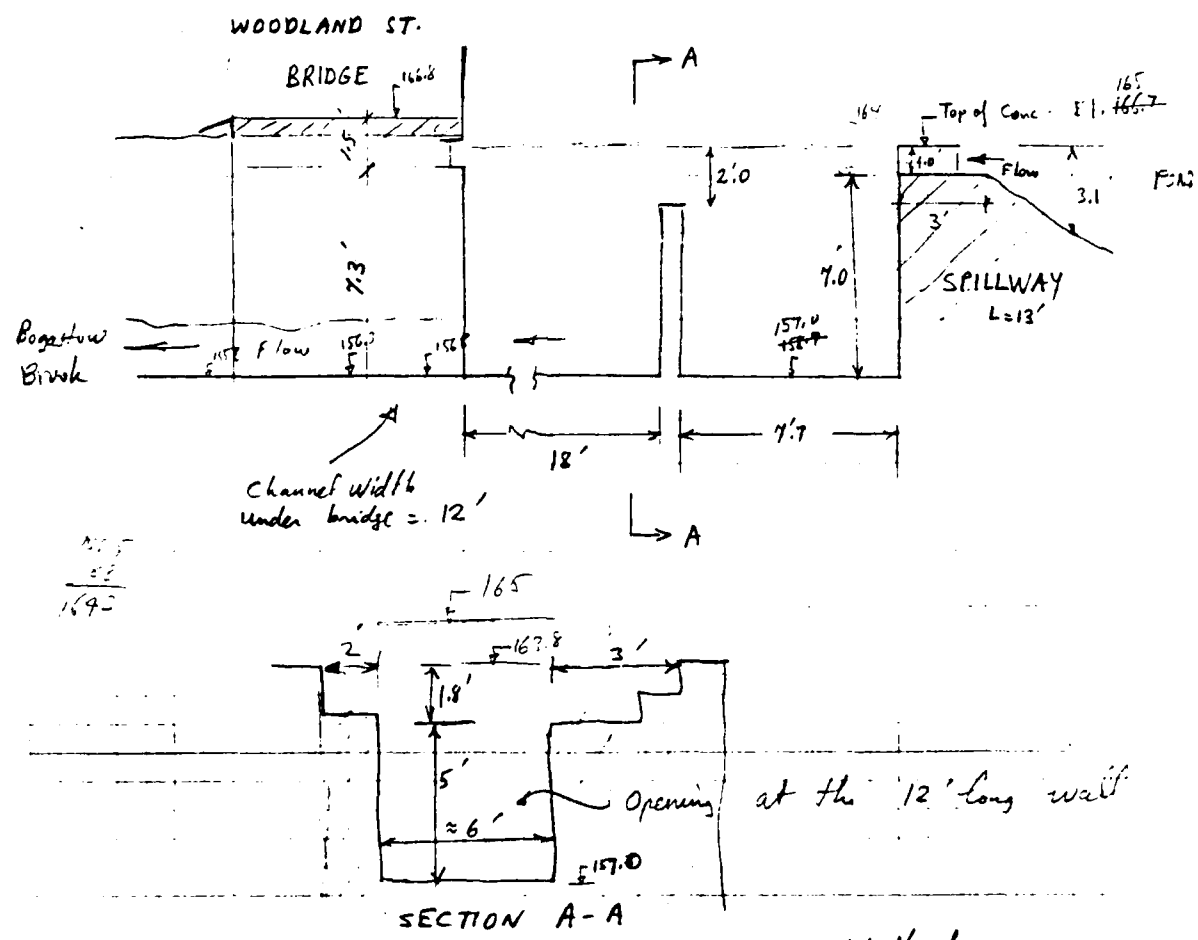
## SECTION THROUGH FACTORY POND OUTLET & WOODLAND STREET BRIDGE

An old road exist on downstr side of the Woodland Str. Bridge. This old road was collapsed and dislocated; its surface hanging into the channel 3.3' below the surface of the Woodland St.
