COASTAL BASIN
LYNN, MASSACHUSETTS

BIRCH POND DAM

MA 00237

PHASE I INSPECTION REPORT
NATIONAL DAM INSPECTION PROGRAM

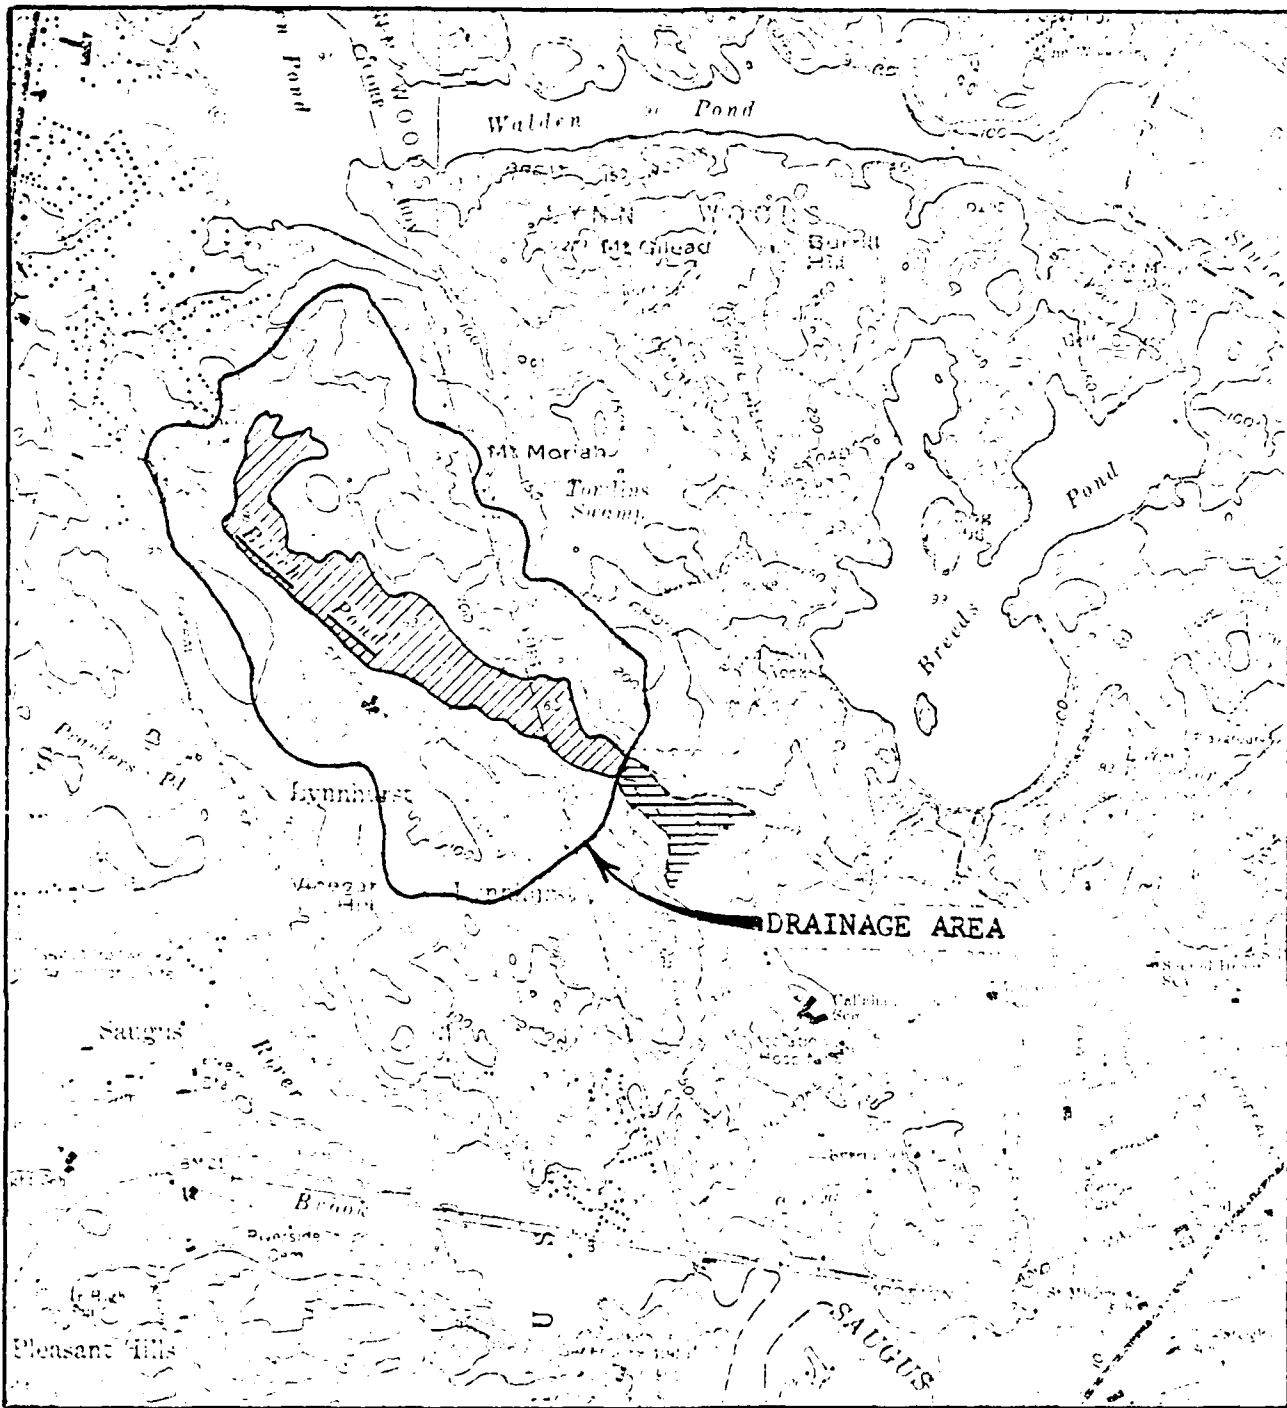
OVERVIEW PHOTO

The dam is in poor condition. The upstream face is overgrown and eroded, the embankment crest deteriorated and abused by improper usage. The spillway contains growth and debris. Apart from an occasional motorbike trail, the downstream slopes are not eroded.

Additional investigations or major modifications are not necessary. Remedial measures that should be implemented by the owner within one year after receipt of this Phase I Inspection Report are described in Section 7. The dam is in serious need of extensive maintenance. The upstream face should be restored, the crest brought to true grade and surfaced, erosion on the downstream face eliminated, and the spillway cleaned and improved.
