# LYNN RESERVOIR DAM

MA 01285

## PHASE I INSPECTION REPORT NATIONAL DAM INSPECTION PROGRAM

JULY, 1981

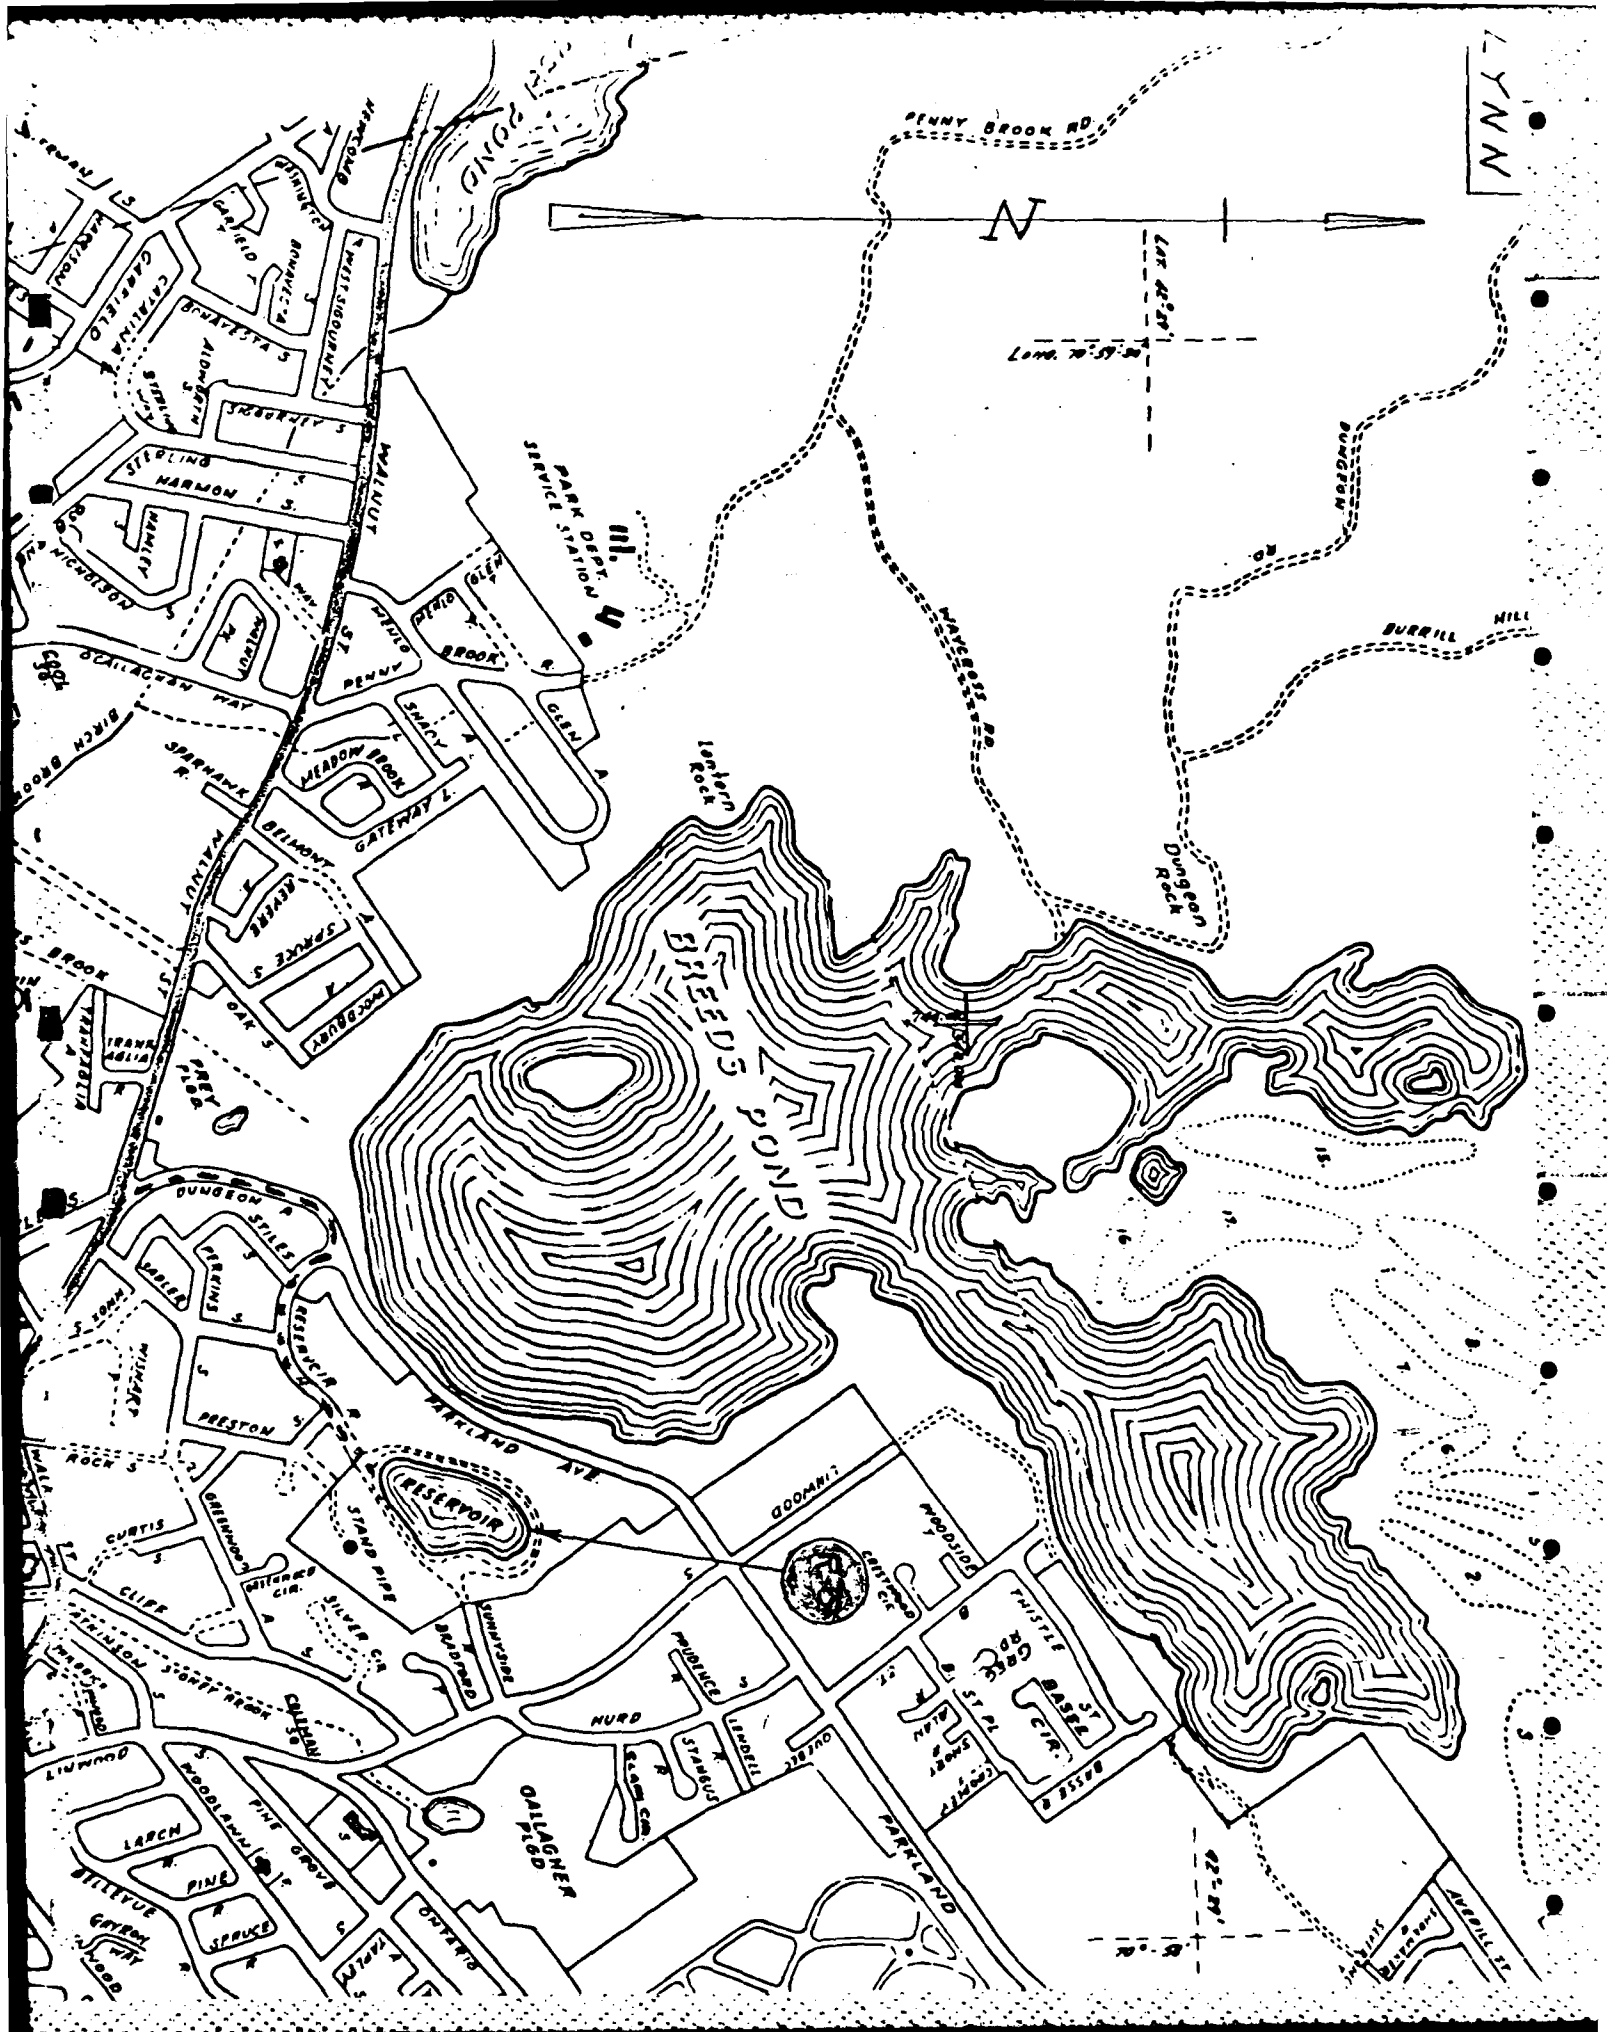
THIS RESERVOIR IN EXCELLENT  
CONDITION. WATER LEVEL TO-DAY 3.0 FT BELOW TOP OF  
CONCRETE AT OVERFLOW STRUCTURE ON EASTERLY SIDE  
OF RESERVOIR. MAN CUTTING SMALL TREES ON EMBANKMENT.

1964 March 1965. P.D.K. & K.M.J. Insp. Trees and brush growing in rip-  
rap should be removed.

1964 Report to Co. Comm. Trees and brush growing in riprap and on  
outside banks should be removed.
