**CONNECTICUT RIVER BASIN
CHARLEMONT, MASS.**

**J. A. WELLS UPPER DAM
MA 01268**

**PHASE I INSPECTION REPORT
NATIONAL DAM INSPECTION PROGRAM**

JUNE 1980

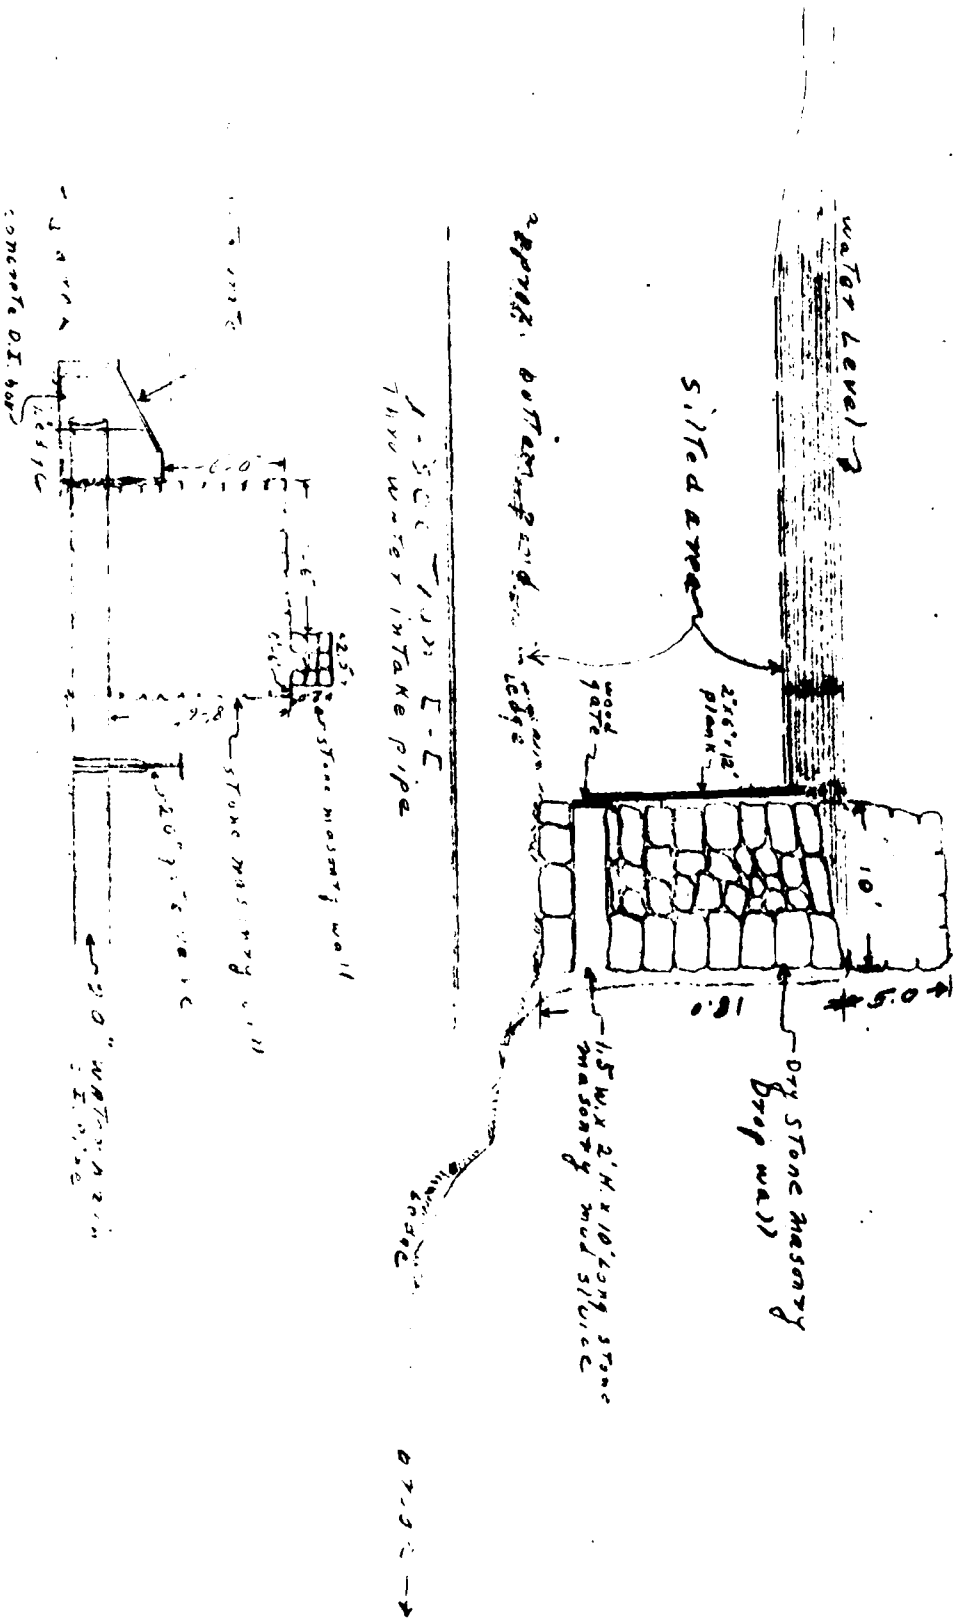
INSPECTION REPORT - DAMS AND RESERVOIRS

Due to silting of pondage area there is not a serious threat to dam wall at present time. However, if silt were to be removed to an overall depth of nine or ten feet of water in pond, repairs should be made to dam wall before it was refilled.

Siltage consists of layers of leaves, clay, gravel and general debris.
