NATIONAL PROGRAM OF INSPECTION OF NON-FEDERAL DAMS
DRAFT REPORT REVIEW COMMENTS

BOULTER DAM, IDENTITY NO. **ME 00194**

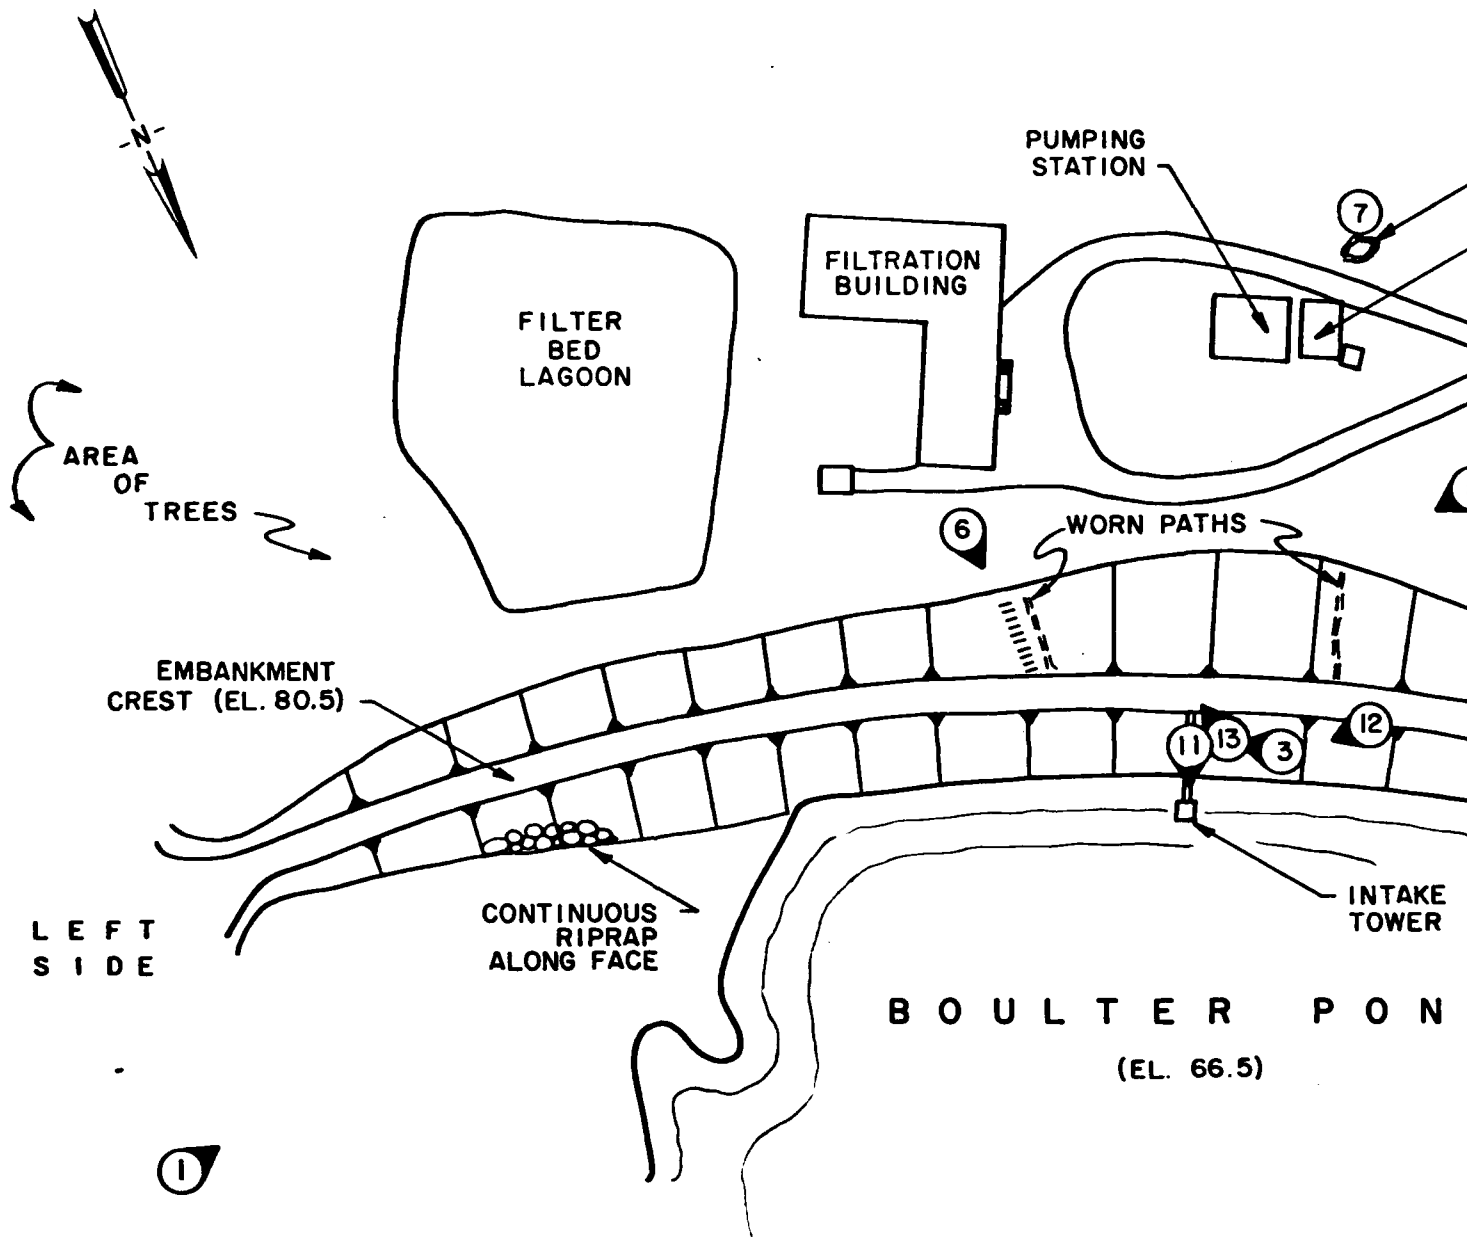
PLAN DEVELOPED FROM "SITE PLAN, PROPOSED DAM, KITTELY WATER DISTRICT, KITTELY, MAINE" BY WHITMAN & HOWARD, ENGINEERS, DATED OCTOBER, 1949 (SEE PAGE B-9) AND FIELD OBSERVATIONS MADE ON 2 NOVEMBER 1980.

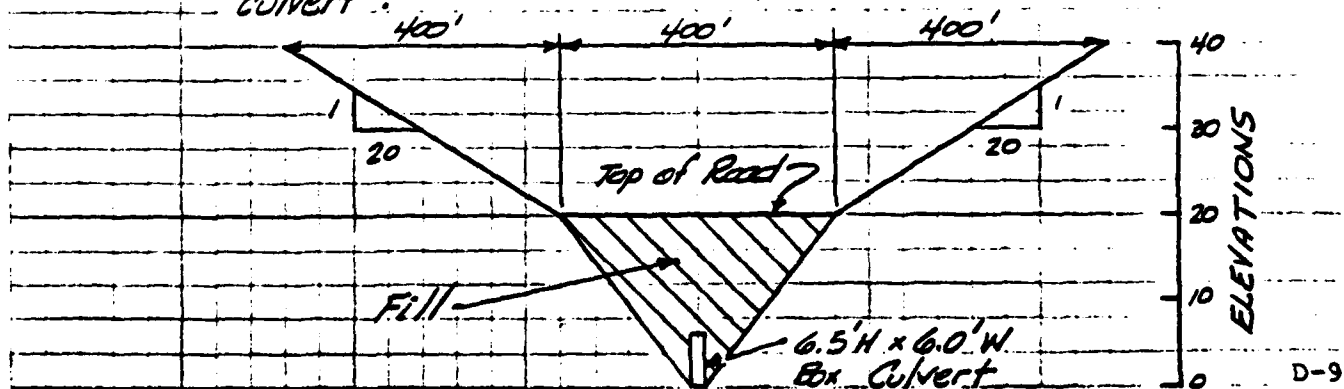
Determine amount of overtopping of the Rte. 91 culvert:
