LITTLE RIVER LOWER DAM  
ME 00288

PHASE I INSPECTION REPORT  
NATIONAL DAM INSPECTION PROGRAM

NOVEMBER 1979

Identification No.: ME00288  
Name of Dam: Little River Lower Dam  
Town: Belfast  
County and State: Waldo, Maine  
Stream: Little River  
Date of Inspection: September 17, 1979

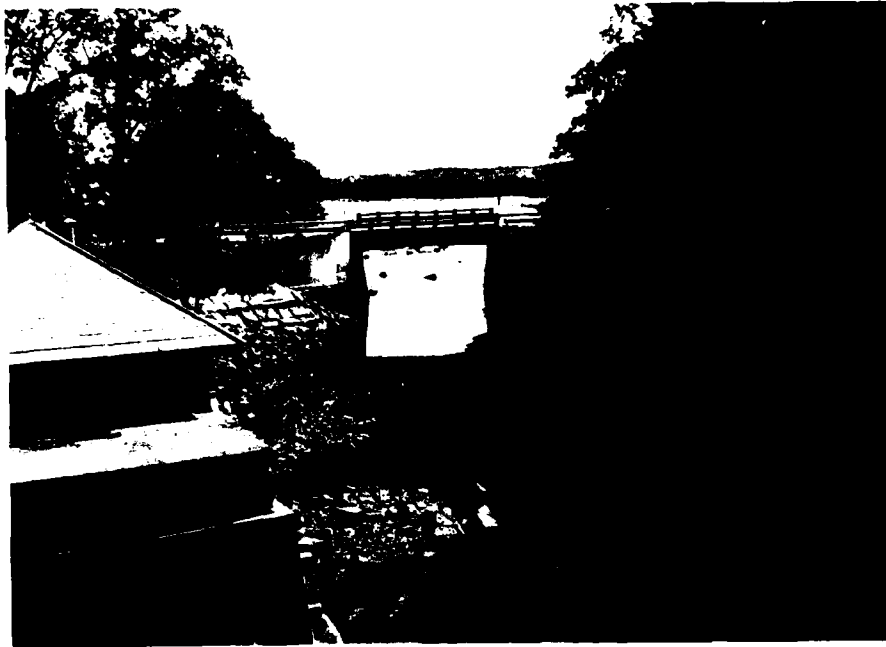
e. Downstream Channel. The downstream channel is bedrock. Trees overhang the south side of the channel. About 400 feet downstream of the dam is the U.S. Route 1 bridge that crosses the channel. (See Appendix C - Figure 12.) Little River discharges into Penobscot Bay through a channel lined with well-placed derrick stone. (See Appendix C - Figure 13.)

September 17, 1979  
 Figure 12 - Looking downstream at U.S. Route 1 bridge  
 from the north abutment of the dam.
