MERRIMACK RIVER BASIN
MANCHESTER, NEW HAMPSHIRE

MASSABESIC LAKE DAM
NH 00103

PHASE I INSPECTION REPORT
NATIONAL DAM INSPECTION PROGRAM

AUGUST 1978

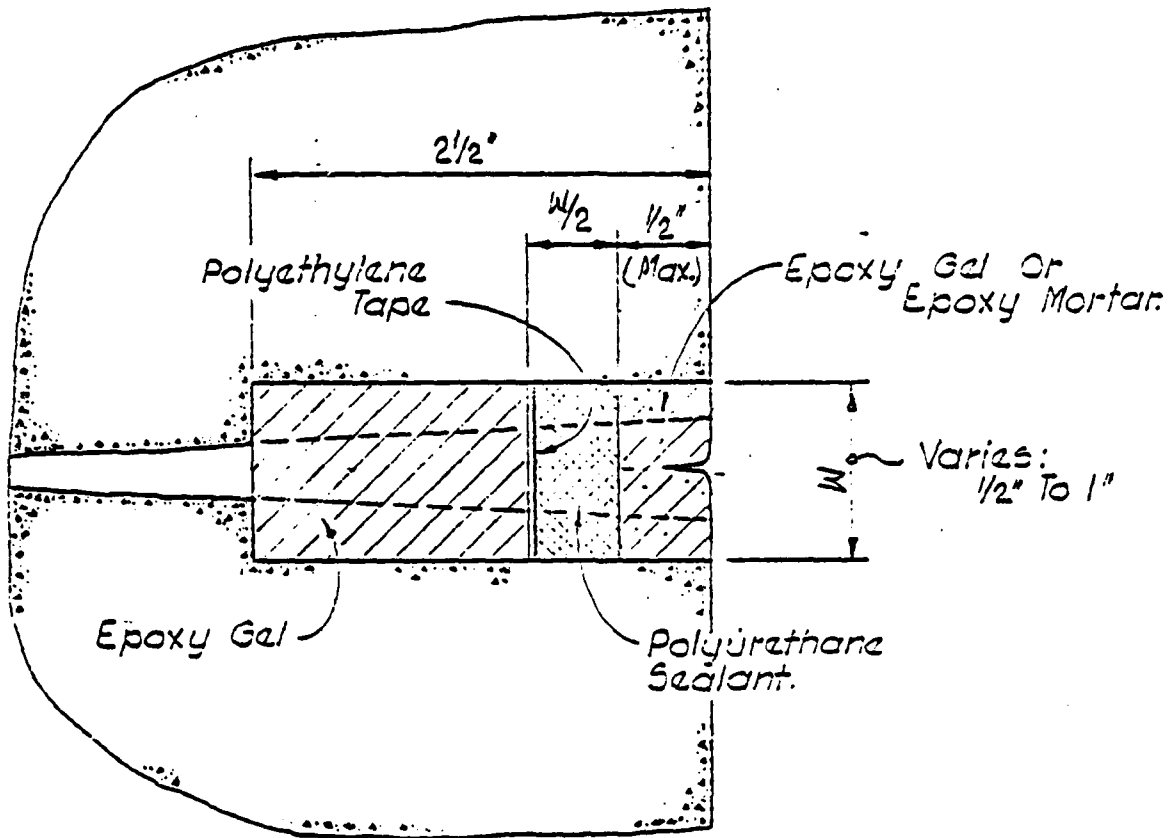
CRACK REPAIR

Vertical cracks on the spillway face have developed in recent years. The Cofferdam appears in sound and serviceable condition.
