CONNECTICUT RIVER BASIN  
CLAREMONT, NEW HAMPSHIRE

FITCH RESERVOIR DAM

PHASE I INSPECTION REPORT  
NATIONAL DAM INSPECTION PROGRAM

DECEMBER 1979

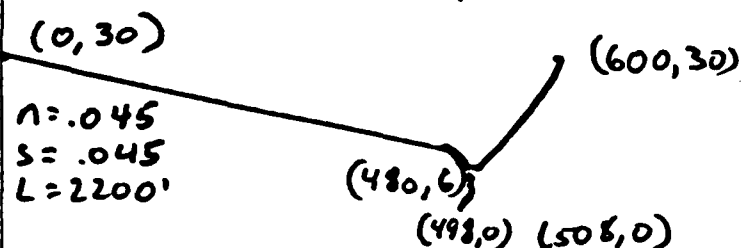
The following cross-section is typical for the reach from McQuade Res. Dam to Road Crossing #1 (based on field

notes and USGS topo):

A Depth-Normal Flow relationship for this reach is given on p. 17. The pre-failure flow of 240 cfs would cause about 2 feet of flow in this reach. The attenuation due to storage in the reach is calculated on p. 18.

The attenuated peak failure outflow of 13,500 cfs would create a stage of 11.2 ft at the downstream end of this reach. The two houses threatened by dam failure are about 25% of the way down this reach. Assuming 25% of the attenuation occurs before these houses are reached:

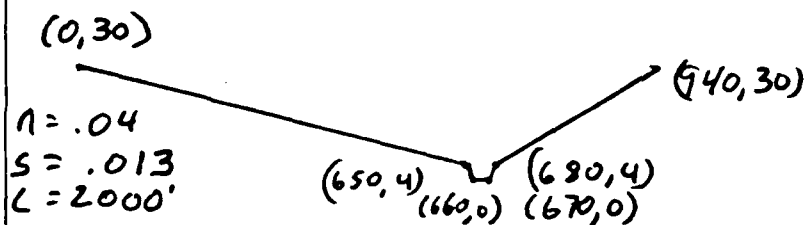
Grandy Brook next runs some 2000 feet through a flatter area with a broad floodplain to a small pond. The following typical cross-section for this reach is based on field notes and U.S.G.S topo information:

A Depth-Normal Flow relationship for this reach is given on p. 24. The pre-failure flow of 240 cfs would cause about 2 1/2 ft of flow. The attenuation due to storage in this reach is calculated on p. 25.
