DAN HOLE POND DAM

NH 00376

PHASE I INSPECTION REPORT
NATIONAL DAM INSPECTION PROGRAM

NOVEMBER 1978

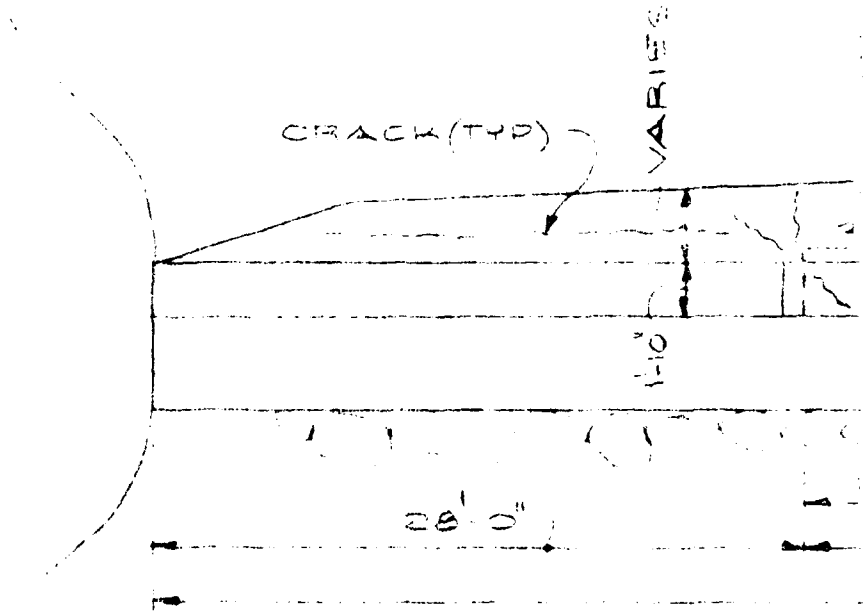
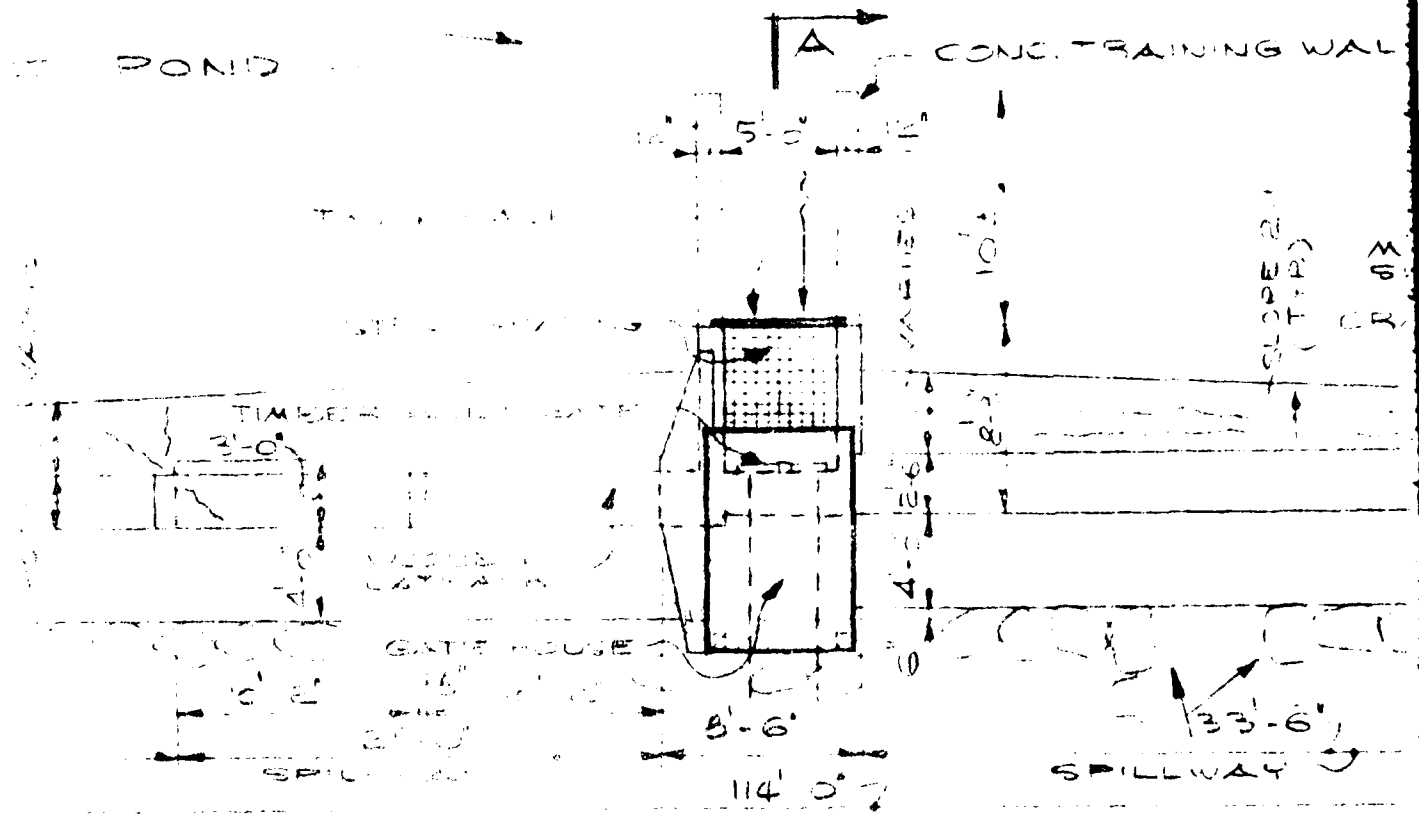
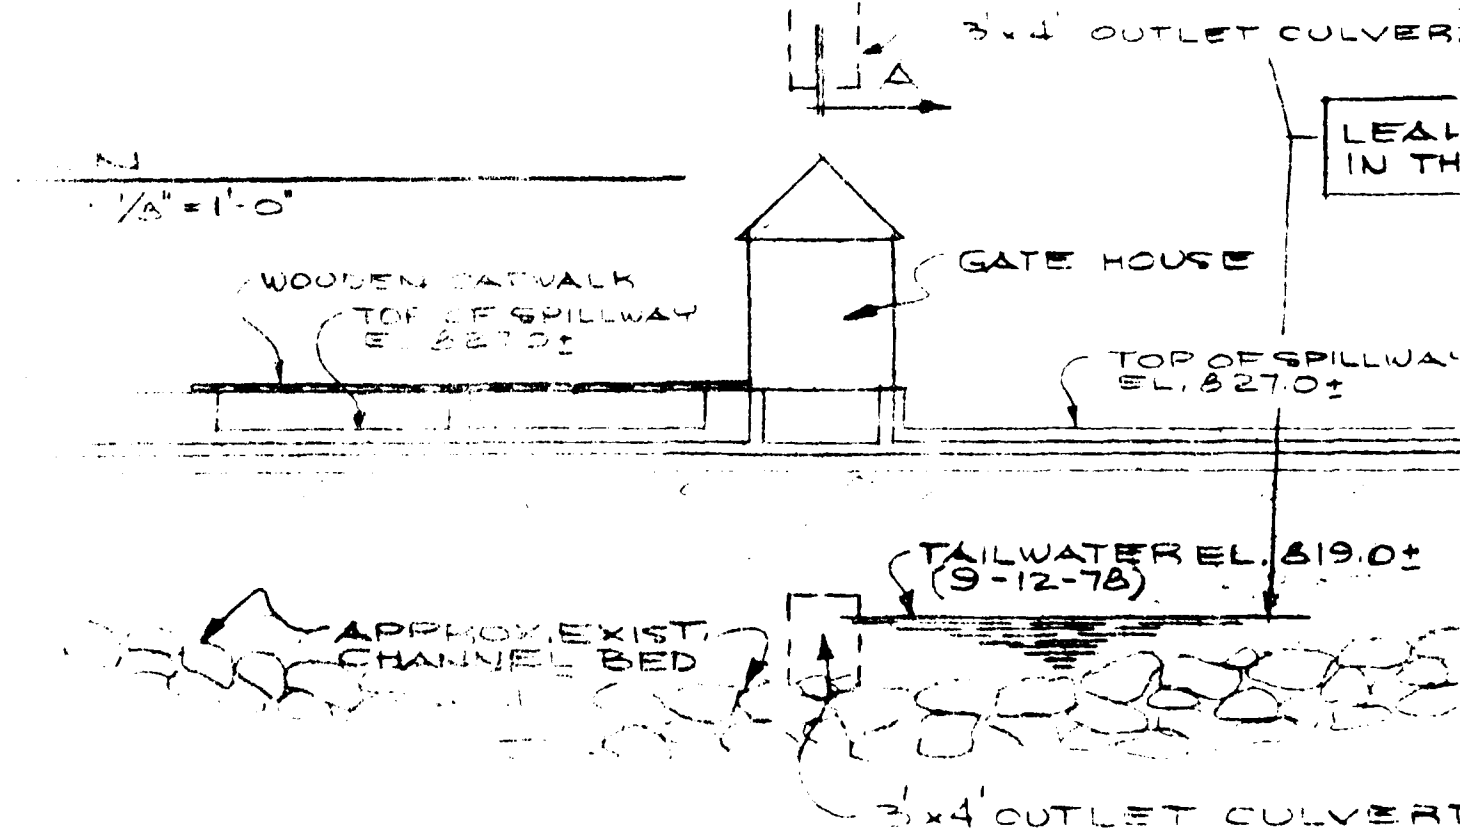
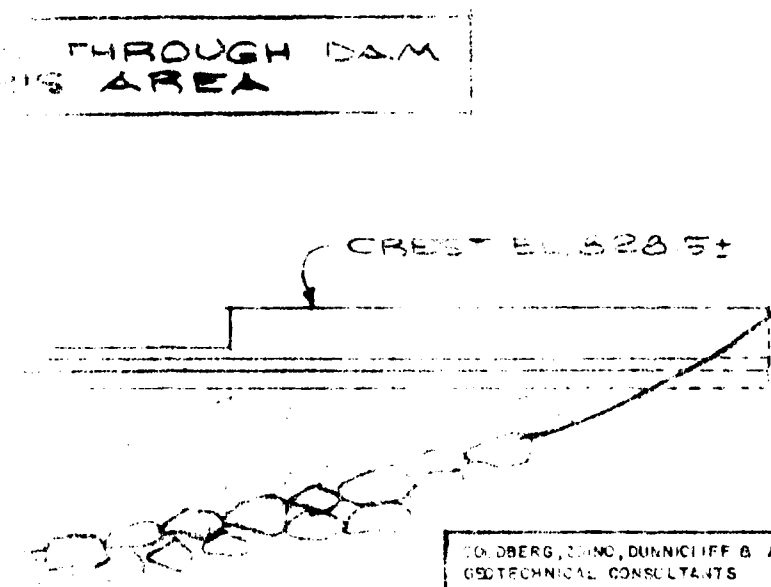
DOBERG, INC., DUNNICHIFF & ASSOC., INC. GEO-TECHNICAL CONSULTANTS NEWTON UPPER FALLS, MASS.		U.S. ARMY ENGINEER DIV NEW ENGLAND CORPS OF ENGINEERS WALTHAM, MASS.	
NATIONAL PROGRAM OF INSPECTION OF NON-FED. DAMS FIG. 2			
DAM HOLE POND DAM		NEW HAMPSHIRE	
		SCALE	AS NOTED
		DATE	SEPT 1978

This dam is a concrete faced, cemented stone masonry gravity structure 114 feet long (Fig. 2). The downstream side of the dam is buttressed with dumped boulders (Fig. 3). A gate house located midway along the length of the dam divides a broad crested spillway, 21 feet long to the right of the structure and 33.5 feet long to the left. The top of the spillway is 1.5 feet below the dam crest. While the dam does contain stanchions for flashboards, this feature is not used. A wooden catwalk spans over the right spillway for access to the gate house. Foundation conditions at the site are not apparent. The dam has a maximum height of approximately 12.5 feet above the channel.
