PISCATAQUA RIVER BASIN
WAKEFIELD, NEW HAMPSHIRE

UNION MEADOWS DAM
N.H. 00222

PHASE I INSPECTION REPORT
NATIONAL DAM INSPECTION PROGRAM

NOVEMBER 1979

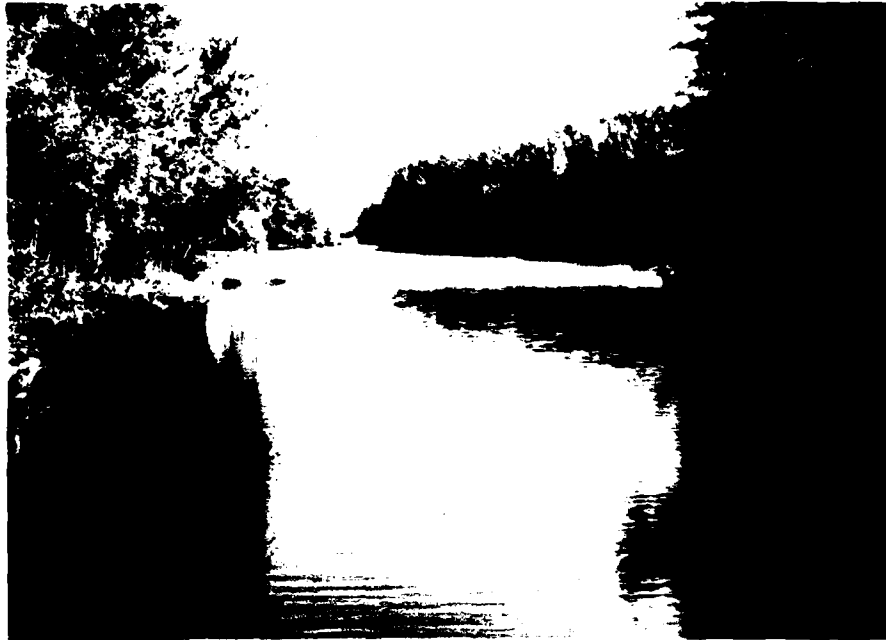
e. Downstream Channel. The bottom of the downstream channel is covered with sand, gravel, and boulders. Trees overhang the east bank of the channel between the dam and the highway bridge immediately downstream of the dam. (See Appendix C - Figure 7.)

condition. Trees growing on the east bank of the discharge channel between the dam and State Route 16 would obstruct the channel and the culvert downstream if they should fall over during floodflow conditions.

September 19, 1979
Figure 7 - Looking north at upstream reservoir from
top of B&M Railroad bridge.
