CONNECTICUT RIVER BASIN  
LEBANON, NEW HAMPSHIRE

MASCOMA DAM NO. 2

PHASE I INSPECTION REPORT  
NATIONAL DAM INSPECTION PROGRAM

JULY 1980

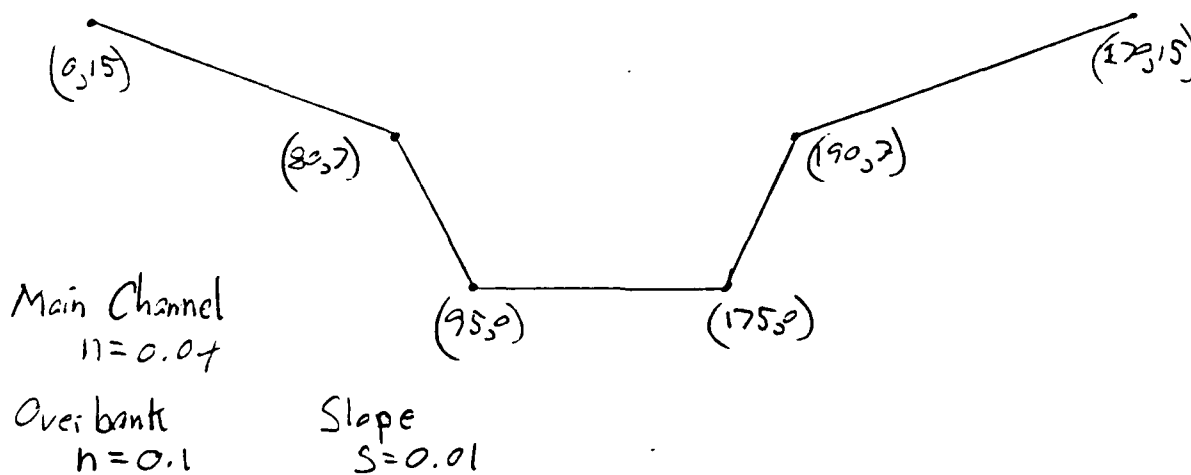
Mascoma R. d/s of Mascoma Dam No. 2

A uniform flow rating table for this reach based on the approxi-  
mate section sketched below is shown on the next page. This was  
calculated using a simple BASIC program.

The calculated rating table agrees reasonably with the FIS profiles  
for this reach.

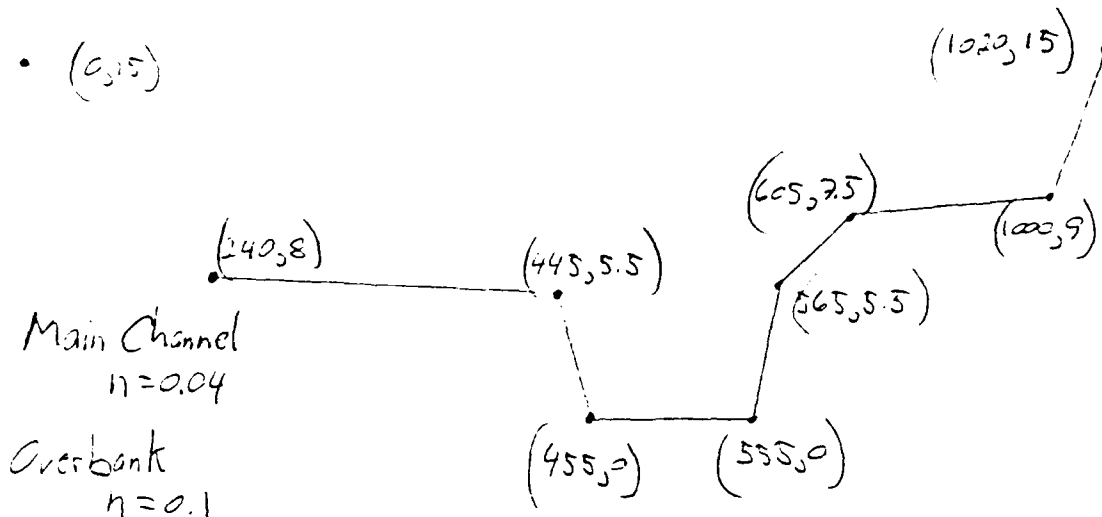
Mascoma R. 3000' d/s  
of Glen Fed. Dam

Prior to Failure
