CONNECTICUT RIVER BASIN
HANOVER, NEW HAMPSHIRE

UPPER RESERVOIR DAM

NH 00049

PHASE I INSPECTION REPORT NATIONAL DAM INSPECTION PROGRAM

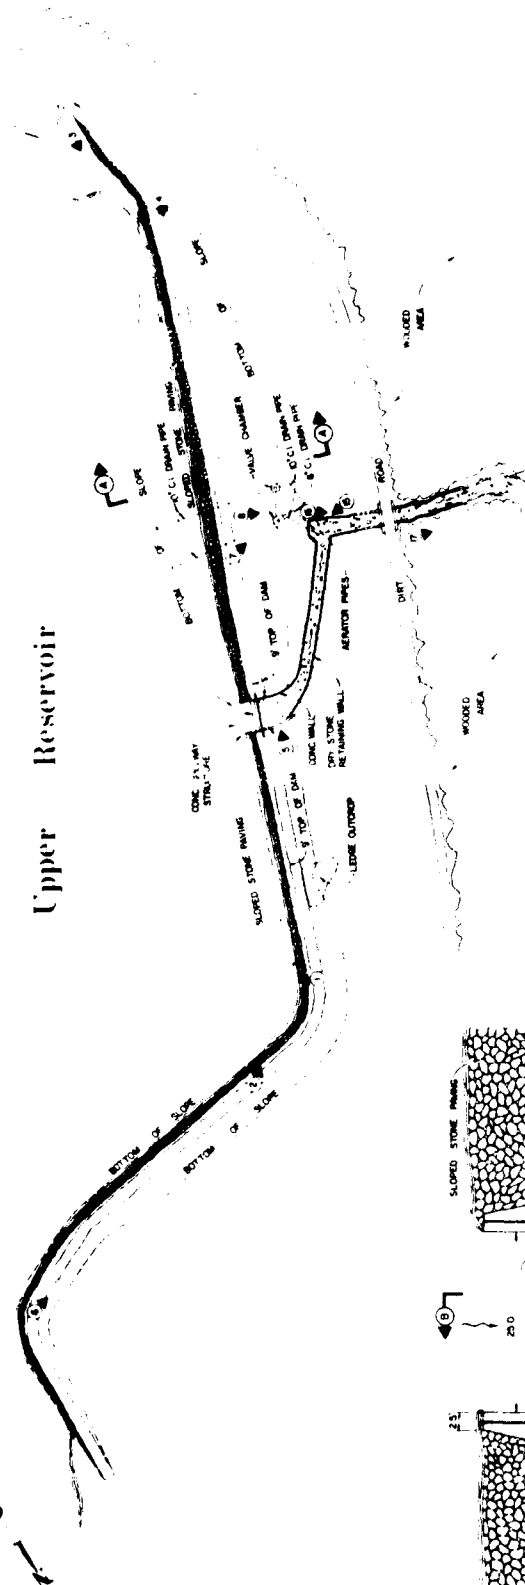
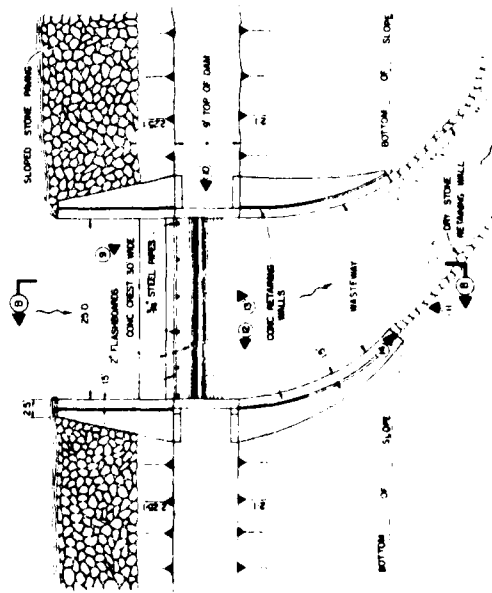
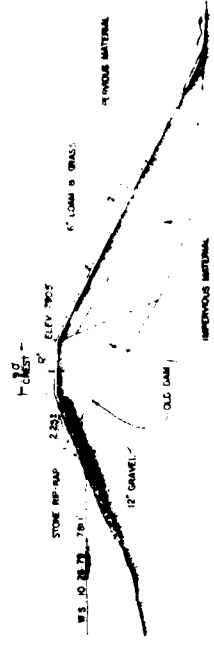
Figure 1 of 2

Figures 1 and 2 located in Appendix B, show a plan of the dam and its appurtenant structures. Photographs of each structure are shown in Appendix C.

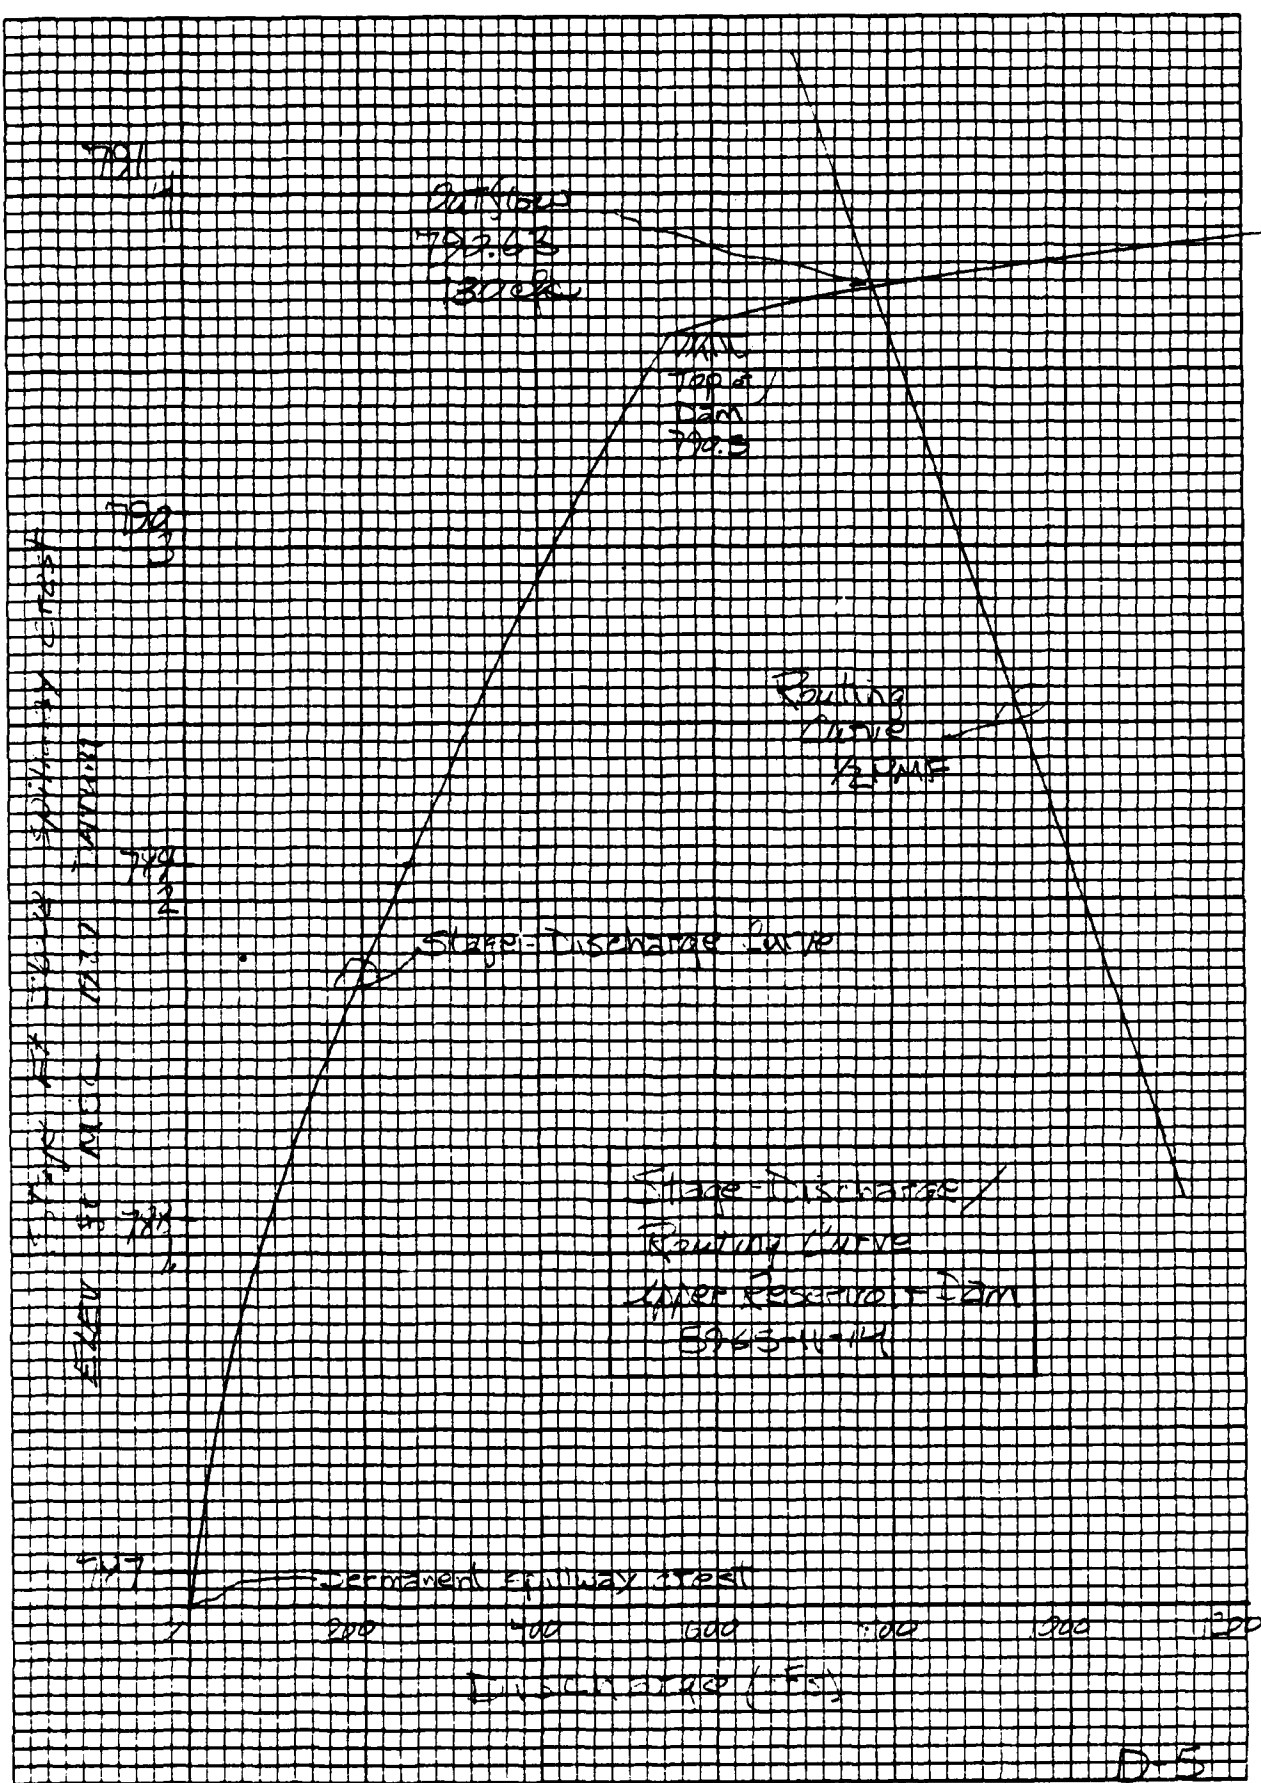
D-5
FIGURE 1

See Figure 1 for Outflow 780 cfs
