PROVIDENCE RIVER BASIN  
WOONSOCKET, RHODE ISLAND

HARRIS POND DAM  
RI 03901

PHASE I INSPECTION REPORT  
NATIONAL DAM INSPECTION PROGRAM

FEBRUARY, 1979

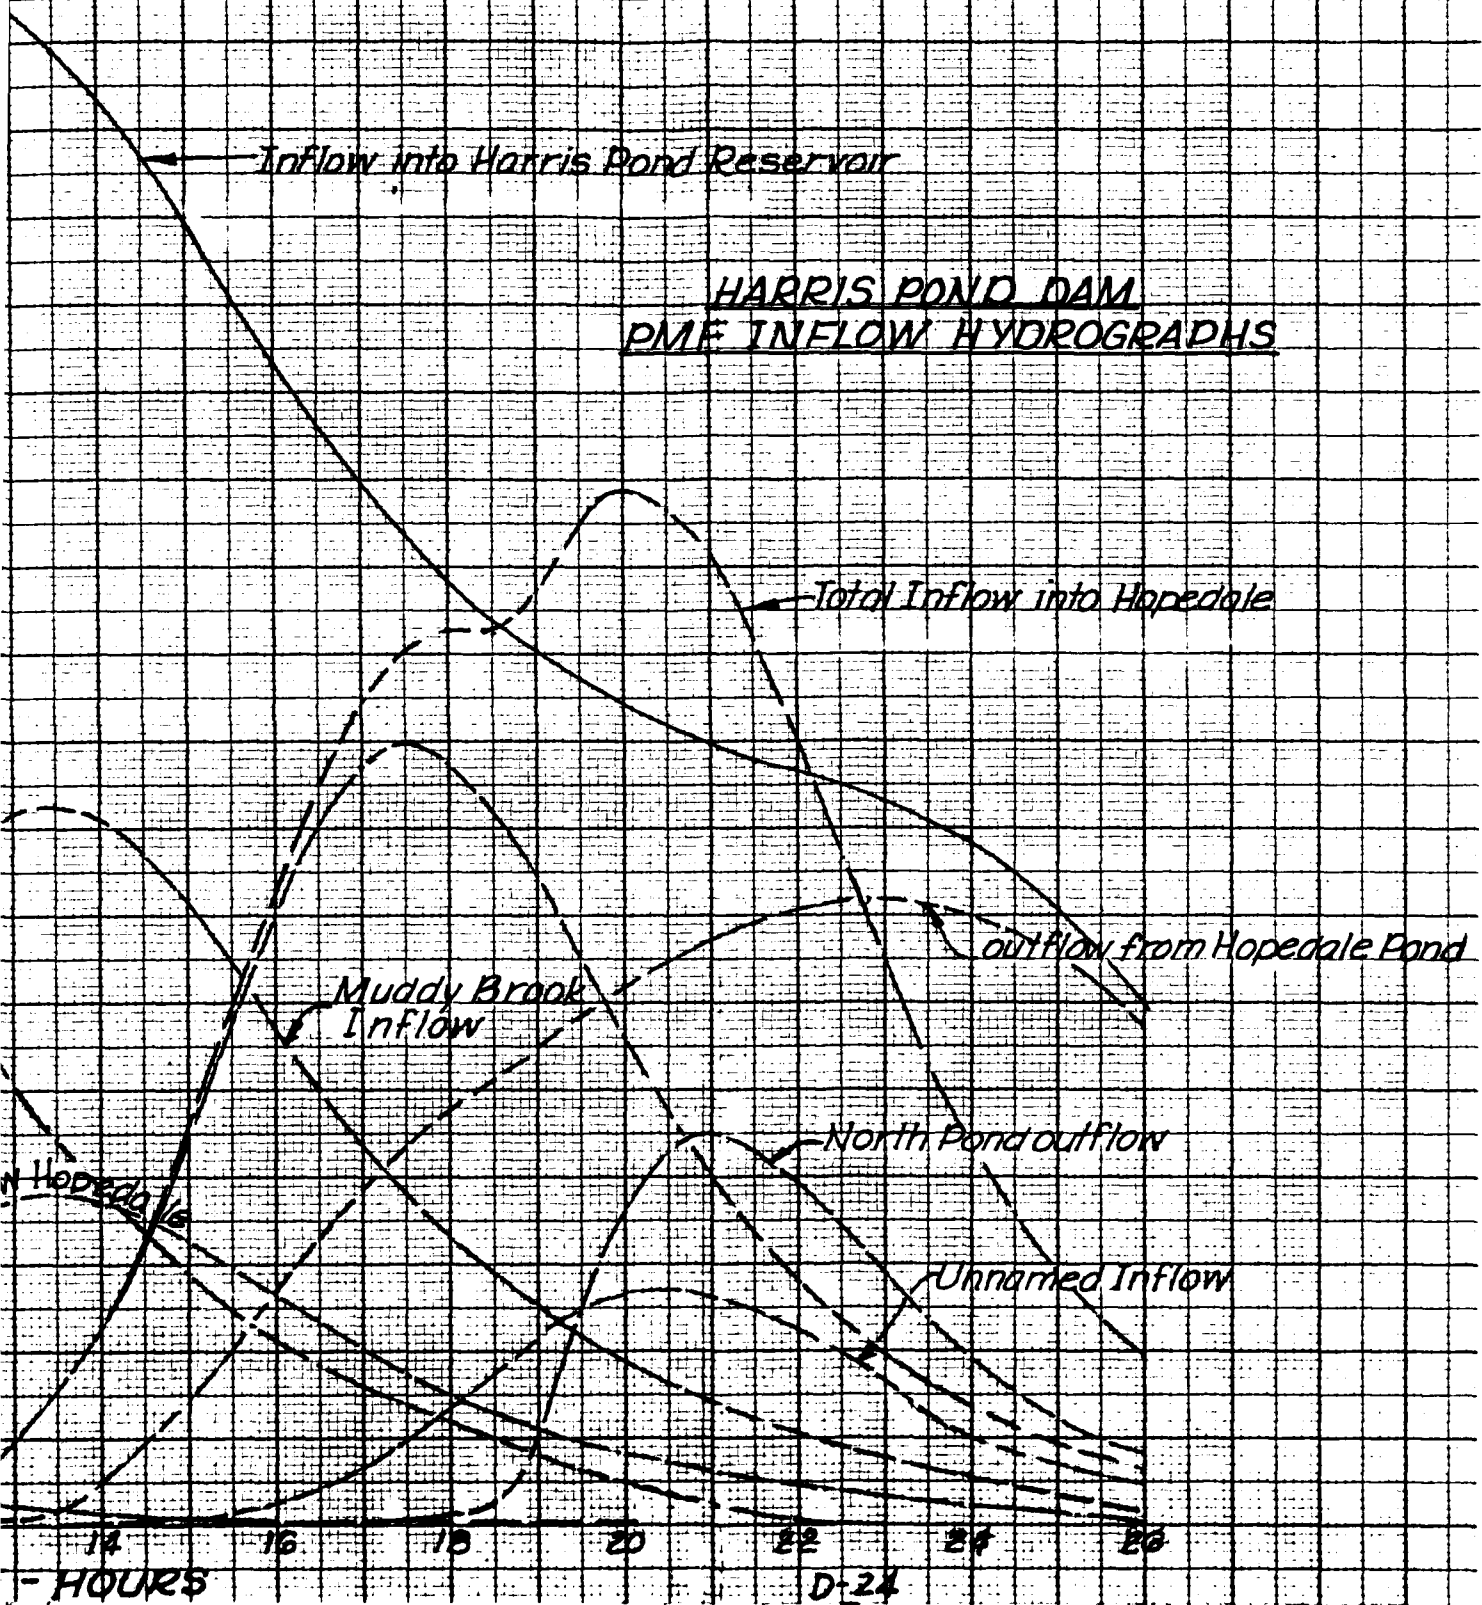
FIG. 6 SHT D-25

reservoir and Lake Hiawatha. This combination of sub-hydrographs is plotted on Fig. 5, Sheet D-24, to represent the PMF inflow for routing through Harris Pond reservoir and spillway. The maximum PMF inflow is 17,500 cfs. The resulting flood routing through Harris Pond reservoir shown on Figure 6, Sheet D-25, indicates a maximum outflow of 17,200 cfs at surcharge storage head elevation 175.9. Of this discharge, 14,400 cfs would be released through the spillway and 2,900 cfs would spill over the right end of the dike and along the mill parking lot (see plan and profile on Figure 1, Sheet D-1). For this flood, approximately 3,000 acre-ft. of the runoff would be spilled over the dike and right abutment during a duration of 20 hrs.
