MERRIMACK RIVER BASIN  
LYNDEBOROUGH, NEW HAMPSHIRE

SOUHEGAN RIVER WATERSHED  
DAM NO. 8  
NH 00474  
NHWRB 147.28

PHASE I INSPECTION REPORT  
NATIONAL DAM INSPECTION PROGRAM

AUGUST 1985

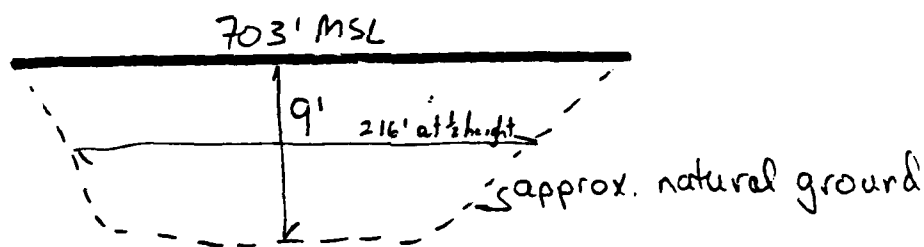
There are three dikes associated with this dam. The critical failure would be the main dam, but we will look quickly at the effects of failure of the others.  
South Dike (or east dike)

This Dike separates the drainage area of Souhegan River Watershed Dam #8 from that of SRWD #33:

Assume failure with watersurface at 699' MSL (see p. 16)

$Q_p = 1625$  cfs. This is the peak dam failure outflow.

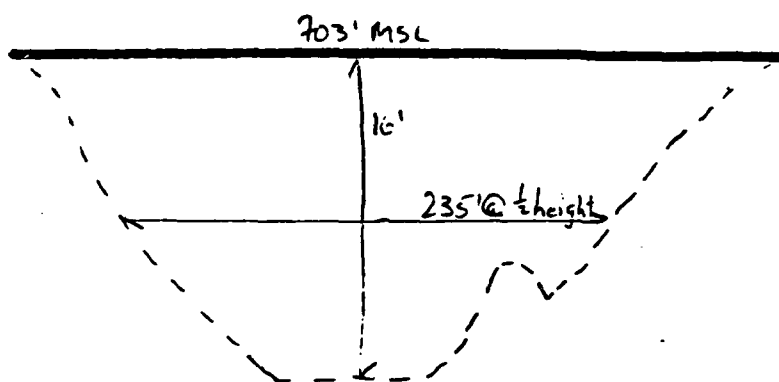
Cemetery Dike

This dike is about 1000 ft. south of the main dam,  
across Cemetery Road:

Assume failure with water surface at 699' MSL (see p. 16)

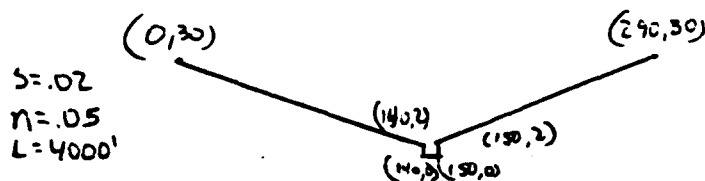
For about 4000 ft. downstream of the dam, Furnace Brook is a mountain stream - steep and in a narrow channel. The only development in this reach from the dam to the Boston and Maine Railroad Bridge is two secondary roads which cross the brook on culverted embankments. The following typical cross-section is based on field notes and USGS topo information:

A Stage-Normal flow relationship for this reach is given on p. 18. The pre-failure flow of 1430 cfs would create a stage of 6.7 feet in this reach, which would overtop the two roadway embankments. The attenuation due to

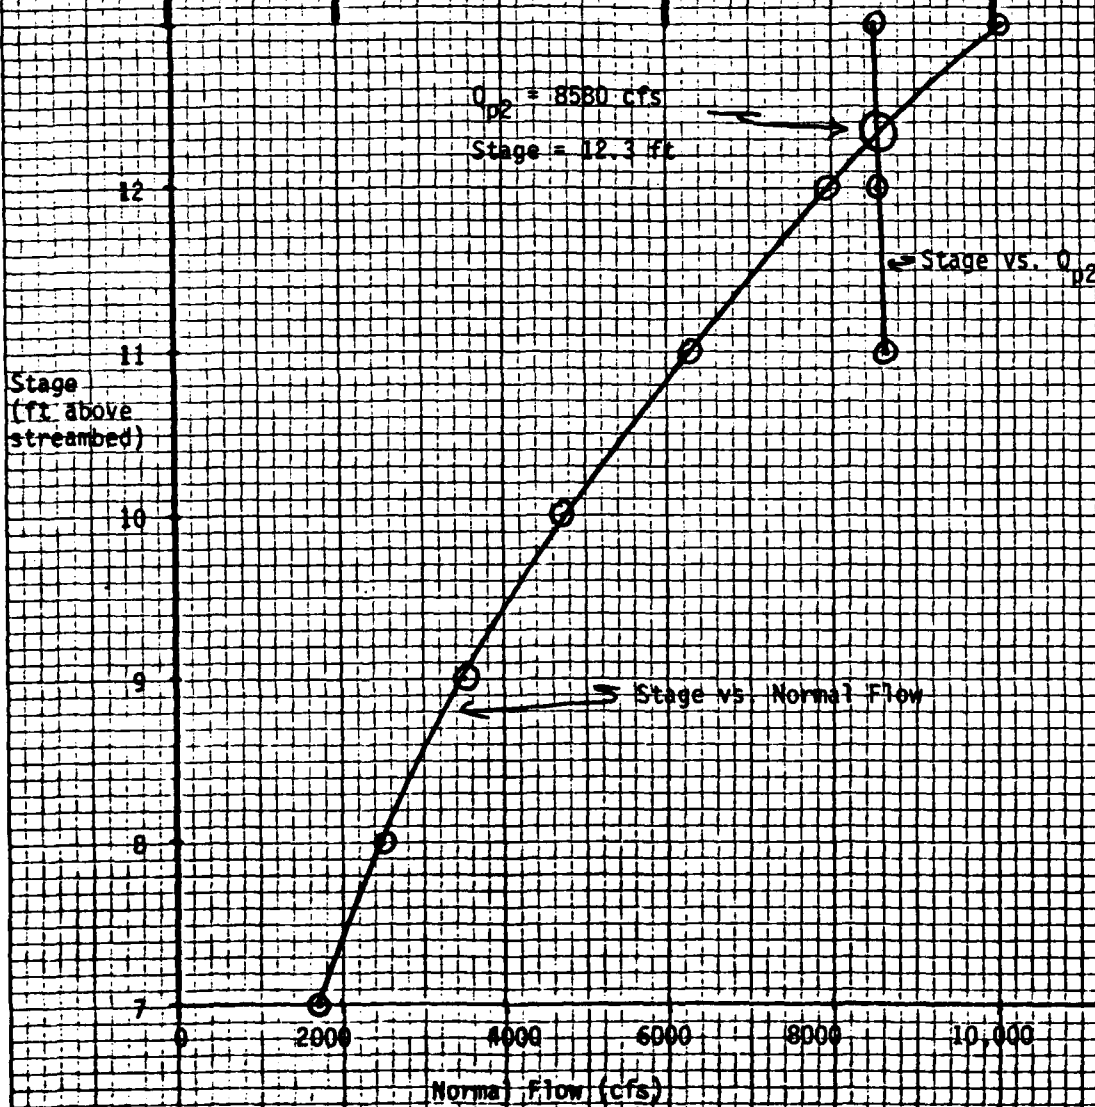
# Attenuated Peak Dam Failure Flow at Boston & Maine Railroad Bridge

Storage in this reach is calculated on p. 19. The attenuated peak dam failure flow at the railroad would be 8580 cfs, which would create a stage of 12.3 ft. in this reach. This would severely overtop and probably damage or destroy the two road crossings in the reach.

The railroad bridge itself has about a 40' x 30' high opening. Therefore, it should neither restrict flows a great deal nor be threatened by dam failure stage.

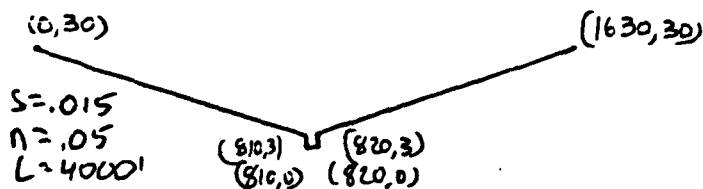
Downstream of this bridge, Furnace Brook is flatter, with a wider floodplain for the 4000' to its confluence with Stony Brook. There is some development in this reach. Just downstream of the railroad bridge there are three houses about 20 feet above the streambed (500 ft. from the stream). At the downstream end of the reach there is another house 15-20' up. The B&M railroad and New Hampshire Highway 31 both parallel Furnace Brook well above the stream. The following typical cross-section for the reach is based on field notes and USGS quad information.

A stage-Normal Flow relationship for this reach is given on p. 21. The pre-failure flow of 1430 cfs would create a stage of 5.7 ft. in the reach. The attenuation due to storage is calculated on p. 22.

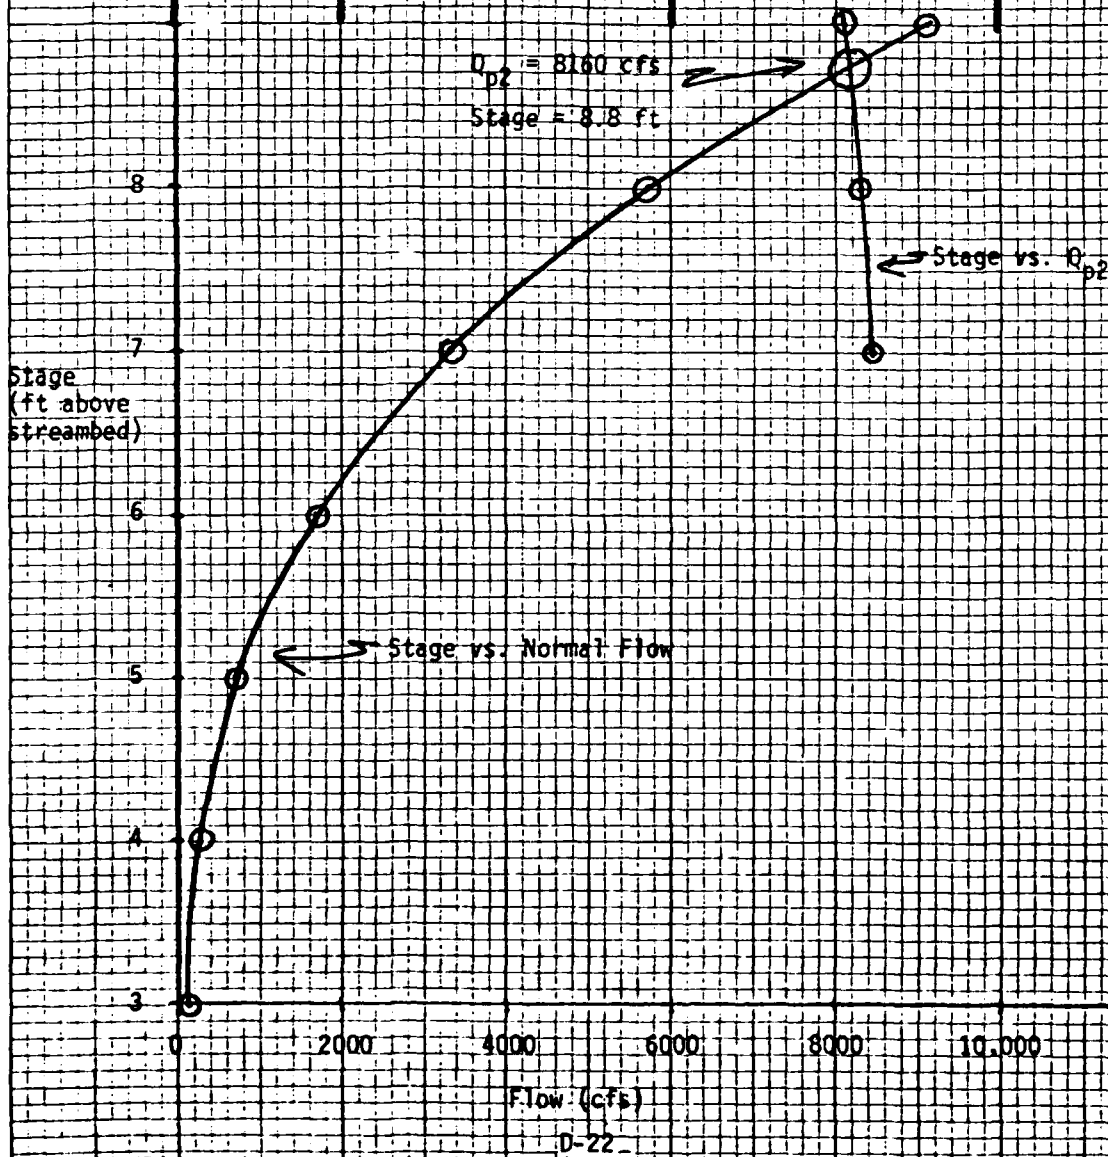
# Attenuated Peak Dam Failure Flow at Confluence with Stony Brook

The attenuated peak dam failure flow at the confluence with Stony Brook would be 8160 cfs, yielding a stage of 8.8 ft. This would not cause significant damage in this reach.

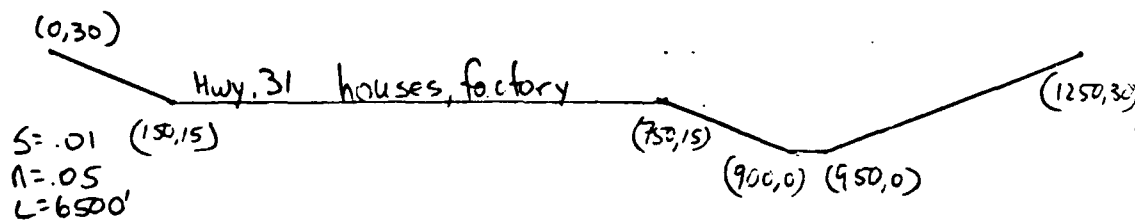
After Furnace Brook enters Stony Brook, Stony Brook flows about 6500 ft. before it is joined by Stockwell Brook. This reach has a broad stream, with an extensive flat area to one side (the southwest) about 15 ft. above the streambed. This flat area contains some development - 1-5 houses and a large large factory-type building (under construction), as well as N.H. Highway 31. The B&M railroad runs well above the stream on the other side. The following typical cross-section for this reach is based on field notes and USGS topographic information.

A Stage-Normal Flow relationship for this reach is given on p. 24. The pre-failure flow of 1930 cfs (assuming 500 cfs inflow from Stony Brook) would create a stage of 3.8 ft. in this reach. The attenuation due to storage in the reach is calculated on p. 25.

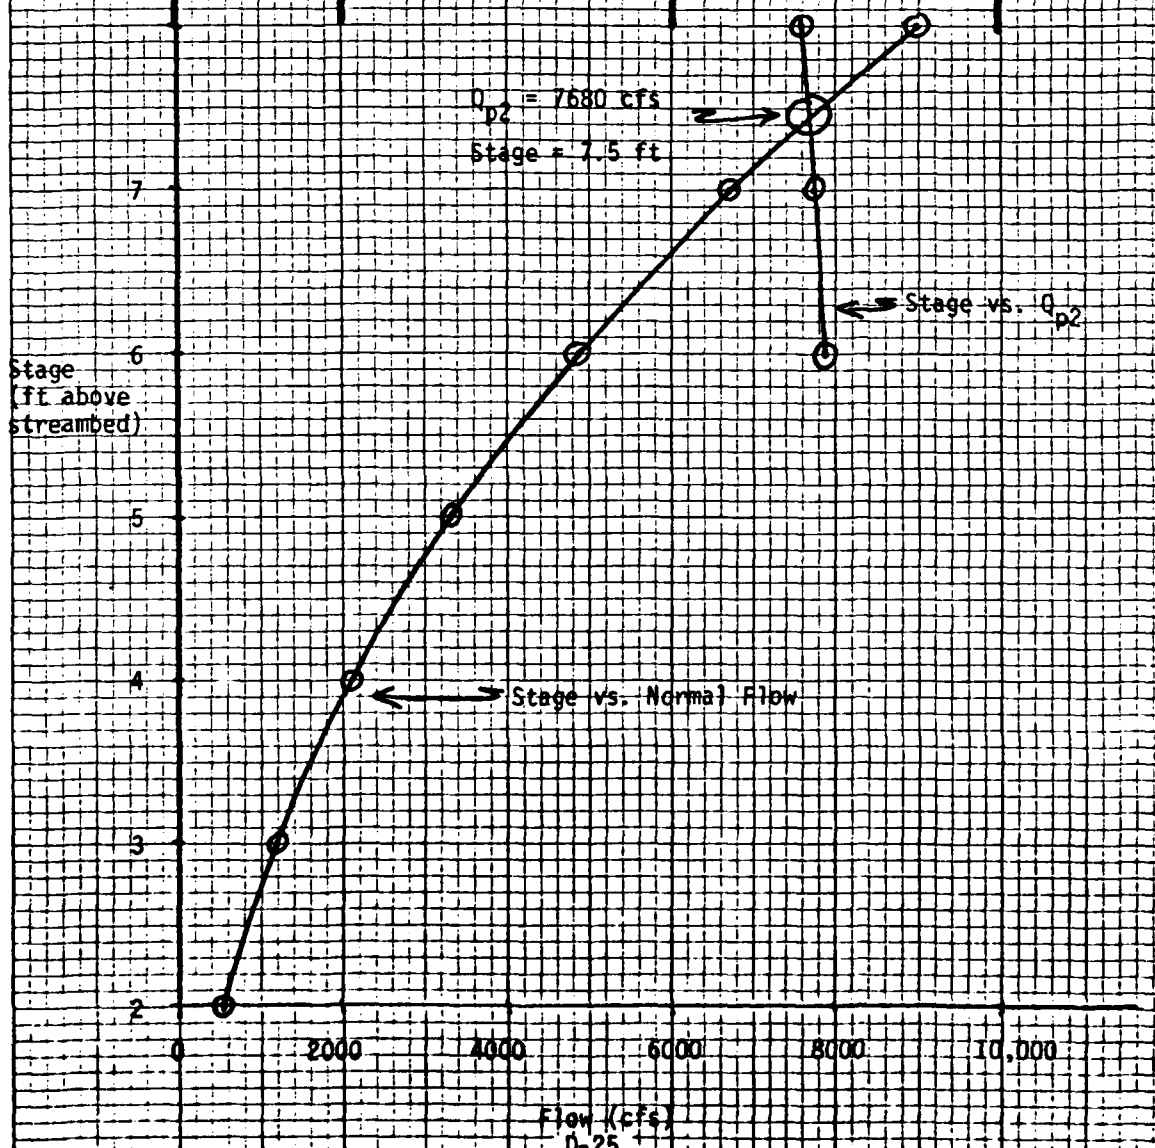
# Attenuated Peak Dam Failure Flow at Confluence of Stony and Stockwell Brooks

The attenuated peak dam failure flow at the confluence of Stony and Stockwell Brooks would be 7680 cfs, yielding a stage of 7.5 ft. This would not cause significant damage in this reach, although at least one dirt road crosses the stream on a low bridge which would probably be overtopped. This flow does not include any assumed inflow from Stony Brook which would make dam failure flows higher and increase downstream damages. If the inflow were on the order of 500 cfs, this increase would be small.

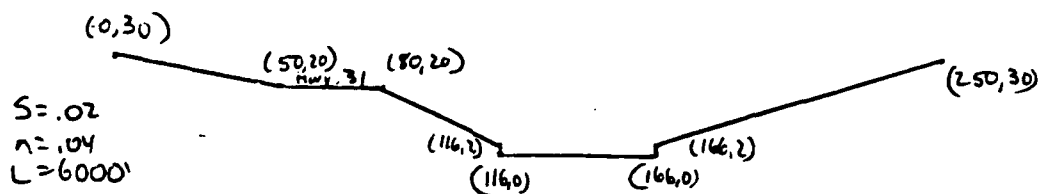
The brook is paralleled by U.S. Highway 31, and crossed by the B&M railroad (on a high trestle). The following typical cross-section is based on field notes and USGS topo information

A Stage-Normal Flow relationship for this reach is given on p. 27. The pre-failure flow of 2430 cfs (assuming 500 cfs inflow from Stockwell Brook) would create a stage of about 4.0 ft. in this reach. The attenuation due to storage in the reach is calculated on p. 28.

The attenuated peak dam failure flow at the downstream end of this reach is 7510 cfs, which creates a stage of 7.6 ft. This would cause little damage in this reach. This flow does not include any assumed inflow from Stockwell Brook, which would make dam failure flows higher and increase downstream damages. If the

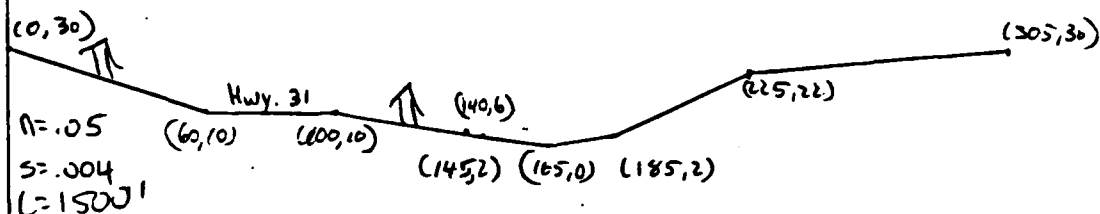
At the outskirts of Wilton, Stony Brook becomes much less steep. The brook is paralleled by Highway 31, and there is a row of houses between the highway and the stream. The first floors of these houses are quite close to Stony Brook. There are nine houses with first floors 7'-12' above the streambed, and two about 18 ft. up. This reach also includes an apartment building about 12 ft. above the streambed and a laundry about 10 ft. up. Across Highway 31 there are numerous (20+) houses and businesses about 25 ft. above the streambed. This reach runs about 1500 ft. to the confluence with the Souhegan River. The typical cross-section for this reach given below is based on USGS topo information and field notes.

Attenuation in this short reach is assumed to be negligible. The pre-failure flow of 2430 cfs would result in a stage of 9.1 feet, which would cause 0-2 ft. of flooding at the nine low-lying houses. The peak dam failure flow of 7510 cfs would result in a stage of 13.9 ft. in this reach, increasing flooding by 5 ft. to 2-7 ft. at the low-lying houses, to 4 ft. at the laundry, and to 2 ft. at the apartment <sub>D-29</sub> (See Stage-Normal Flow, p. 30)

This sudden rise would present a threat of loss of life, especially at the houses. It would also flood (by about 4 ft.) and possibly damage Highway 31 in this area.
