PAWTUXET RIVER BASIN  
CRANSTON, RHODE ISLAND

CRANSTON PRINT WORKS POND DAM  
RI 00701

PHASE 1 INSPECTION REPORT  
NATIONAL DAM INSPECTION PROGRAM

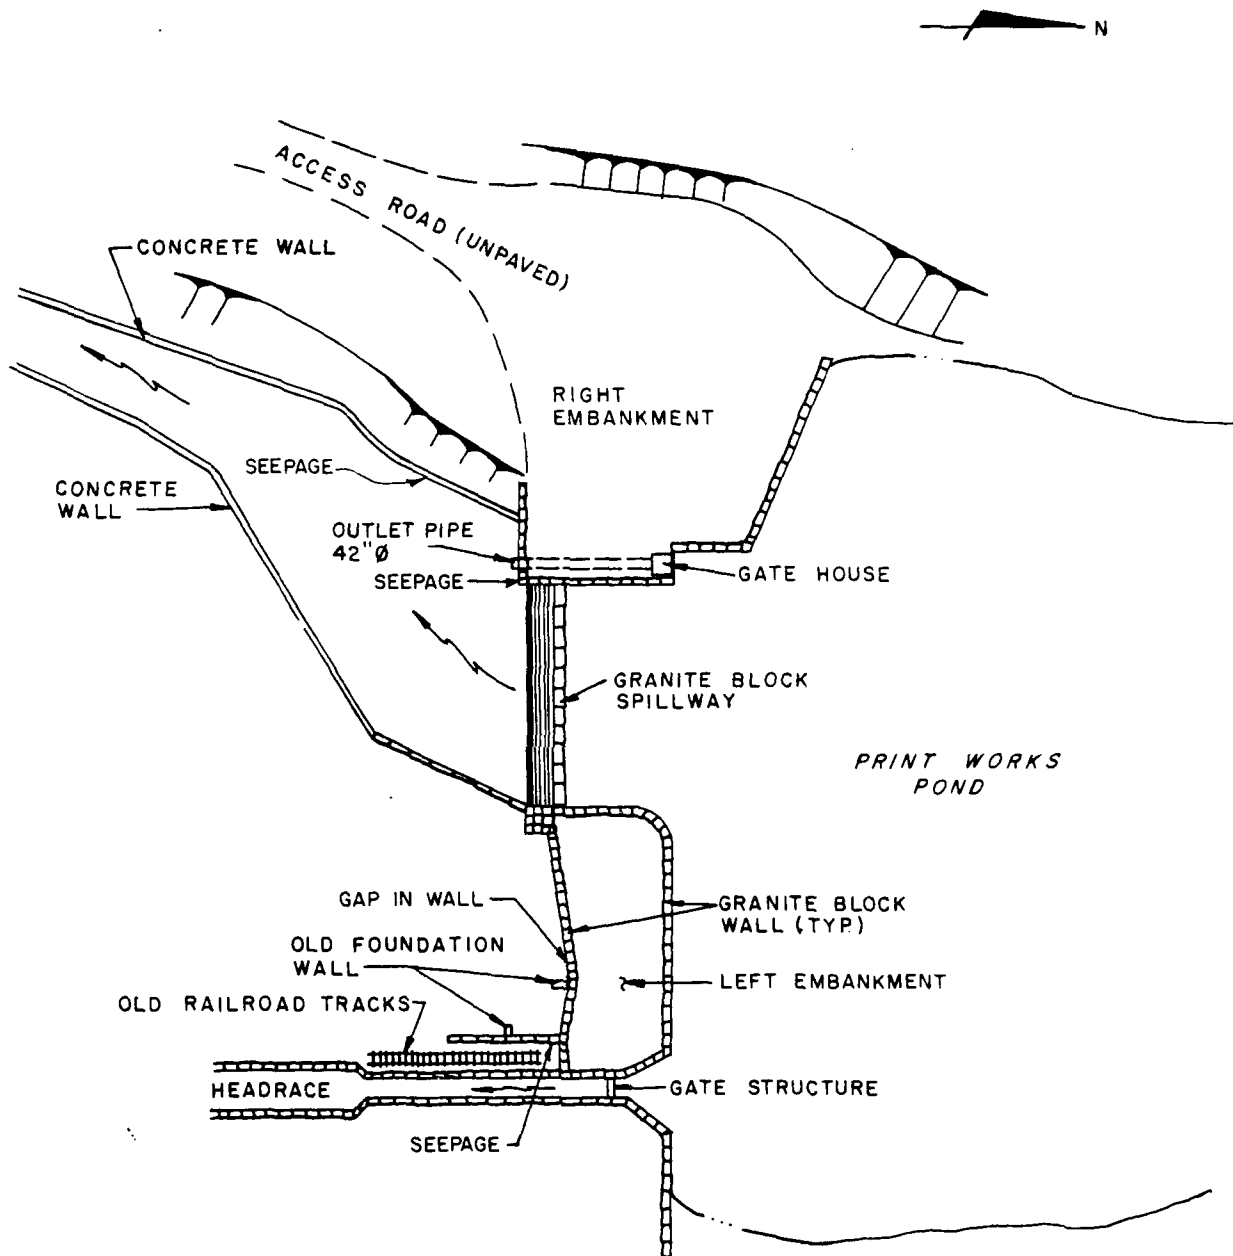
PLATE B

The left embankment which is longer than the right (see Plate 2) joins the spillway and the headrace which is at the dam's extreme left abutment. The grouted masonry wall of the upstream face at the left dam embankment has joints without mortar and is leaning slightly into the reservoir (see Photo C-13). There has been about two inches of vertical displacement between the blocks on top of the wall. Some small trees and large bushes are growing on the crest of the dam (see Photos C-4,18). There is a gap in the downstream face of the masonry wall of the left embankment and some erosion has occurred from under the top blocks of the wall. (See Plate B in Appendix B-3.
