CONNECTICUT RIVER BASIN
WHITINGHAM, VERMONT

JACKSONVILLE POND DAM
VT 00148

PHASE I INSPECTION REPORT
NATIONAL DAM INSPECTION PROGRAM

JANUARY 1981

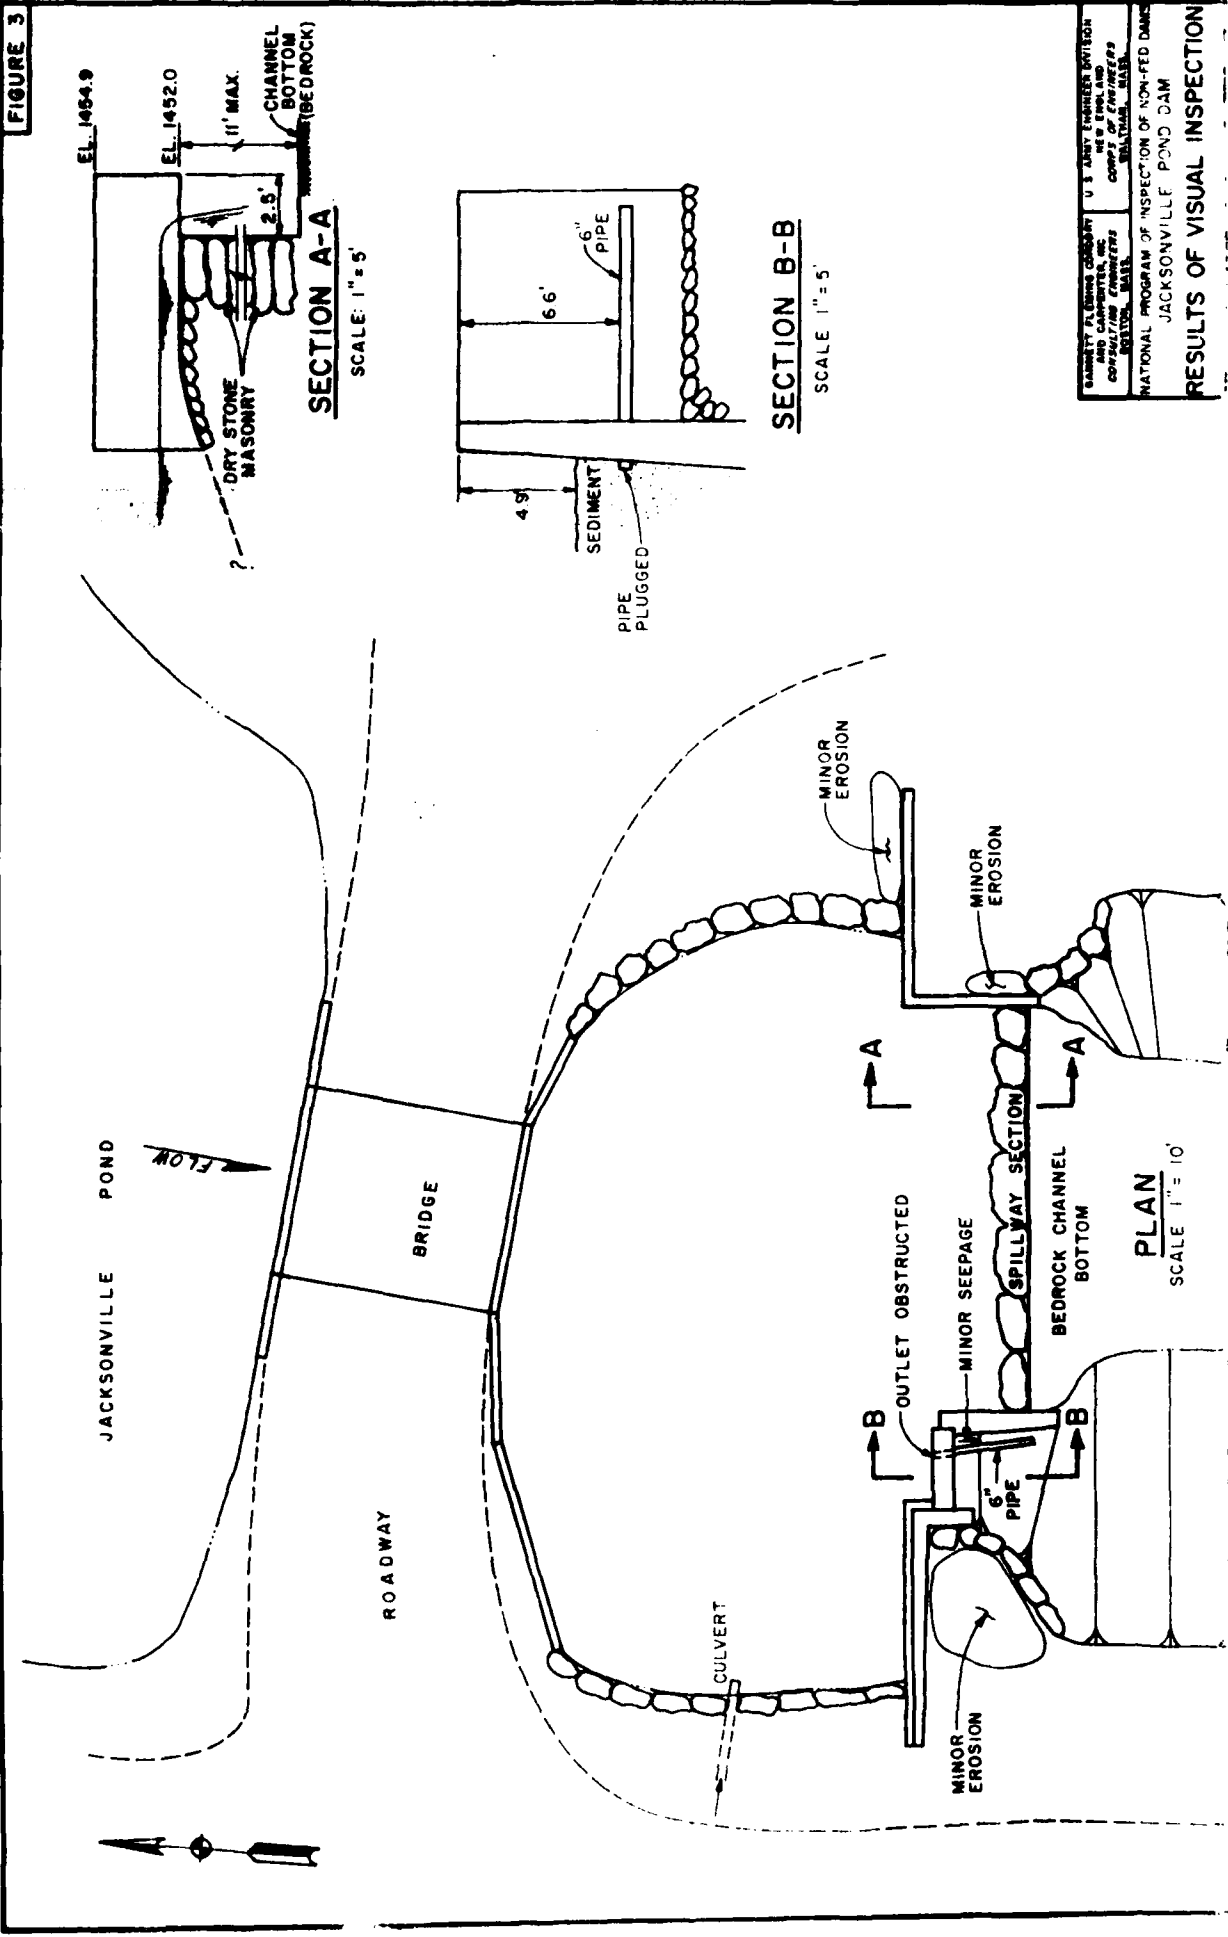
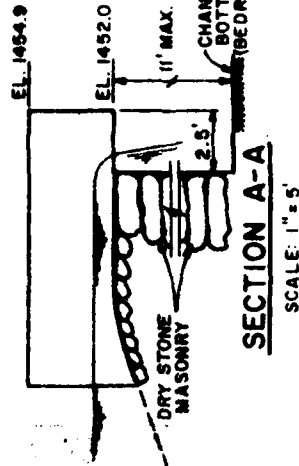
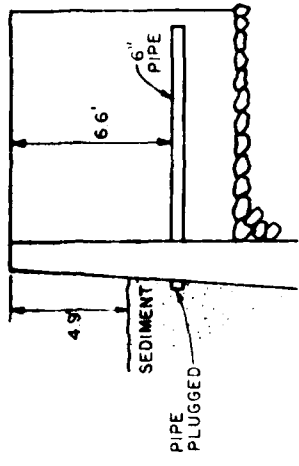
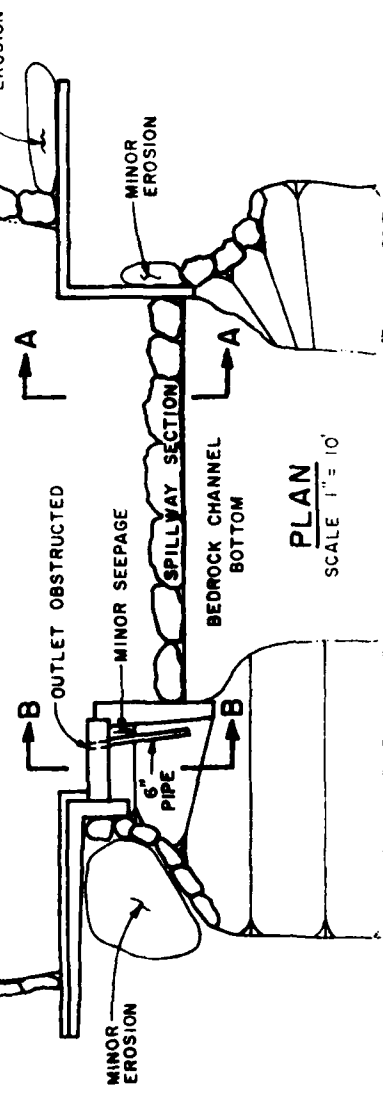
NATIONAL PROGRAM OF INSPECTION OF NON-FED DAMS
JACKSONVILLE POND DAM
RESULTS OF VISUAL INSPECTION

a. General. The Phase I inspection of the dam at Jacksonville Pond was performed on November 11, 1980. A copy of the inspection checklist is included in Appendix A. A previous inspection was conducted by the State of Vermont, Water Quality Division, on October 6, 1978. A copy of the inspection report is included in Appendix B. Photographs taken during the current inspection are included in Appendix C. A summary of the results of this visual inspection is included in Appendix B (Figure 3).

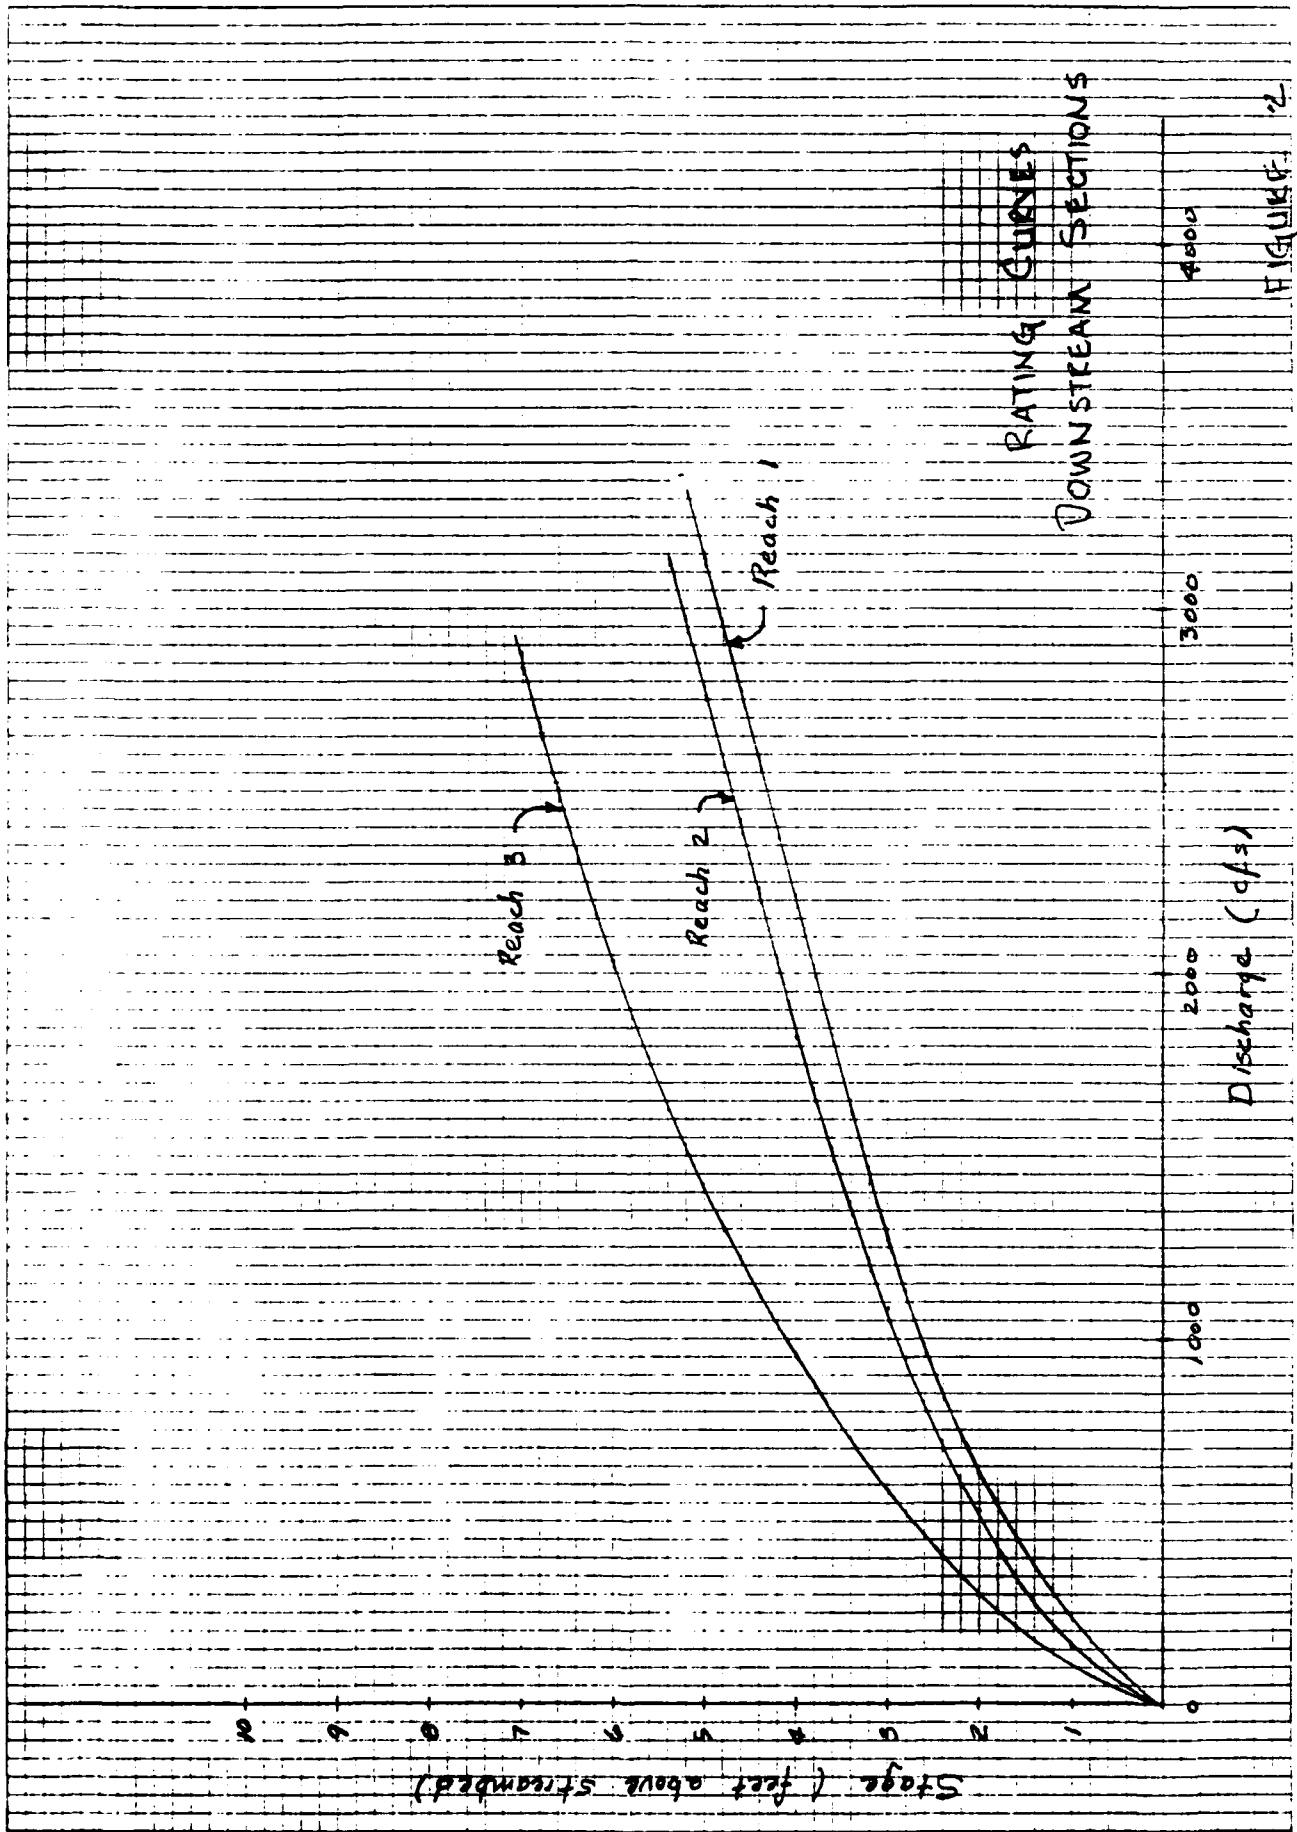
FIGURE 12

Rise in stage at damage center due to dam failure is 4.0'. Maximum stage during failure is 6.7'. Approximate velocity is 12.7 fps. First floor level of houses is at stage = 5.0 feet. Due to flow depth and velocity, high hazard classification is warranted.
