NATIONAL PROGRAM FOR INSPECTION OF NON-FEDERAL DAMS  
SITE 1 - BASIN BROOK. (U) CORPS OF ENGINEERS WALTHAM MA  
NEW ENGLAND DIV FEB 80

| REPORT DOCUMENTATION PAGE | | READ INSTRUCTIONS<br>BEFORE COMPLETING FORM |
|---|---|---|
| 4. TITLE (and Subtitle)<br><br>Site 1- Basin Brook Dam<br>NATIONAL PROGRAM FOR INSPECTION OF NON-FEDERAL DAMS | | 5. TYPE OF REPORT & PERIOD COVERED<br>INSPECTION REPORT |

I wish to take this opportunity to thank you and the Water Resources Board for your cooperation in carrying out this program.

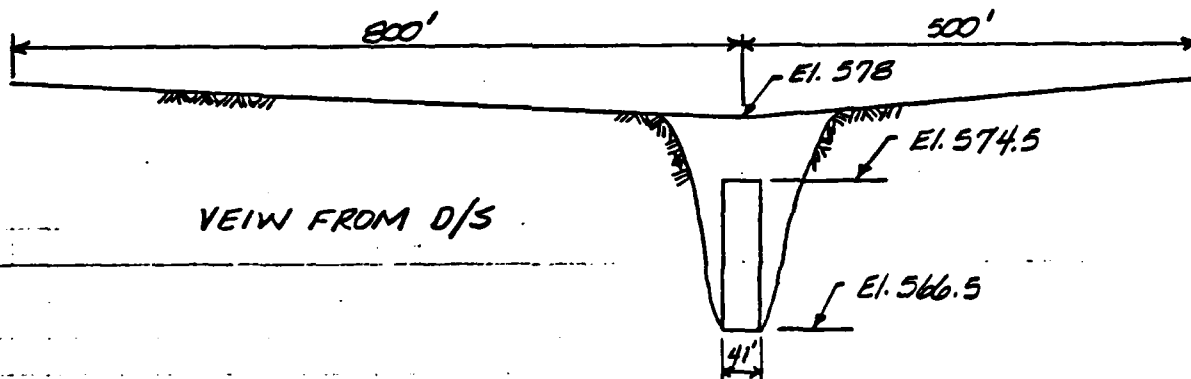
X-SECT. OF RTE 113 BRIDGE & EFFECTIVE WEIR

From dam to Rte. 113 bridge, distance ~ 4,000 ft.  
 Heavily forested, no existing development which could be effected. Bridge ~ 400 ft. d/s of confl. w/ Cold R.
