**RICHELIEU RIVER BASIN  
STOWE, VERMONT**

**LAKE MANSFIELD DAM  
VT 00100**

**PHASE I INSPECTION REPORT  
NATIONAL DAM INSPECTION PROGRAM**

**MARCH, 1979**

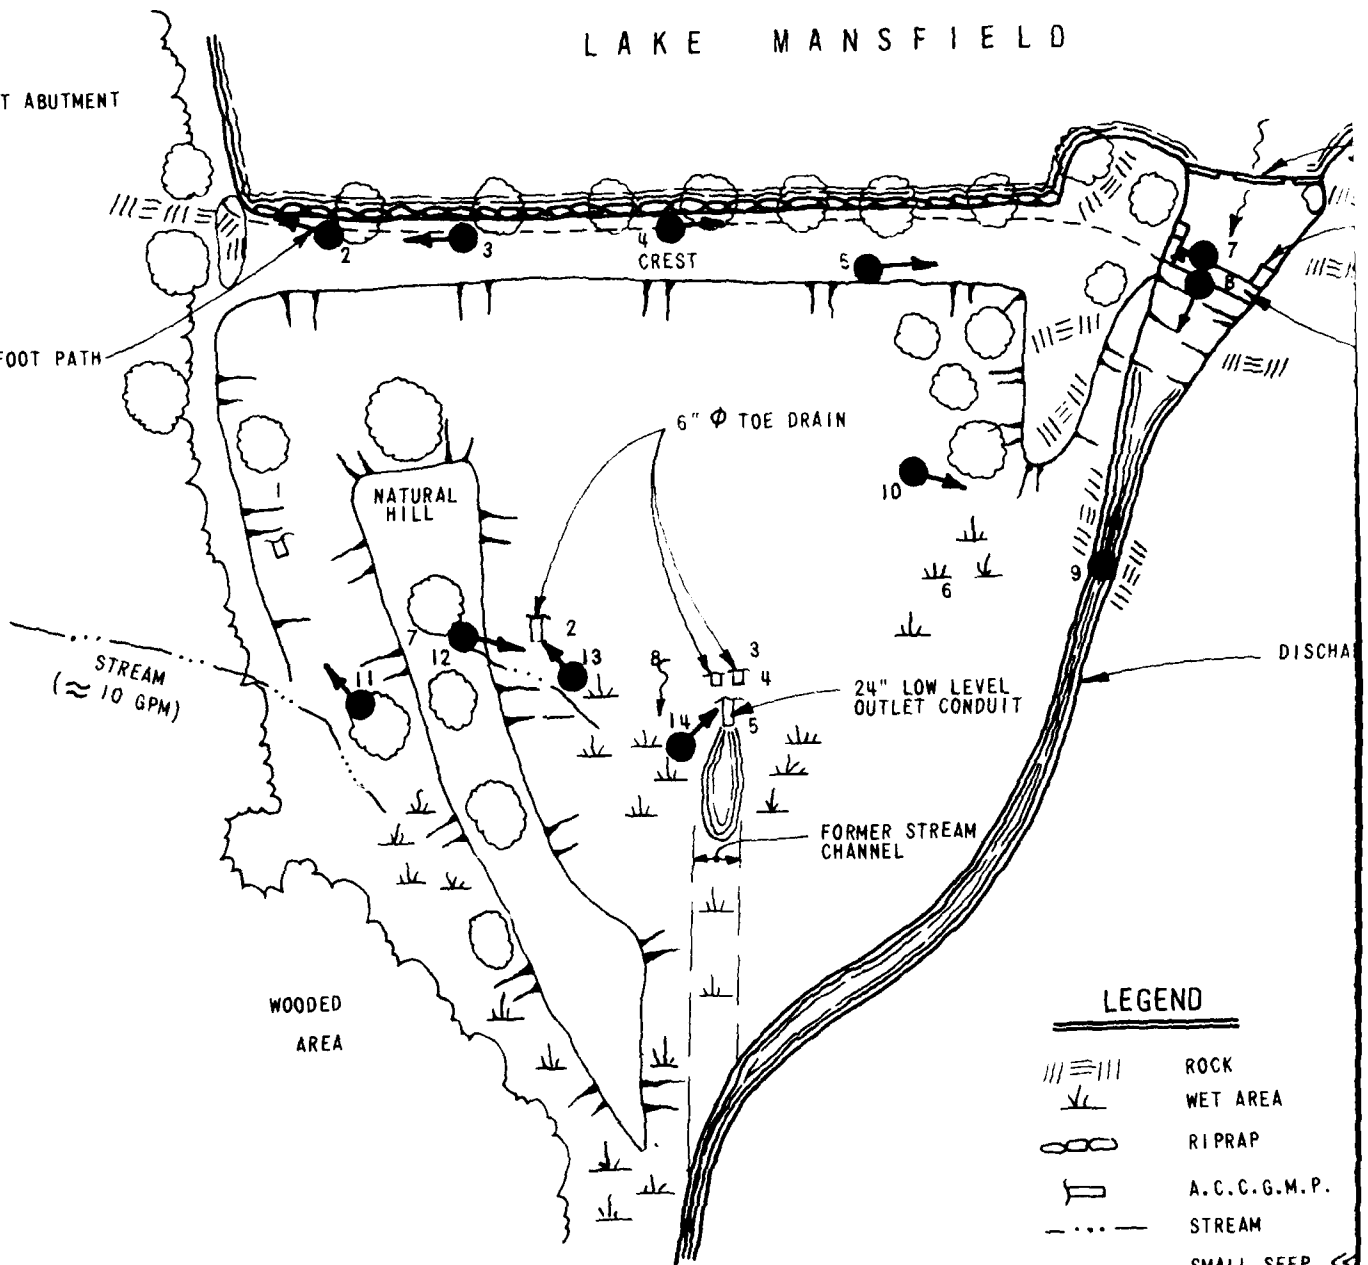
The crest of this dam is not at a uniform elevation. There is a low zone near the right abutment which is about 8 to 10 inches lower than the remainder of the crest (see Figure 1). According to Mr. Al Lane, water has passed over this zone in the past, when other portions of the crest were not overtopped. This portion of the crest is shown in Photos 2 and 3. The dip in the crest is not visually discernible; however, it is plotted in profile in Figure 1, Appendix B. Scour and other effects of such past overtopping are not evident now. The dates when overtopping occurred, whether pre-1965 or post-1965, are not known.

1. The trees on the crest of the dam should be cut and the root structures removed.
2. The crest should be made level over the entire length.
3. Repairs to the riprap on the upstream side of the crest should be implemented.
4. Discharge from drains and seepage should be analyzed and recorded on a monthly basis for flow and suspended solids concentration.
5. Growth on the downstream slope of the dam should be mowed yearly.

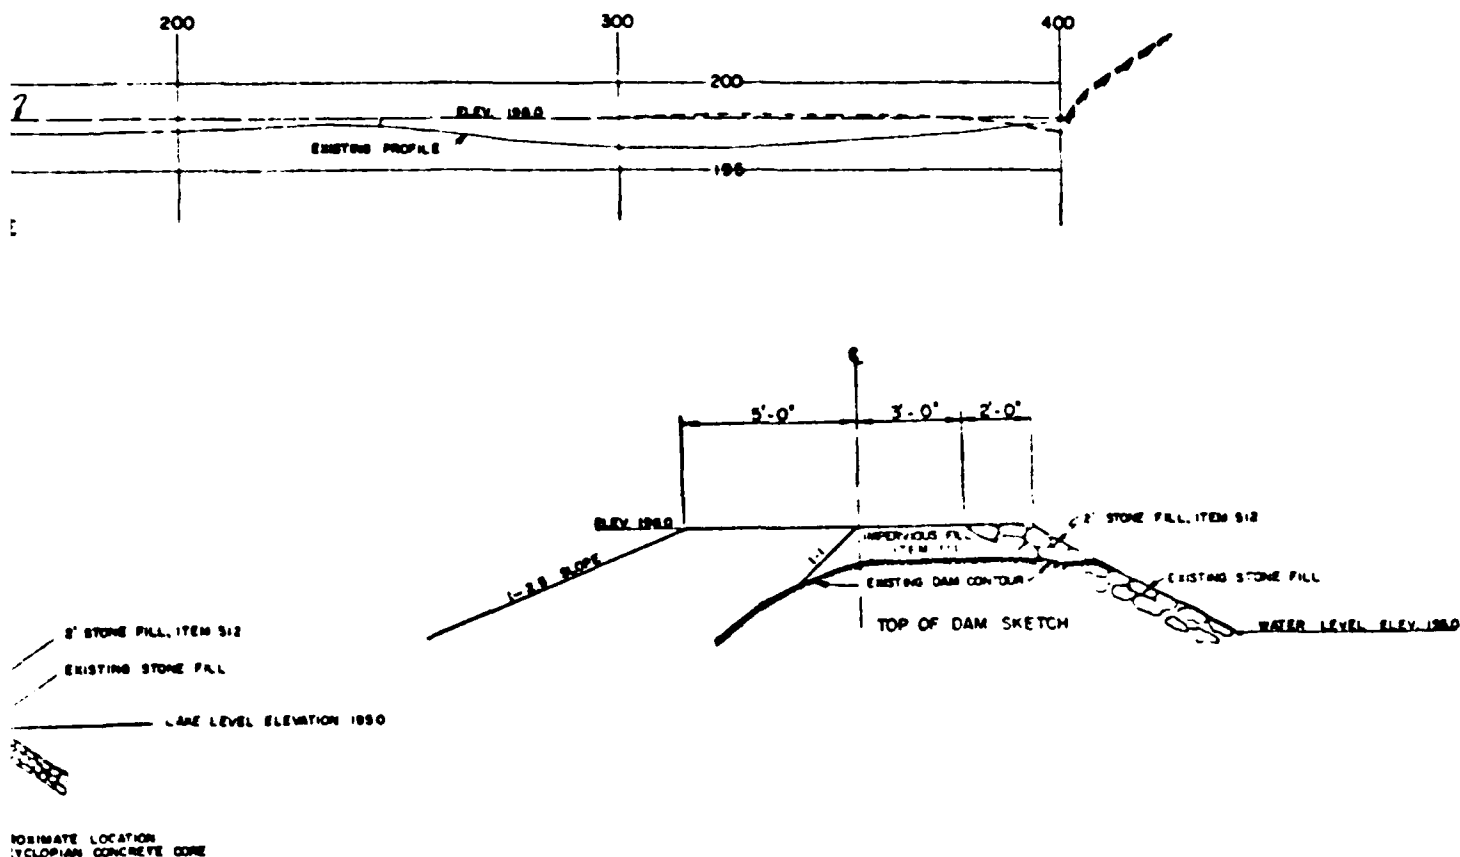
FIGURE 2

A cyclopean core wall at an approximate elevation to 1152 presumably constructed to serve as an impervious core. Thickness about 2 feet at the top and 4 feet at the bottom, see Figure 2, Appendix B. Based on the method of construction of such walls and on seepage observed downstream, it is judged that this core wall is not impervious.

Earth embankment. A cyclopean core wall with top at about elevation 1152 is shown in Figure 2, Appendix B.
