CONNECTICUT RIVER BASIN  
LYNDON, VT

INSTITUTE POND DAM  
VT 00216

PHASE I INSPECTION REPORT  
NATIONAL DAM INSPECTION PROGRAM

DECEMBER 1980

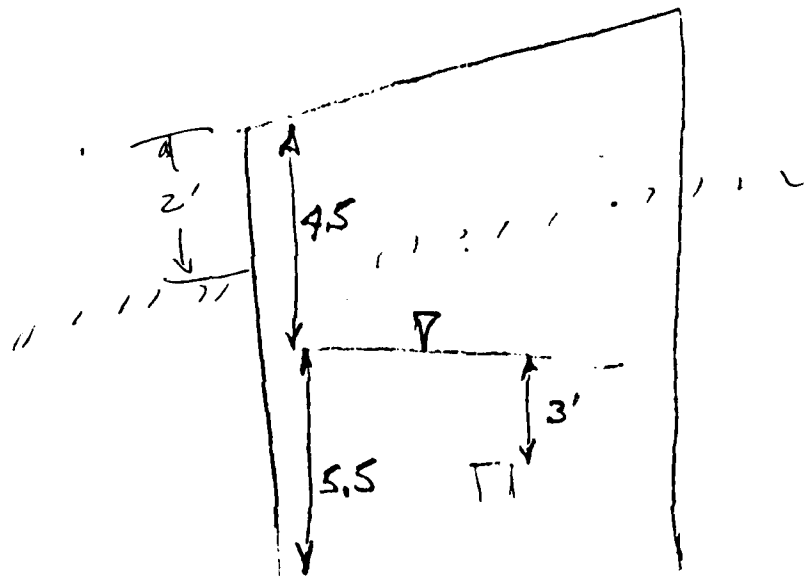
-Typ Valve Box

Mr. Matheson would like to know if  
his should still be in the balance  
vase box + not be done because of possible blowout of foundation, due to  
extent of seepage + possibly quick conditions. Advised need  
a well designed filter/drainage system. ASD

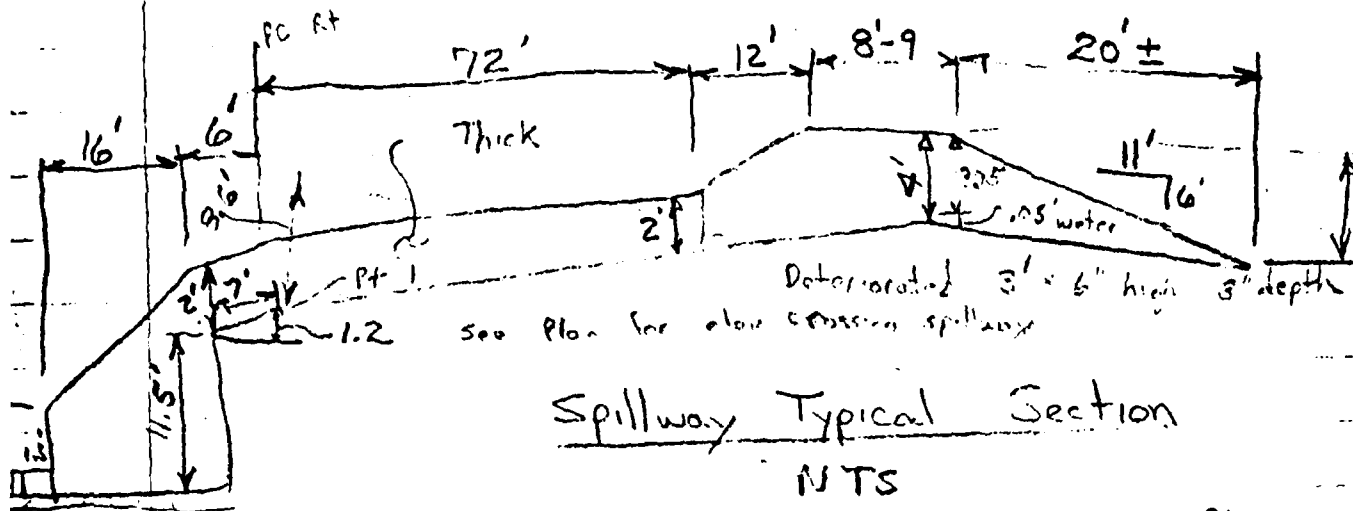
### Spillway Typical Section

Looking Westerly Rt wing
