MISCELLANEOUS PAPER GL-85-21

# CRATER REPAIR OF NORTH AUXILIARY AIRFIELD, SOUTH CAROLINA

Samuel J. Alford and Albert J. Bush III

August 1985

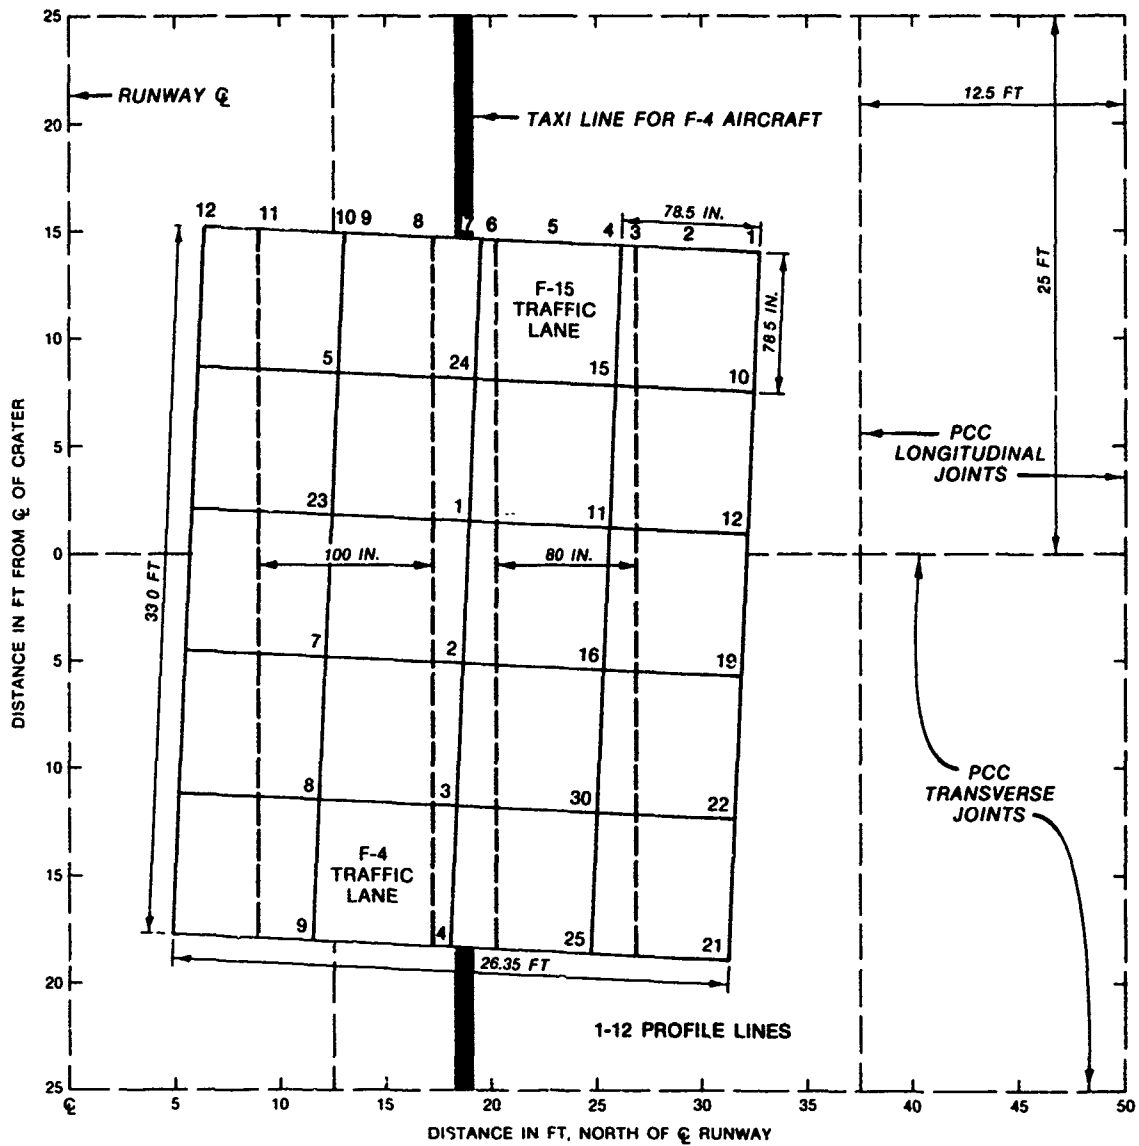
Figure 15. Profile and cross-section data lines

Figure 15 shows the lines in relation to the crater repair. Figures 16 through 27 are profile plots comparing data taken before traffic (0 coverages) and data after run 15 of the aircraft.

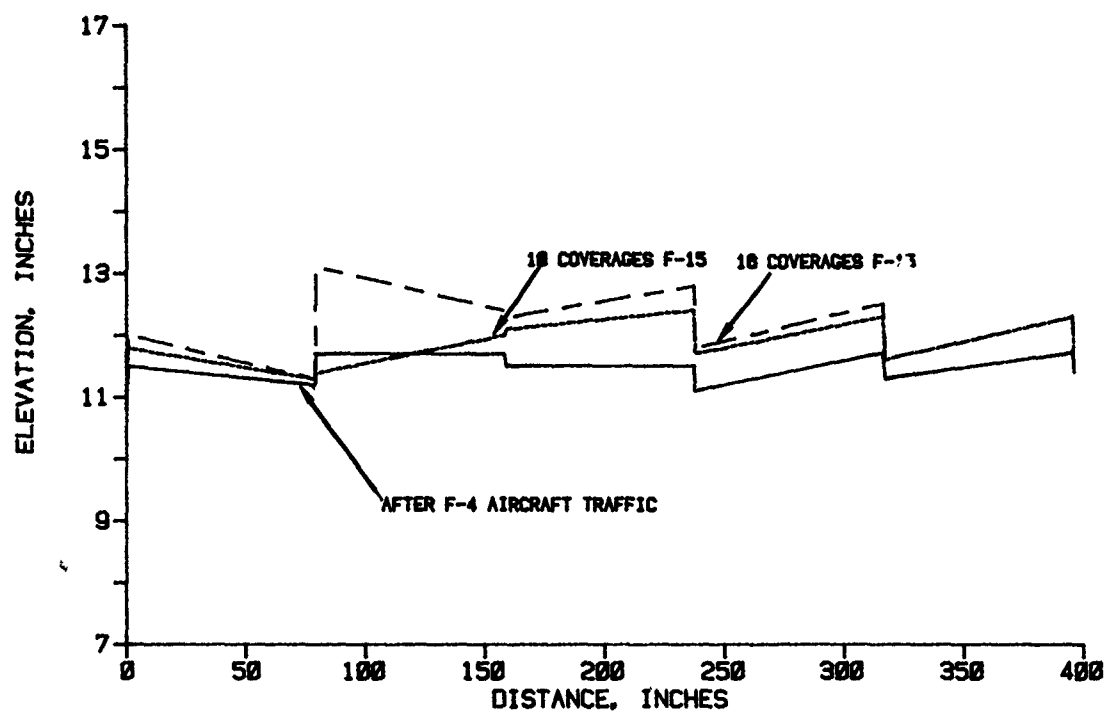
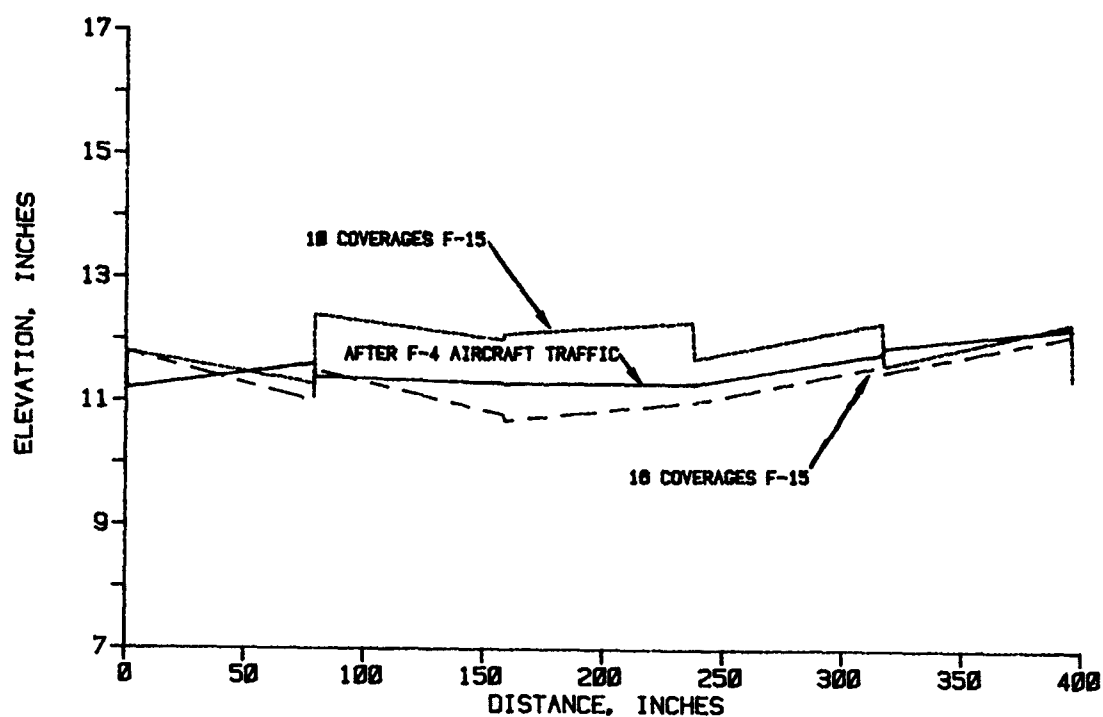
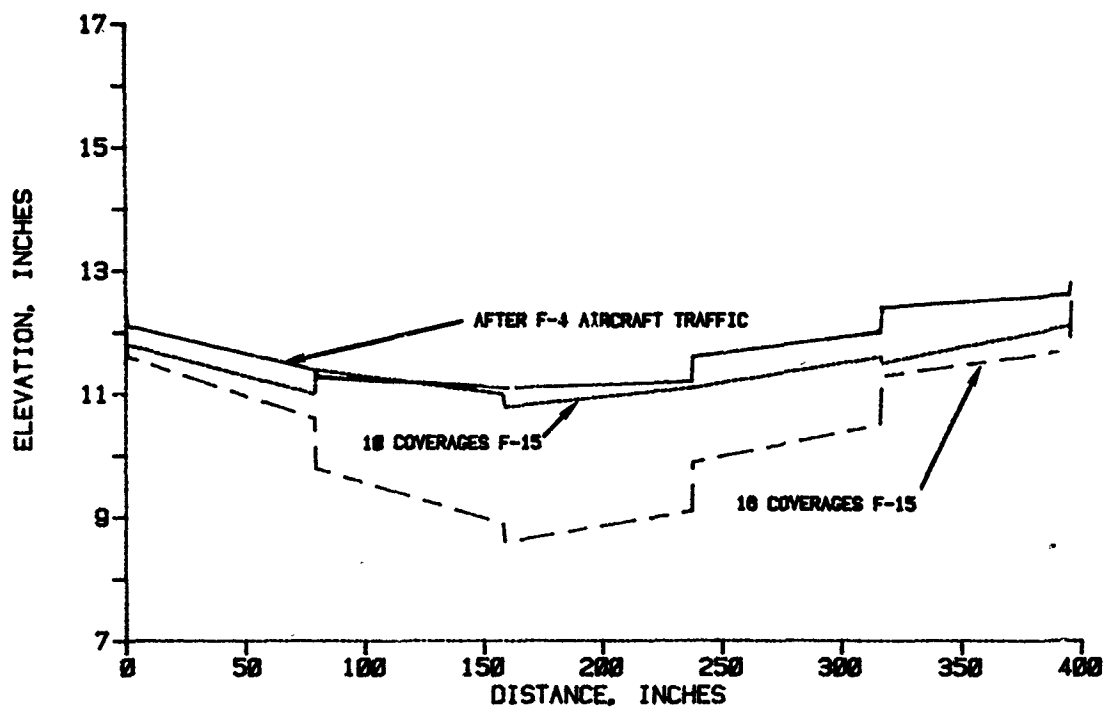
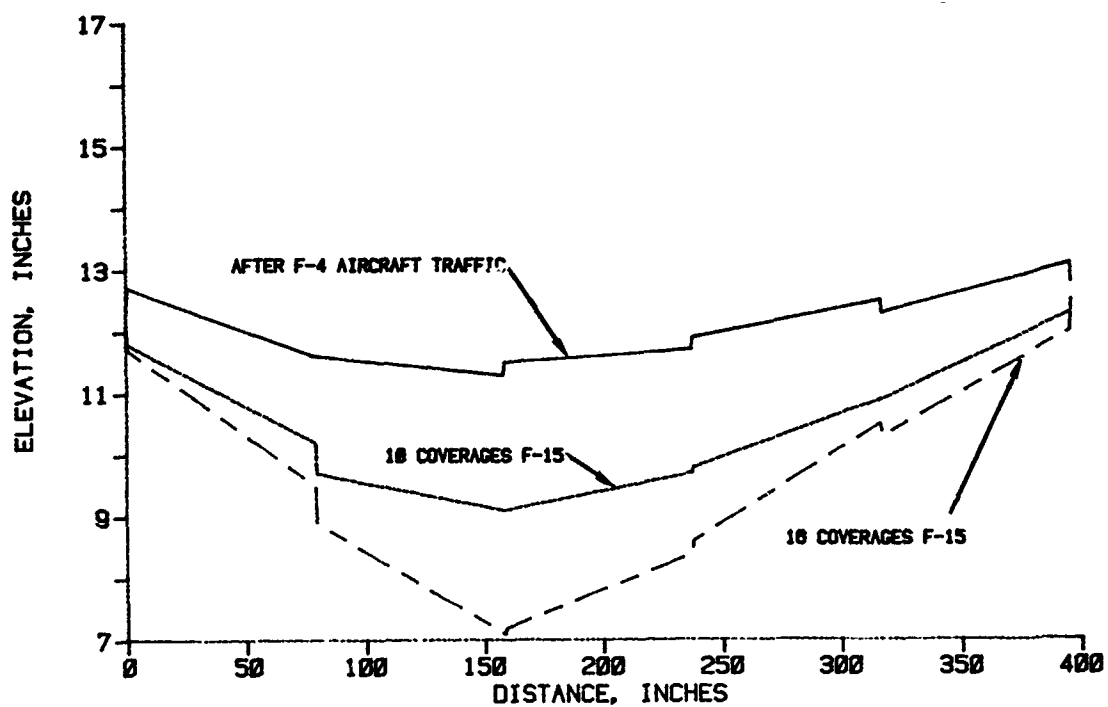
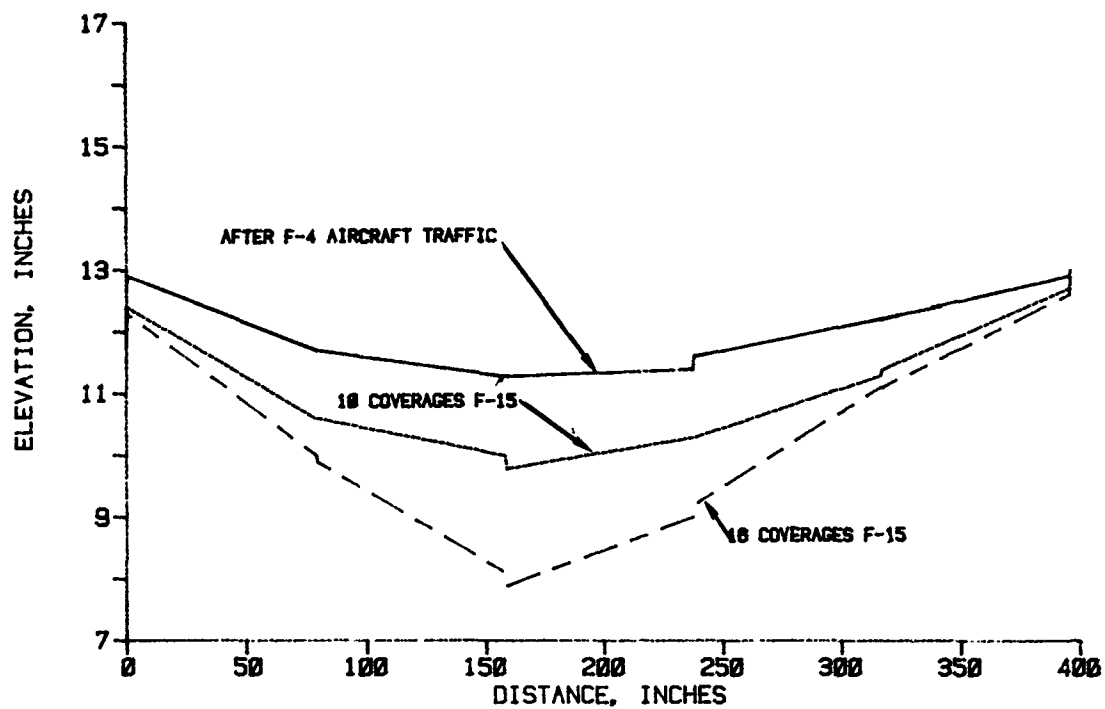
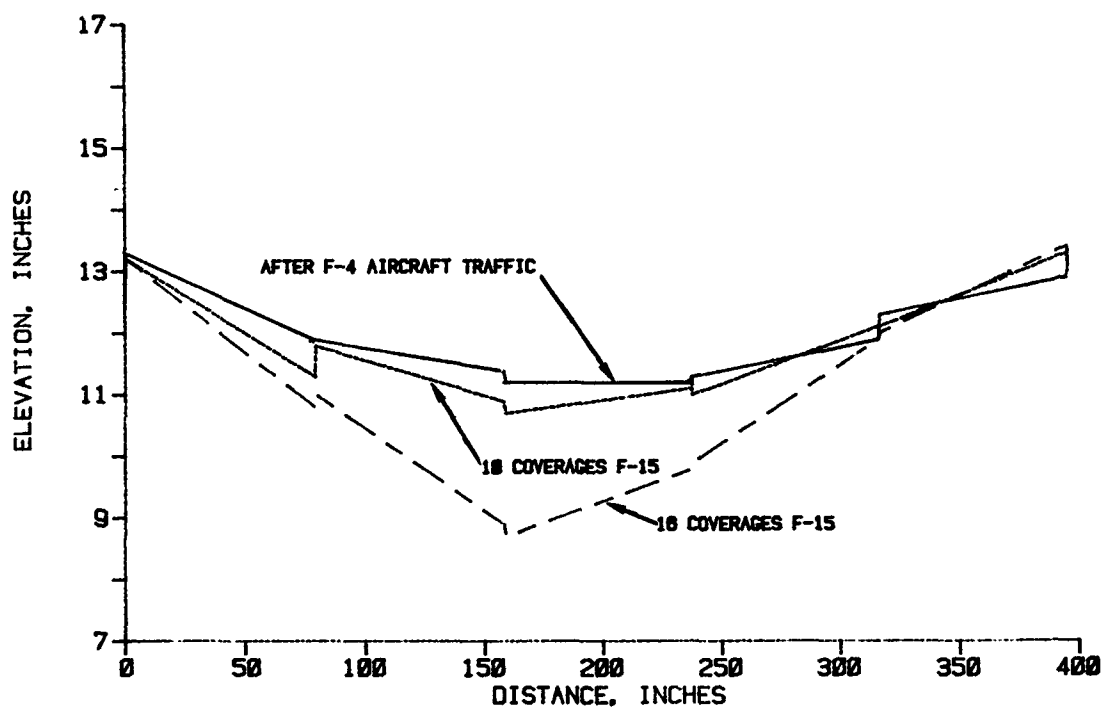
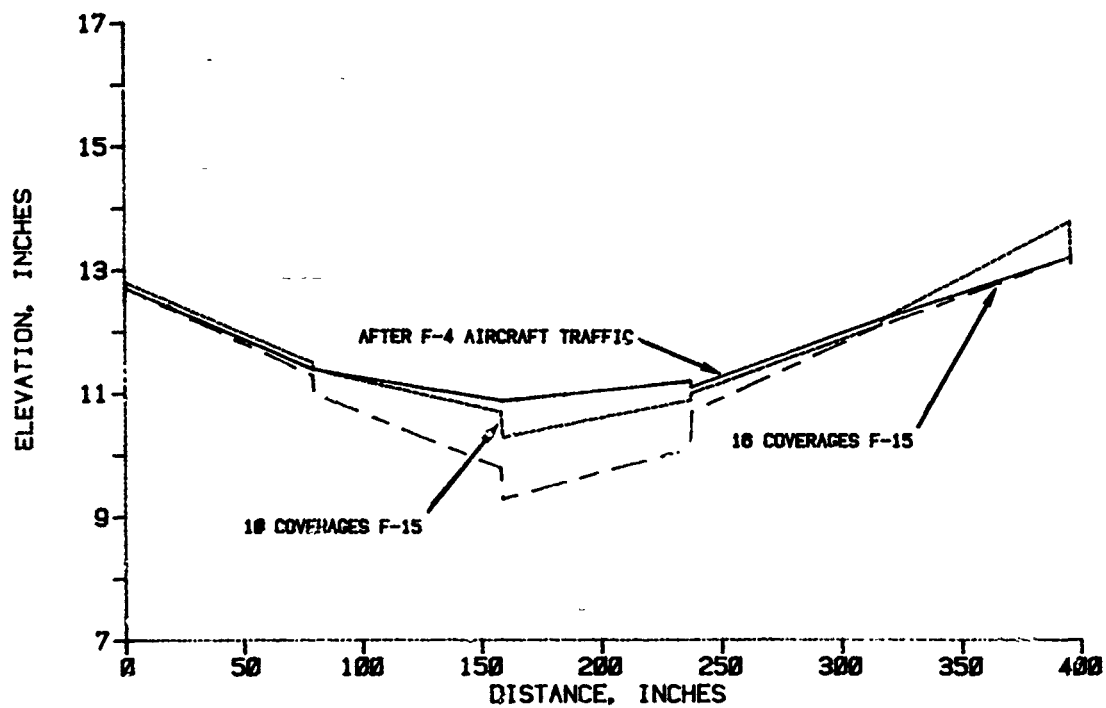
runs (Table 5). These runs presented no apparent problem for the repair technique. Photo 28 shows the crater repair after all of the aircraft test runs. Note that rubber was left across the crater repair by the touch-and-go traffic. Figures 28 through 34 show profile data for the crater repair after the aircraft.

sag measurement had increased to 4.63 in. (Table 4). This measurement was made without the load wheel on the repair. Photo 31 shows the sag measurement along with the spalling on slabs 16, 19, 11, and 12. Traffic was stopped after 16 coverages when a maximum sag of 5.25 in. was measured (Photo 32). The maximum sag measurements and the maximum joint difference (step) between the slabs recorded during all phases of traffic applied on the north side of the crater repair (F-15 traffic lane) are plotted and shown in Figure 37. Photo 33 is a general view of the traffic lane and Photo 34 shows the traffic with a 10-ft straightedge across the traffic lane after the 16 coverages. Figures 28 through 34 contain profile data after the 16 coverages. Figure 38

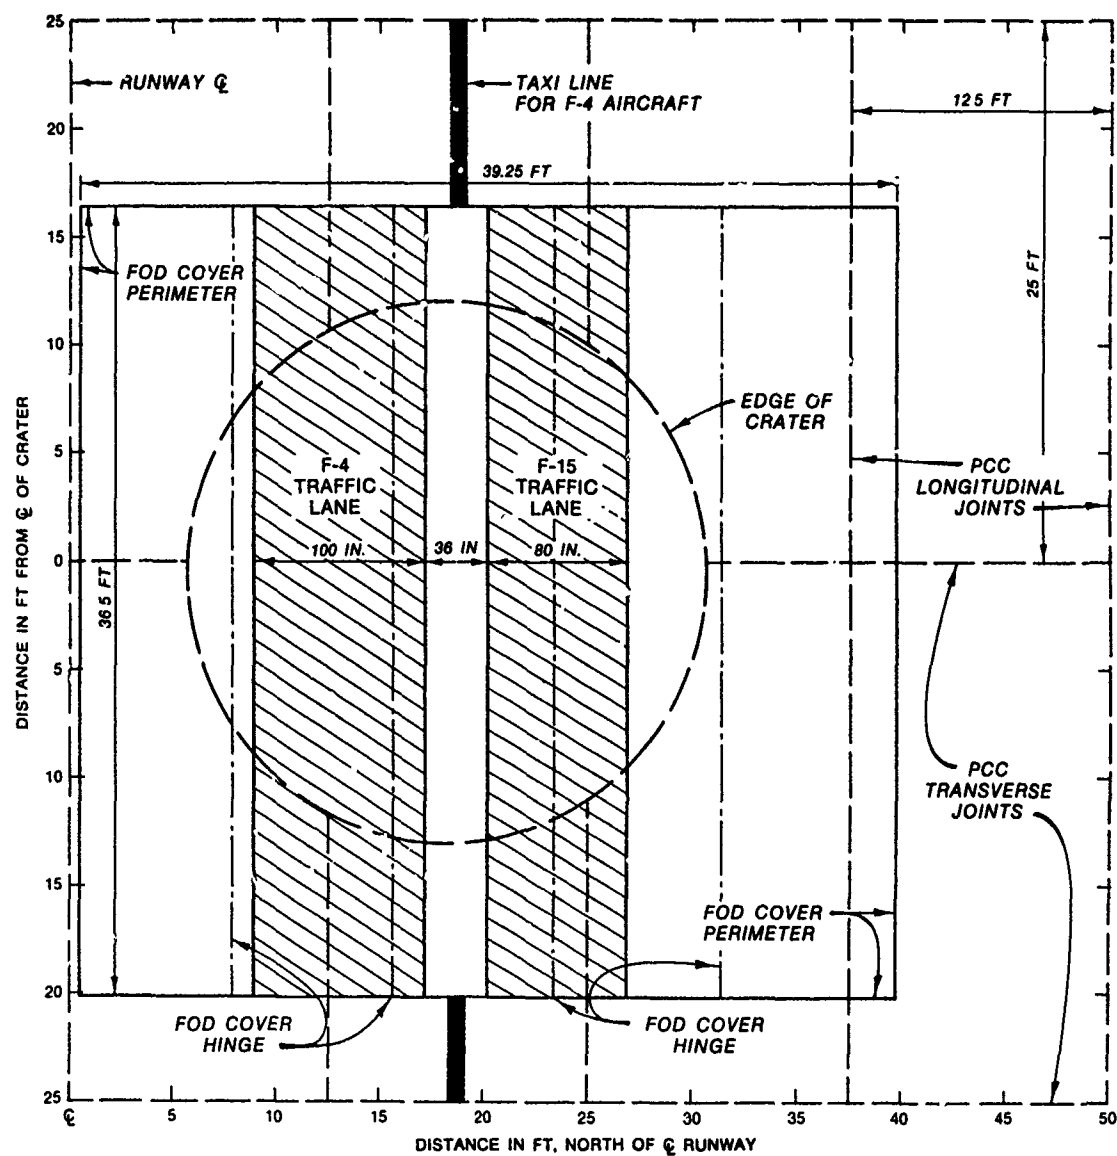
Figure 66. Layout of FOD cover repair

30. A layout of the crater repair is shown in Figure 66. Surface roughness measurements recorded before traffic as shown in Table 6 indicate a 2.5- to 3.0-in. upheaval and a 0.5- to 1.0-in. sag in the surface of the crater repair. These measurements were recorded in the wheel (gear) paths of the F-4 aircraft. Three profiles (in the direction of traffic), one in each wheel (gear) path, were measured and the results are plotted in Figures 67 through 69. Figures 70 through 72 show cross-section data (transverse to traffic) at the west quarter point, center, and east quarter points of the crater, respectively. After placement of the FOD cover, the crater repair was proof rolled before F-4 aircraft traffic. Proof rolling was accomplished by applying two coverages of F-4 load cart traffic over the entire crater repair area. The load cart proof loading was started on the south side of the crater repair and approximately one tire print width outside the edge of the crater. The load cart was driven forward and backward in the same path and then shifted north one wheel path (10 in.) and the load cart was again driven forward and backward. This rolling pattern, which resulted in two coverages of the F-4 load cart, was repeated until the entire width of the crater repair had been rolled. A slight bow wave was noticed in the FOD cover when the load

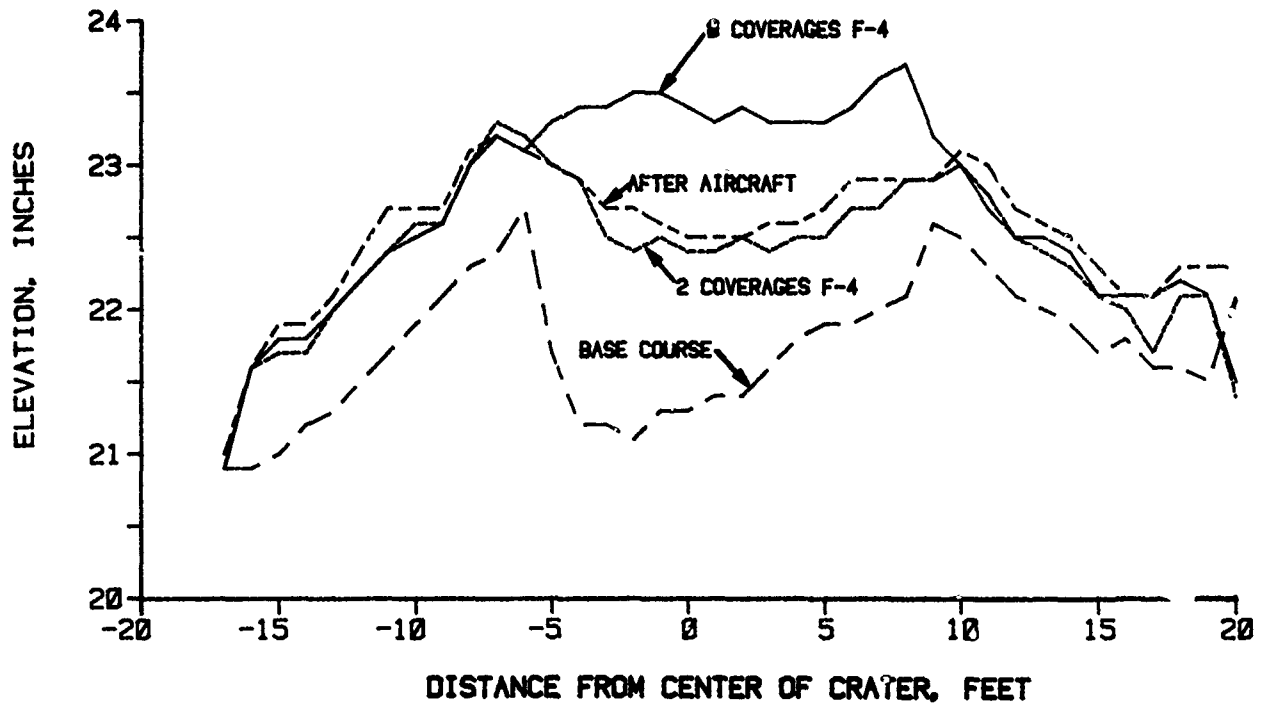
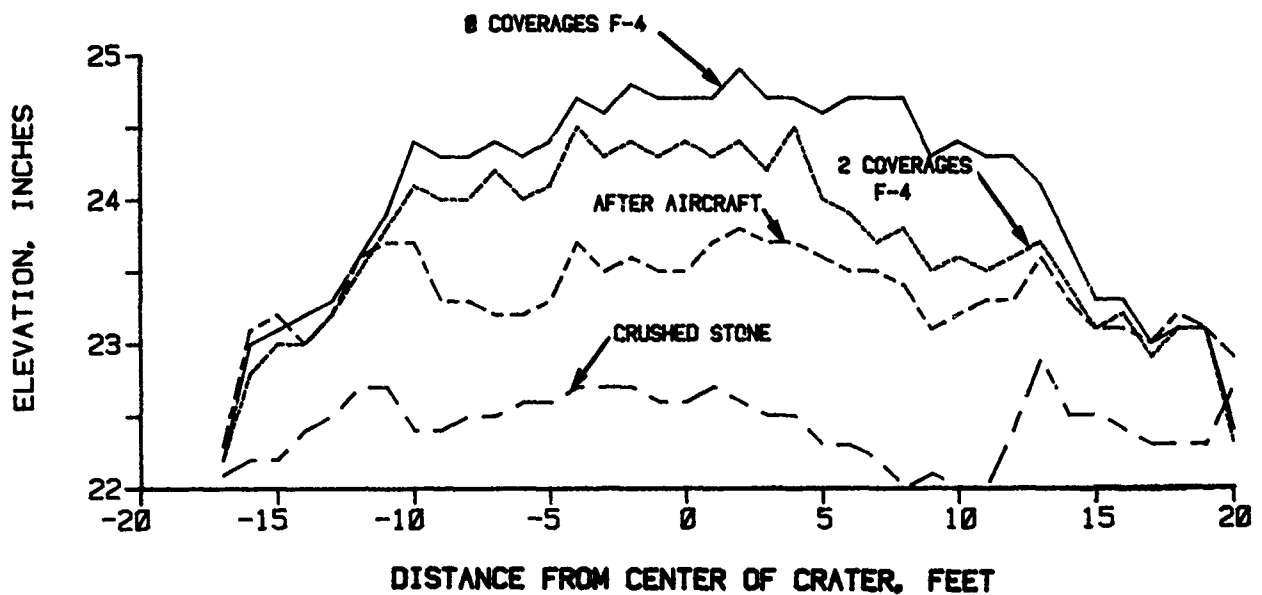
Figure 67. North wheel path profile, FOD cover repair, 0 coverages, 2 coverages of F-4 load cart, and after F-4 aircraft traffic

Figure 68. Center profile, FOD cover repair, 0 coverages, 2 coverages of F-4 load cart, and after F-4 aircraft traffic

Figure 69. South wheel path profile, FOD cover repair, 0 coverages, 2 coverages of F-4 load cart, and after F-4 aircraft traffic

Figure 70. West quarter point cross section, FOD cover repair, 0 coverages, 2 coverages of F-4 load cart, and after F-4 aircraft traffic

Figure 71. Center cross section, FOD cover repair, 0 coverages, 2 coverages of F-4 load cart, and after F-4 aircraft traffic

Figure 72. East quarter point cross section, FOD cover repair, 0 coverages, 2 coverages of F-4 load cart, and after F-4 aircraft traffic

wheel was located inside the actual crater. The bow wave was first observed when the load wheel first traversed the south side of the crater and continued until the load wheel had moved approximately 4 ft inside the crater (after about five passes). A bow wave was not observed as proof rolling continued across the remaining 21-ft crater width. After proof loading, two tears were observed in the top ply of the FOD cover. A 10-in. tear (Photo 41) was located 2 ft east of the center of the crater on the crater east-west center line and the other, a 15-in. tear, was located on the third FOD cover hinge from the south edge of the FOD cover (Figure 66). The FOD cover had numerous small ridges or wrinkles (manufacturing defects), most of which contained hairline cracks after the proof loading. Surface roughness measurements without a load show a 1.0- to 2.75-in. upheaval with zero sag after proof loading (two coverages, F-4 load cart); however, loaded measurements using the load wheel on the F-4 load cart show no upheaval and sag measurements that range from 0.8 to 1.2 in. (Table 6). This would indicate that underlying fill material was consolidated during proof loading which resulted in a 0.8- to 1.2-in. void between FOD cover and the fill material. Cross-section plots after two coverages of the F-4 load cart (proof loading) are shown in Figures 67 through 72.

cover (Photo 42). The loose fiberglass landed approximately 165 ft behind the crater repair. The performance of the FOD cover repair was not affected by the 20- by 74-in. damaged area. After the touch-and-go operations, light and heavy braking runs and a sharp turn maneuver by the aircraft were made on the FOD cover. No additional distress to the FOD cover was observed during these operations. Photo 43 is a general view of the FOD cover repair after the aircraft test runs. Figures 67 through 72 show profile and cross-section plots of the crater repair after aircraft traffic.

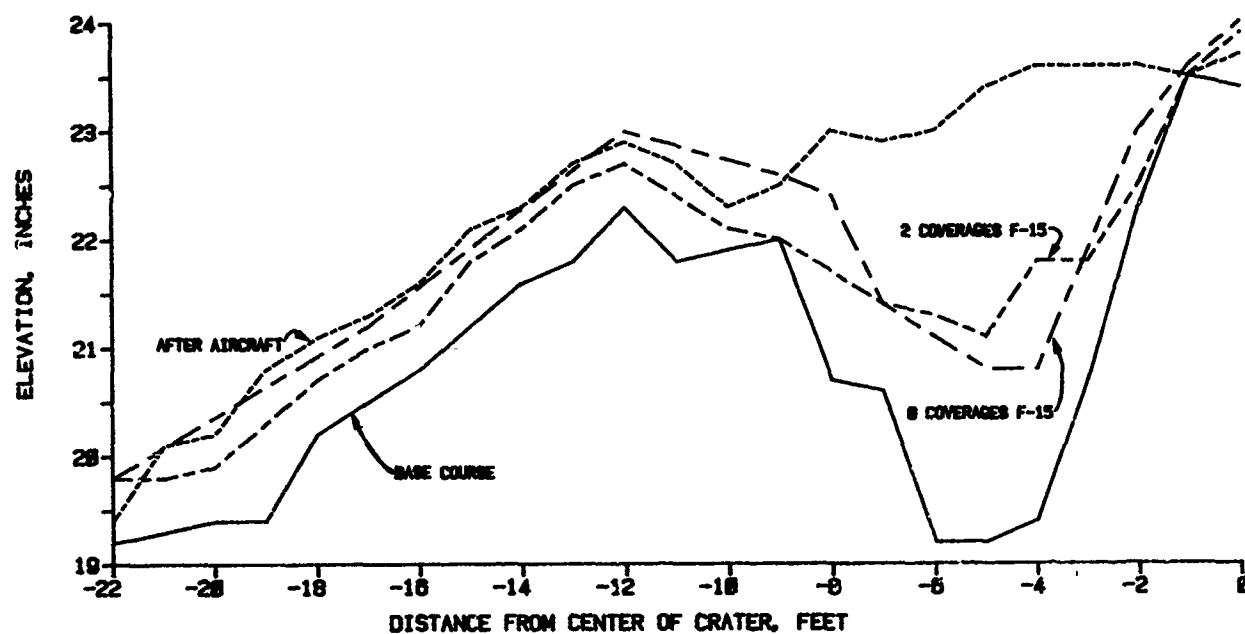
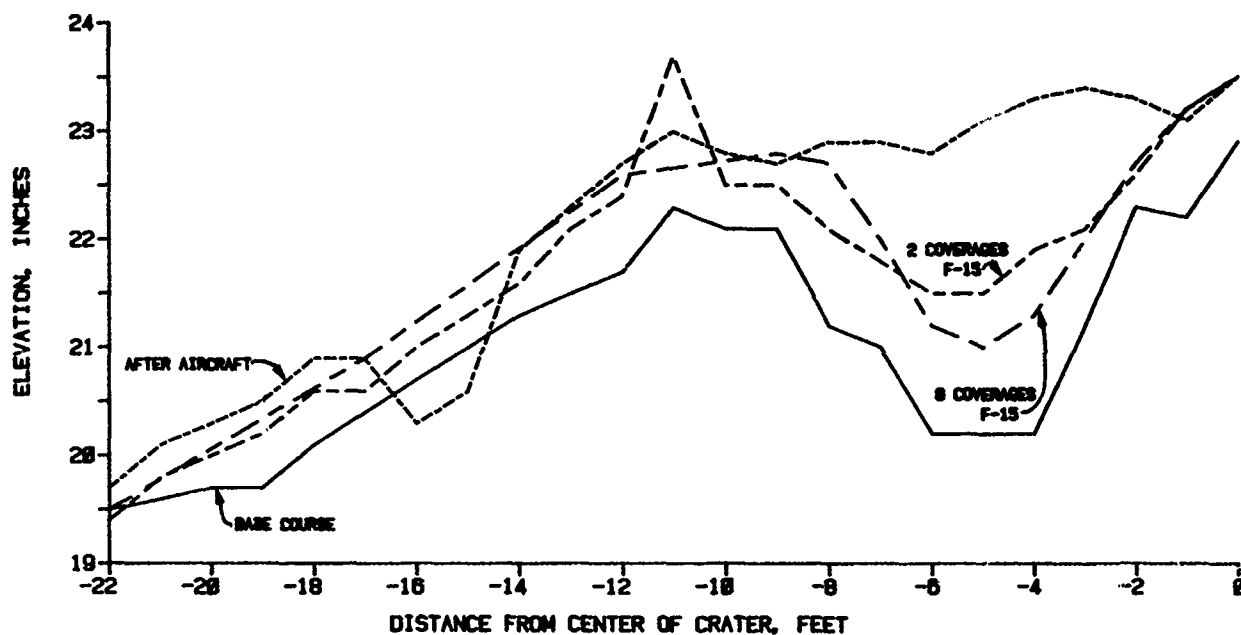
Figure 73. Profile, center of the F-15 traffic lane, FOD cover repair, 0 coverages, 2 coverages, and 6 coverages

Figure 74. West quarter point cross section, F-15 traffic lane, FOD cover repair, 0 coverages, 2 coverages, and 6 coverages

Figure 75. Center cross section, F-15 traffic lane, FOD cover repair, 0 coverages, 2 coverages, and 6 coverages

Figure 76. East quarter point cross section, F-15 traffic lane, FOD cover repair, 0 coverages, 2 coverages, and 6 coverages

lane at this time. None of these additional tears was located on a hinge and they ranged in length from 1 to 4 ft. Four of these tears were in the top ply and one tear, 1 ft long, was through both plies. Figures 73 through 76 show profile and cross-section data on the FOD cover and base course (FOD cover removed) for the traffic lane after six coverages.

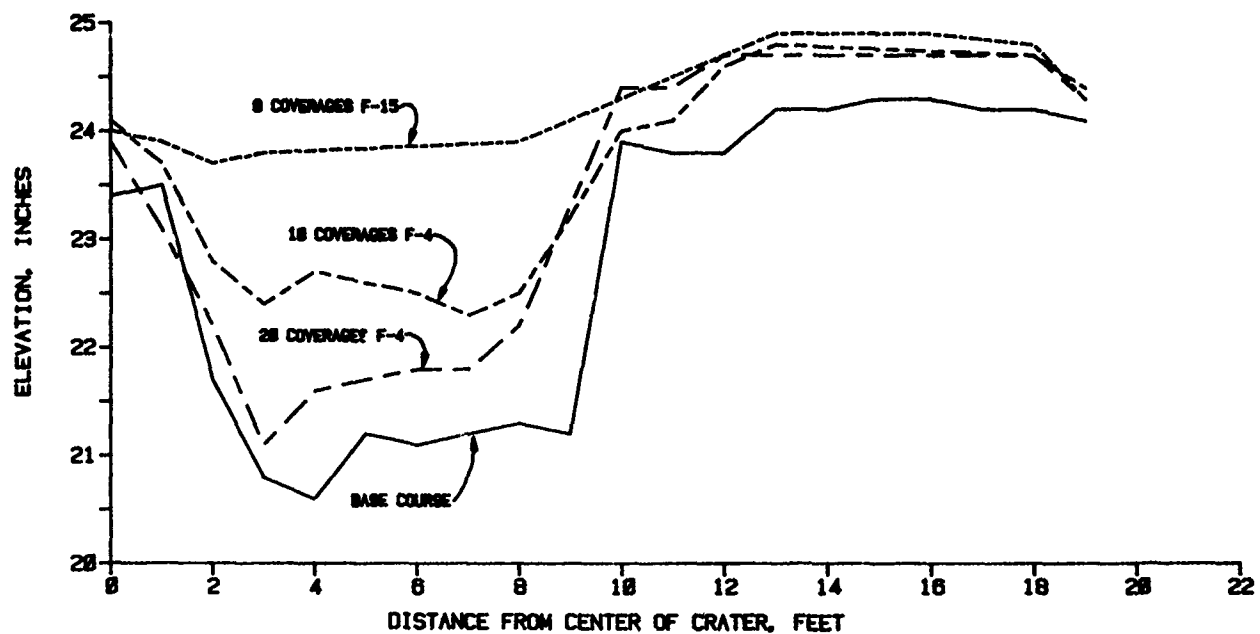
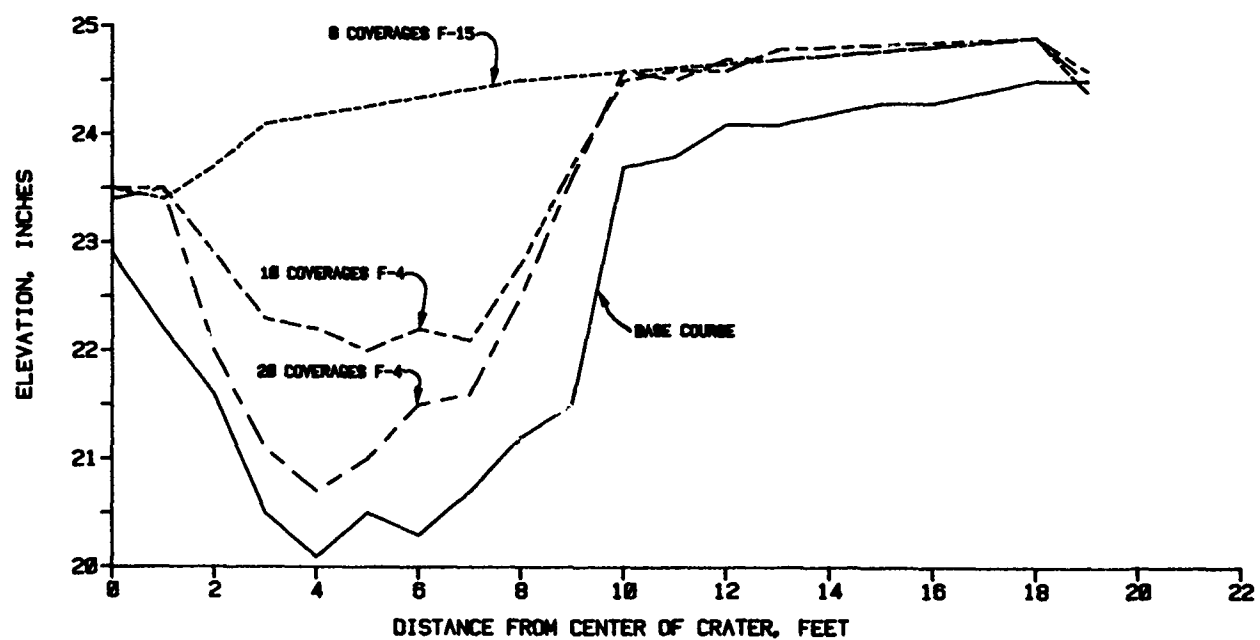
edge of this traffic lane. The two coverages of F-4 load cart traffic that were placed on the crater repair during the proof testing are included in the following performance data. Photo 49 shows the general condition of the traffic lane after proof testing (2 coverages). It should be noted that due to the previous weather conditions and the poor condition (tears) of the FOD cover in the F-15 traffic lane rainwater was trapped between the FOD cover and base material. Before test traffic was begun in this lane a 0.5-in. sag was measured along the center line of the traffic lane (Table 6). Plots of the profile data recorded along the center line of the traffic lane after various traffic levels are shown in Figure 78 and plots of the cross-section measurements taken during traffic are shown in Figures 79 through 81. The measurements for the plot labeled "2 coverages" in Figure 78 were taken after proof loading and before actual test traffic was applied in the test lane. The plots labeled "6 coverages F-15" in the Figures 79 through 81 are results of measurements recorded across the entire FOD cover width and before actual load cart test traffic was applied in the F-4 traffic lane. The first distress in the FOD cover was observed after six coverages of traffic. This distress included three tears through both plies of fiberglass, one tear in the top ply of fiberglass along the hinge, and damage to a patched portion of the hinge. The tears ranged in length from 1.5 to 3.0 ft. Photo 50 shows two of these tears. The patch damage consisted of the pond between a 8- by 20-in. patch and the hinge becoming loose on the south half of the patch. The maximum sag measured after six coverages of traffic was 1.75 in. As traffic was continued, it was noticed that the fiberglass along the hinge began to spall. This spalling which could possibly be a minor FOD problem was observed between six and ten coverages of traffic. The largest spalled area at this time was approximately 3 by 10 in. Other distresses observed after 10 coverages included the 8- by 20-in. patch which was completely disengaged from the hinge and either additional tears or an increase in length of the tears which occurred after six coverages. Photo 51 shows the surface condition along the hinge after 10 coverages. At this time four tears in the FOD cover hinge totaled 8.9 ft in length and the length of four top ply tears not on the hinge ranged between 1 and 5 ft. The maximum sag measured in the center of the traffic lane and at the hinge after 10 coverages of traffic was 2.13 and 3.00 in., respectively. Plots of the profile and cross-section data taken after 10 coverages of F-4 traffic are shown in Figures 78 through 81. The sag

Figure 78. Profile, center of F-4 traffic lane, FOD cover repair, 2 coverages, 10 coverages, and 20 coverages

Figure 79. West quarter point cross section, FOD cover repair after 6 coverages of F-15 traffic, 10 and 20 coverages of F-4 traffic

Figure 80. Center cross section, FOD cover repair after 6 coverages of F-15 traffic

Figure 81. East quarter point cross section, FOD cover repair after 6 coverages of F-15 traffic, 10 and 20 coverages of F-4 traffic

increased as traffic continued. After 16 coverages the sag along the center line of the traffic lane was 2.75 in. Traffic was discontinued after 20 coverages because of high sag measurements and the difficulty of the load cart traversing the test area. The maximum sag measured after 20 coverages along the center line of the traffic lane was 3.0 in. and 3.5 in. along the hinge. The maximum sag measurements recorded during all phases of traffic applied on the south side of the crater repair (F-4 traffic lane) are plotted and shown in Figure 82. Before traffic was stopped, the load cart's pull wheels tended to spin as the load wheel approached and tried to negotiate the transition between the crater and existing PCC pavement. The load cart also leaned from one side to the other as it negotiated this transition. Photo 52 shows a general view of the traffic lane after 20 coverages. After traffic the FOD cover hinge was inspected and found to be torn almost the entire length of the crater and minor spalling of the fiberglass was also observed along the tear. Photo 53 shows a close-up of the torn hinge and spalling. Figures 78 through 81 show profile and cross-section plots taken on the surface of the FOD cover and on the surface of the base material after

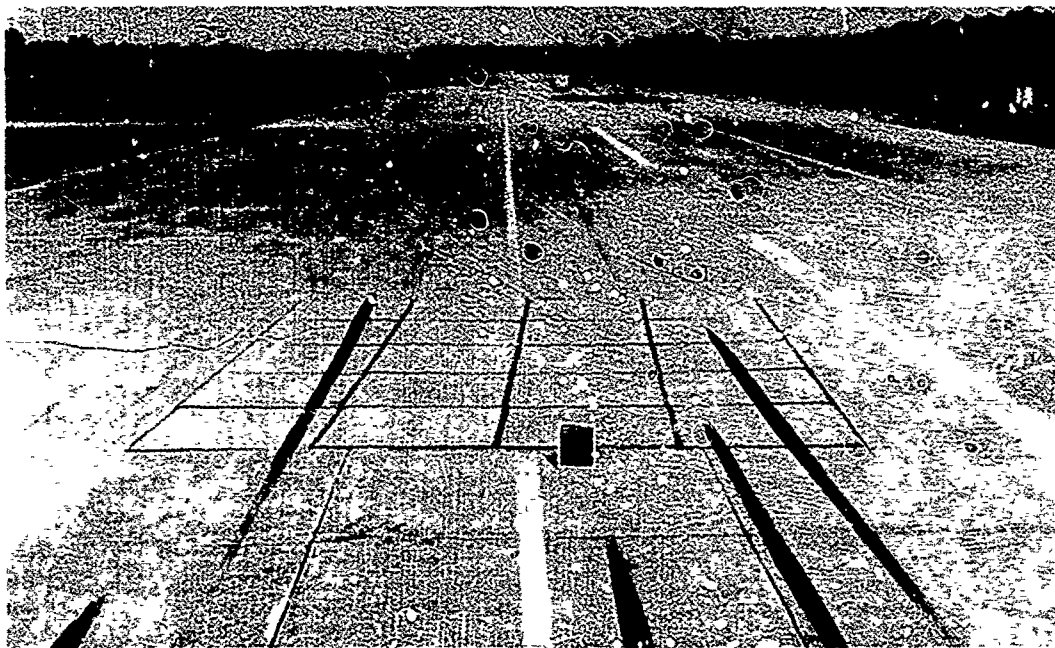
Photo 28. Precast slab repair after F-4 aircraft traffic

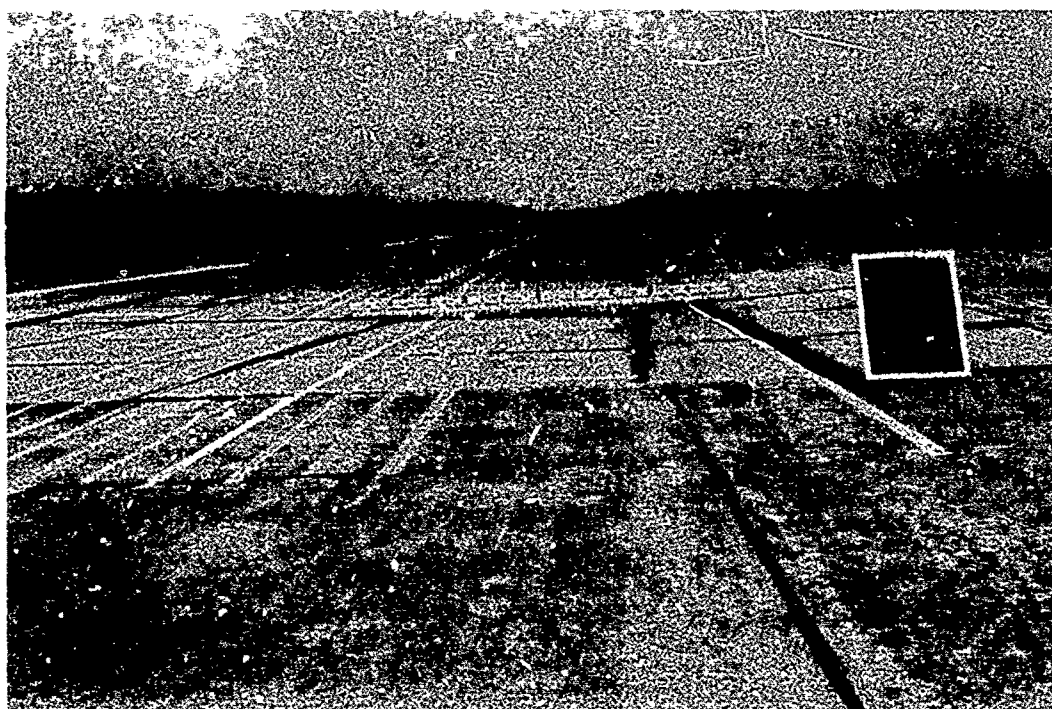
Photo 34. F-15 traffic lane with 10-ft straightedge after 16 coverages, precast slab repair

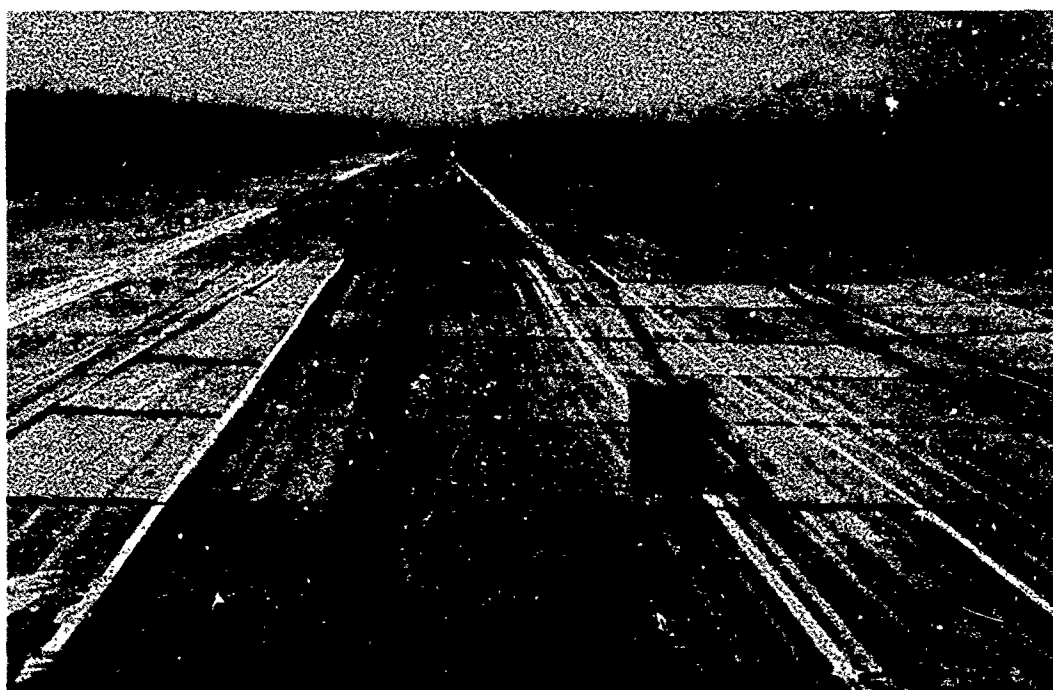
spalling of the PCC was noted (Figure 39). Photo 36 shows the traffic lane after 10 coverages. The spalling that is visible is located on slabs 7, 8, and 3 (Figure 40). The maximum sag measurement was 4.38 in. As traffic continued to 20 coverages, the sag measurement decreased to 4.00 in. Figures 41 through 46 compare profile data at 20 coverages of F-4 traffic with 16 coverages of F-15 traffic (conditions before F-4 traffic was resumed). Figure 47 shows the location of the spalling in the slabs. Photo 37 is a general view of the traffic lane after 20 coverages. At that time, the angle iron band on slab 8 was starting to work loose and the 6-in. PCC (runway, not repair) on the east edge of the crater repair was starting to break up. At

Photo 36. F-4 traffic lane after 10 coverages, precast slab repair

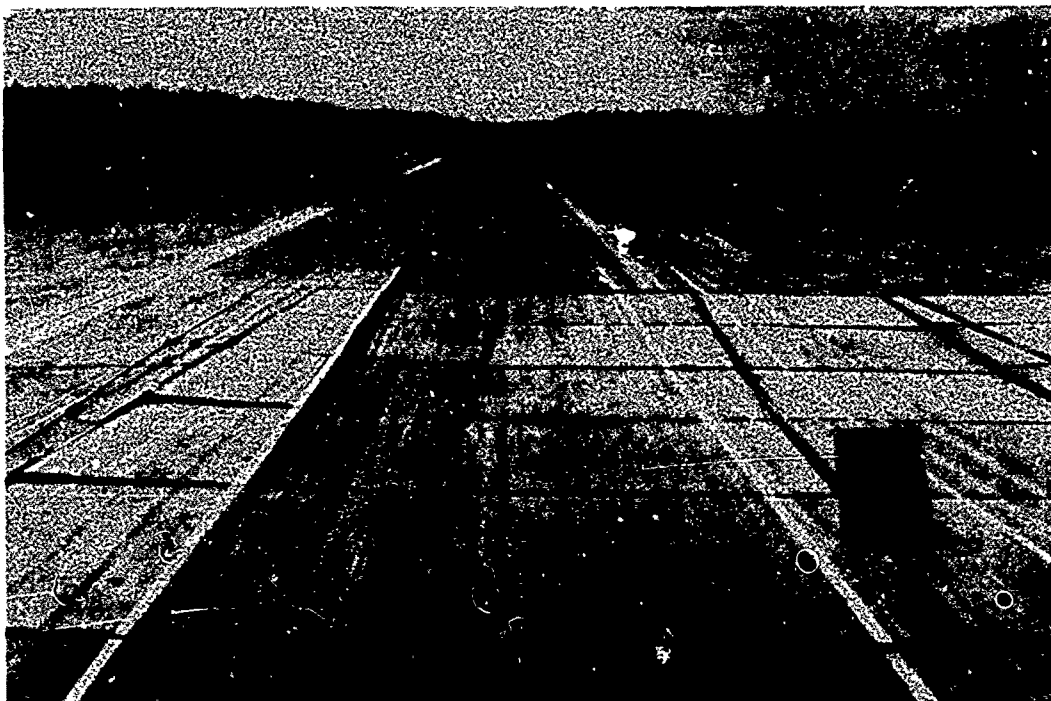
Photo 37. F-4 traffic lane after 20 coverages,  
precast slab repair

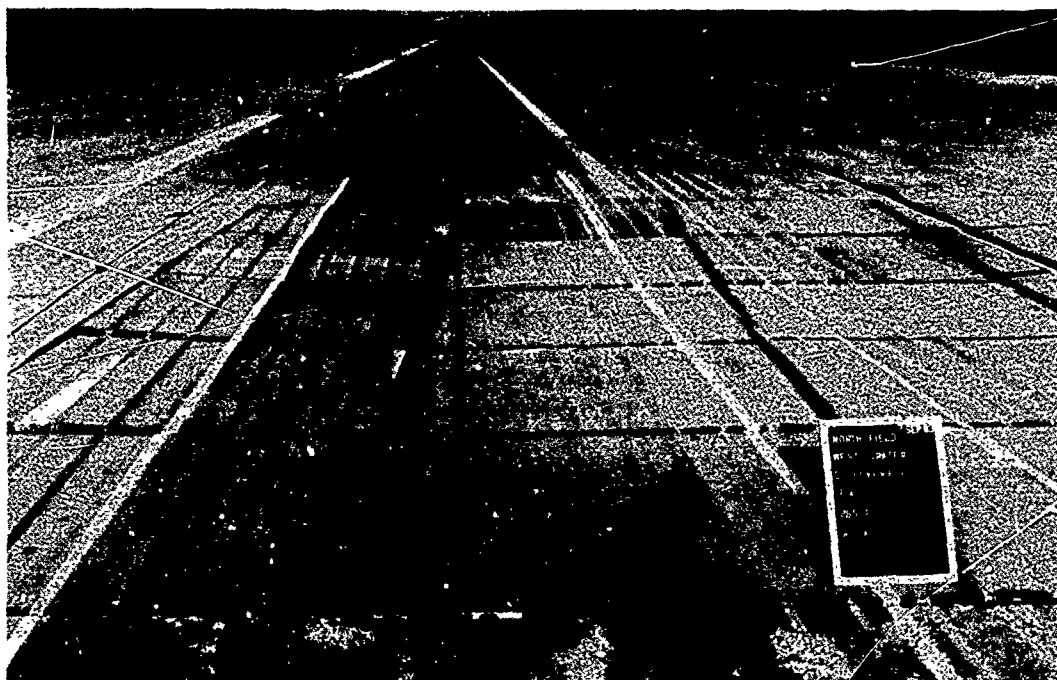
the cracks in the original PCC east of the crater repair. Figure 49 shows the location of all the spalling in the crater repair. There were no breaks or cracks generated in any of the slabs by F-4 load cart traffic. Figures 41 through 46 show profile data (50 coverages) in comparison with data when F-4 load cart traffic was resumed and after 20 coverages.

Photo 39. General view of F-4 traffic lane after 50 coverages,  
precast slab repair

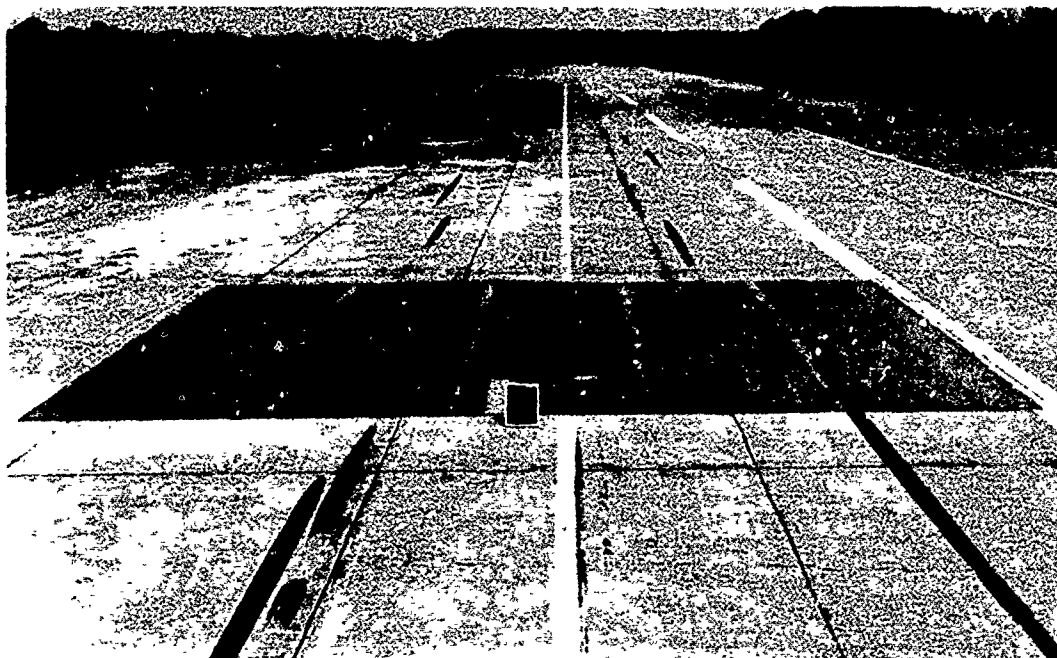
Photo 43. General view of FOD cover repair  
after F-4 aircraft traffic

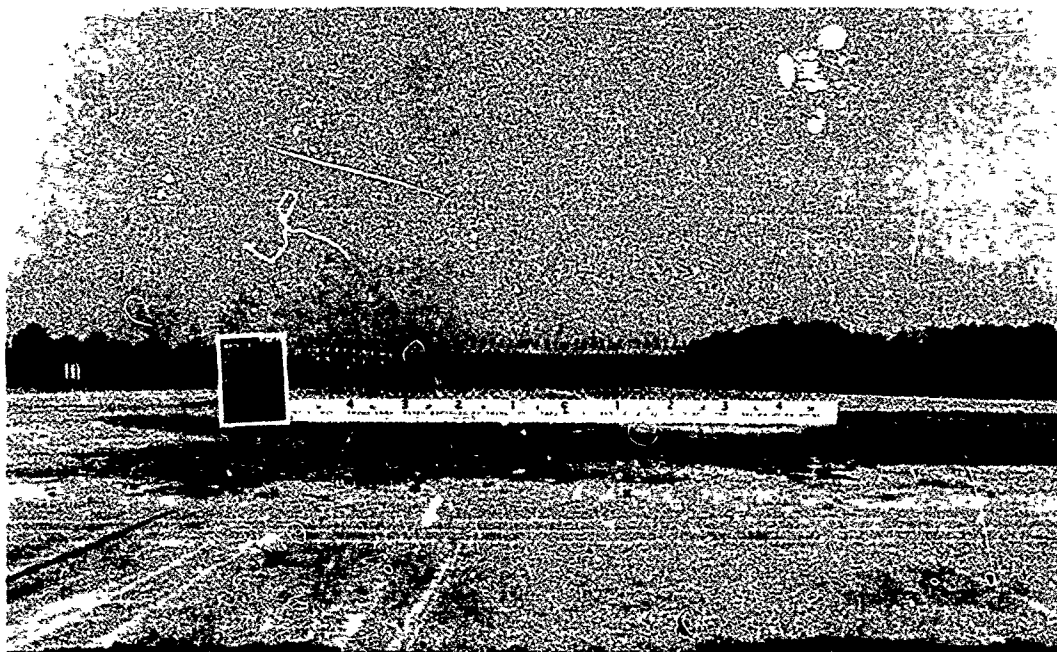
32. After aircraft traffic, the FOD cover was removed to obtain data on the base material and then the FOD cover was installed and load cart traffic begun. Photo 44 shows the rutting that had developed in the base course during proof loading and aircraft tests. Plots of the profile and cross-section measurements taken on the base course after aircraft traffic are shown in Figures 67 through 72. The average of five nuclear density tests performed on the base course after the aircraft traffic was 133.6 pcf (Table 2). Surface measurements taken during traffic and recorded in Table 6 indicate that a 1.5-in. maximum sag occurred in the south wheel (gear) path of the F-4 aircraft. Surface roughness measurements recorded after aircraft traffic and compared with those measured before traffic indicate a maximum consolidation of 4.5 in. (3.0-in. upheaval and 1.5-in. sag) had taken place in the wheel paths.

39. The findings from traffic testing of the FOD cover repair show that:
- a. The crater repair as built (Figures 9 and 10) was under-designed.
  - b. The thicknesses of the crater fill material (base course and ballast) were inadequate to withstand the test traffic.
  - c. Although the test results indicate poor performance of this type of crater repair, the performance would have been

Photo 44. Rutting in the base course of the FOD cover repair

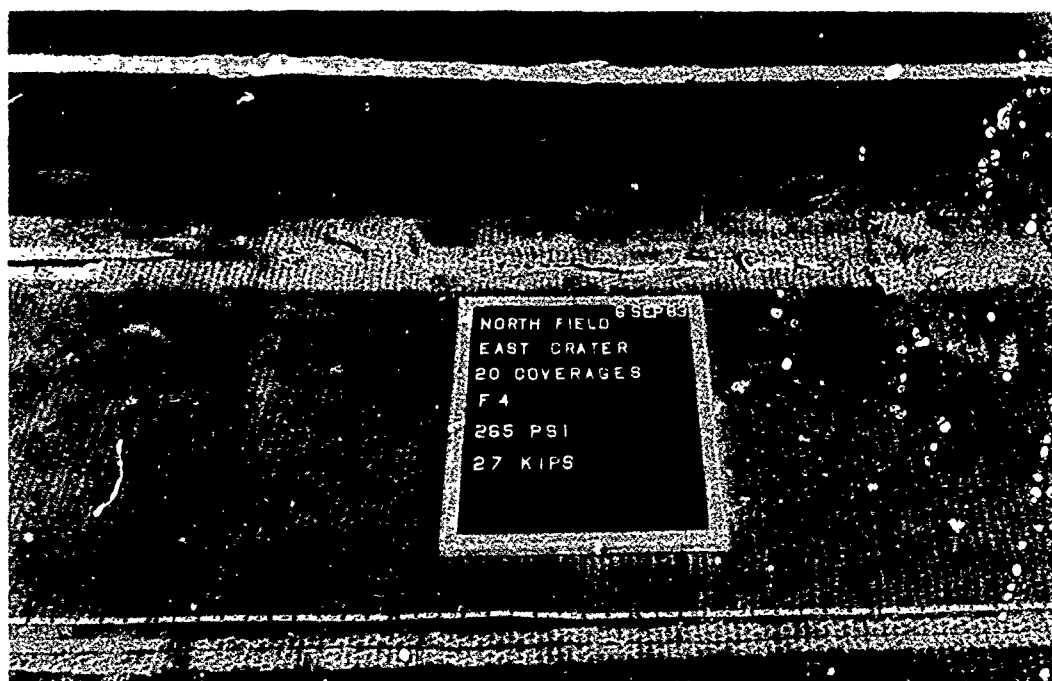
Photo 53. Close-up of spalling on torn hinge in the FOD cover repair after 20 coverages of F-4 traffic
