# TRAY PACK IMPROVED DURABILITY PACKAGING ROUGH HANDLING TEST RESULTS

RICHARD D. CUMMINGS

JUNE 1983  
FINAL REPORT  
1 JANUARY 1983 TO 30 JUNE 1983

UNITED STATES ARMY NATICK  
RESEARCH AND DEVELOPMENT CENTER  
NATICK, MASSACHUSETTS 01760-5000  
FOOD ENGINEERING LABORATORY

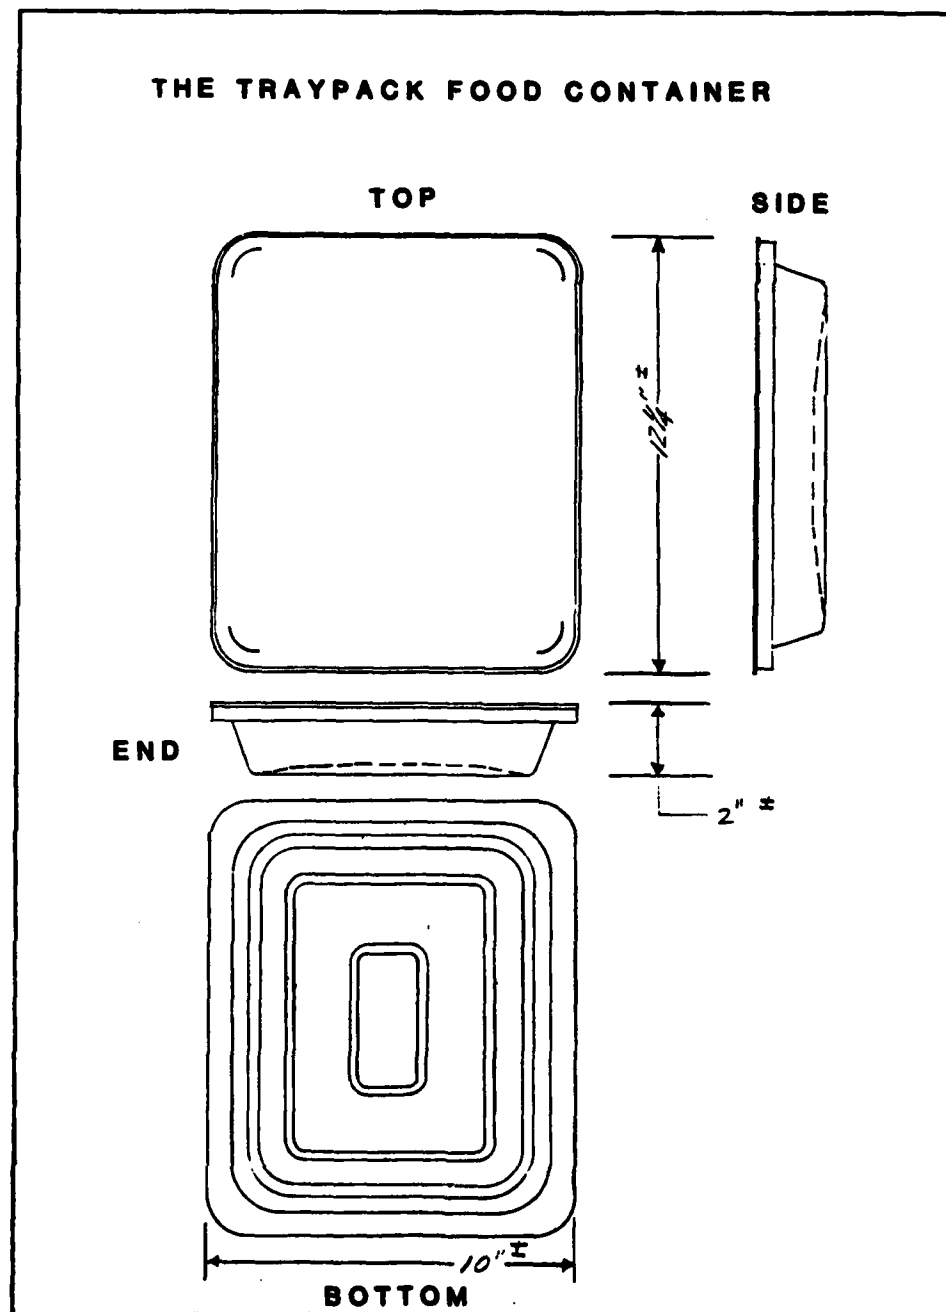
The top or lid is drawn from 85-pound (0.0094-inch-thick) steel. The lid material has an inner polymeric liner to prevent food contamination and an exterior coating to retard corrosion and oxidation. The lid is nearly flat across its entire surface.

The bottom or can is drawn from 75-pound (0.0083-inch thick) steel. The bottom also has a polymeric inner liner and an outer metal coating. The drawing process on the bottom results in numerous material excesses and these are drawn into a regular pattern by means of vertically oriented indentations and bulges of approximately 0.070" depth around the perimeter of the can. Around the corners these indentations and bulges are sinusoidal in cross

Figure 1. The Tray Pack food container

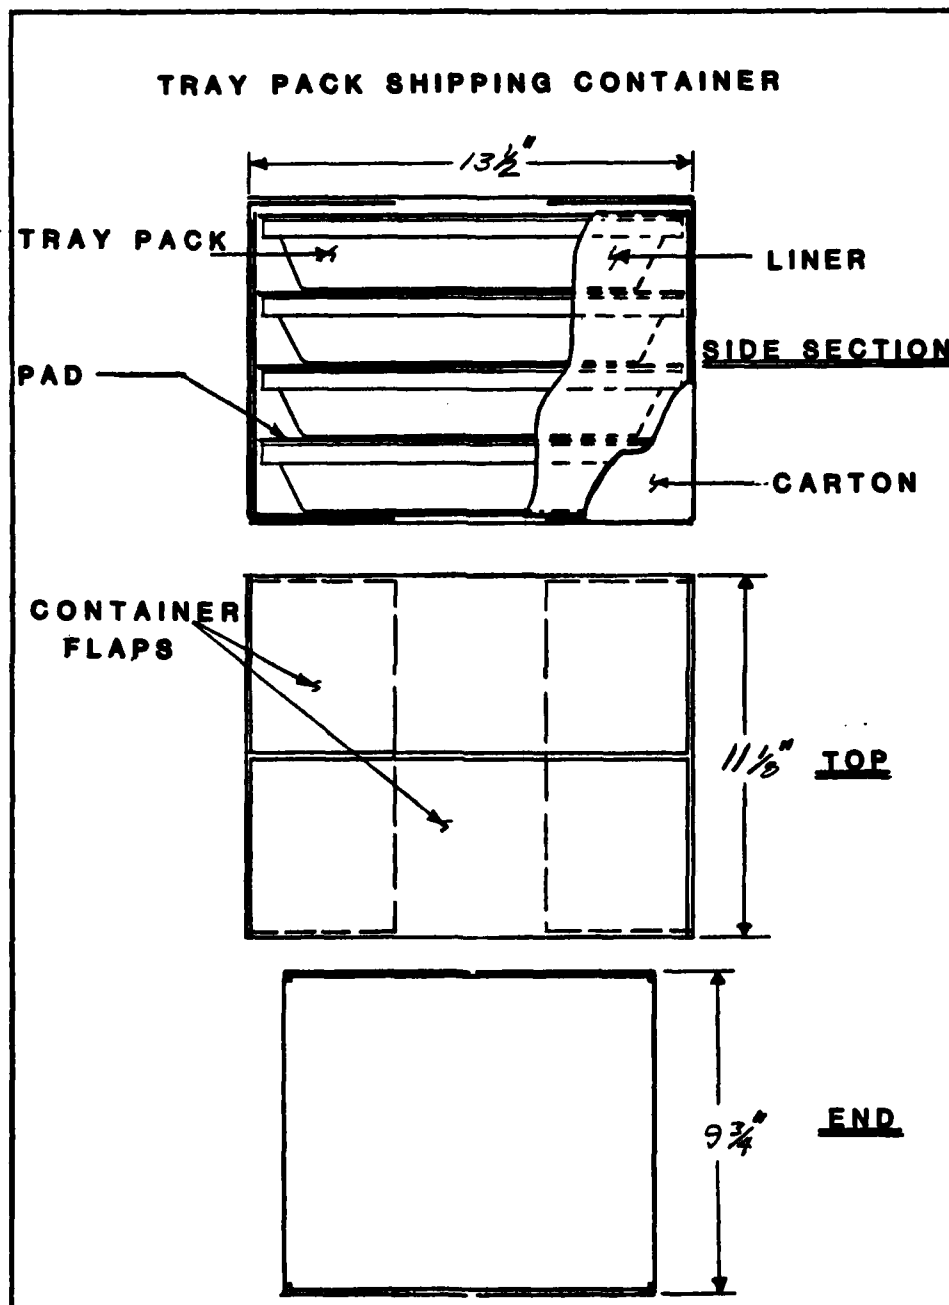
The shipping container material is V3C fiberboard made by St. Regis Paper Co. The sides of the container are reinforced by means of an inner liner that increases its buckling resistance. A pad is placed on the bottom of the container, between each Tray Pack, and at the top of the container.

Figure 2. Tray Pack shipping container

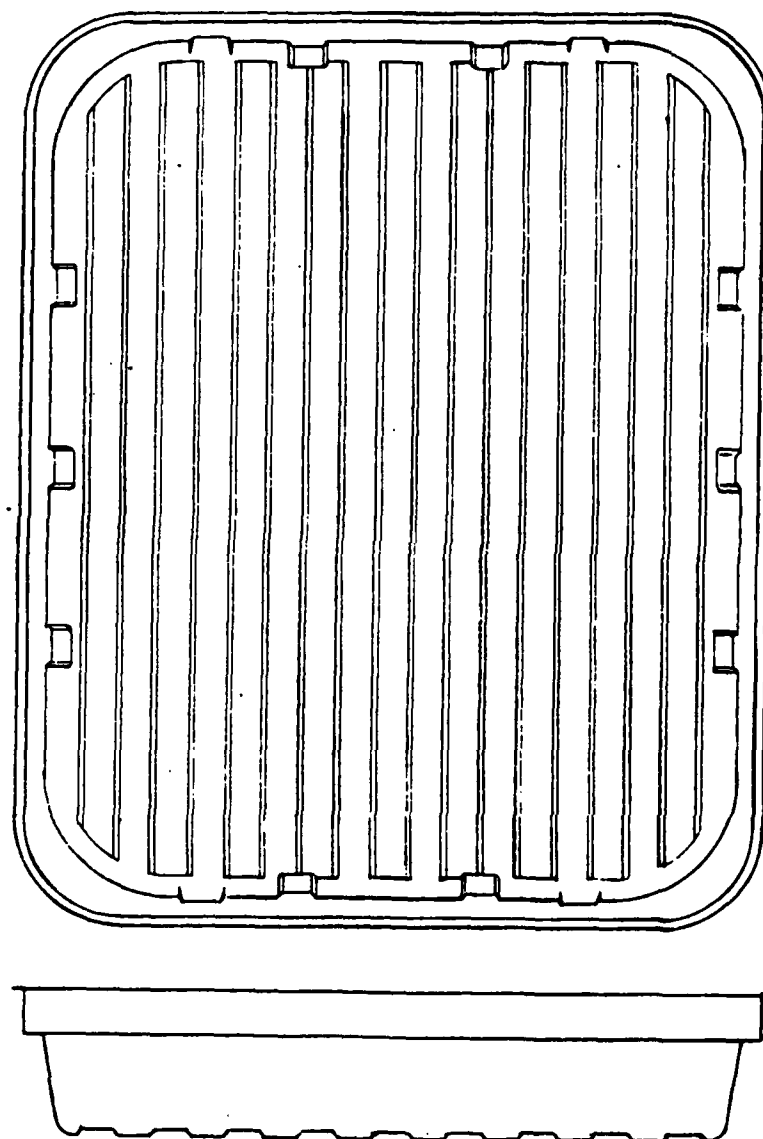
Figure 14a. Reinforced Tray Pack concept

Figure 14b. Reinforced Tray Pack concept

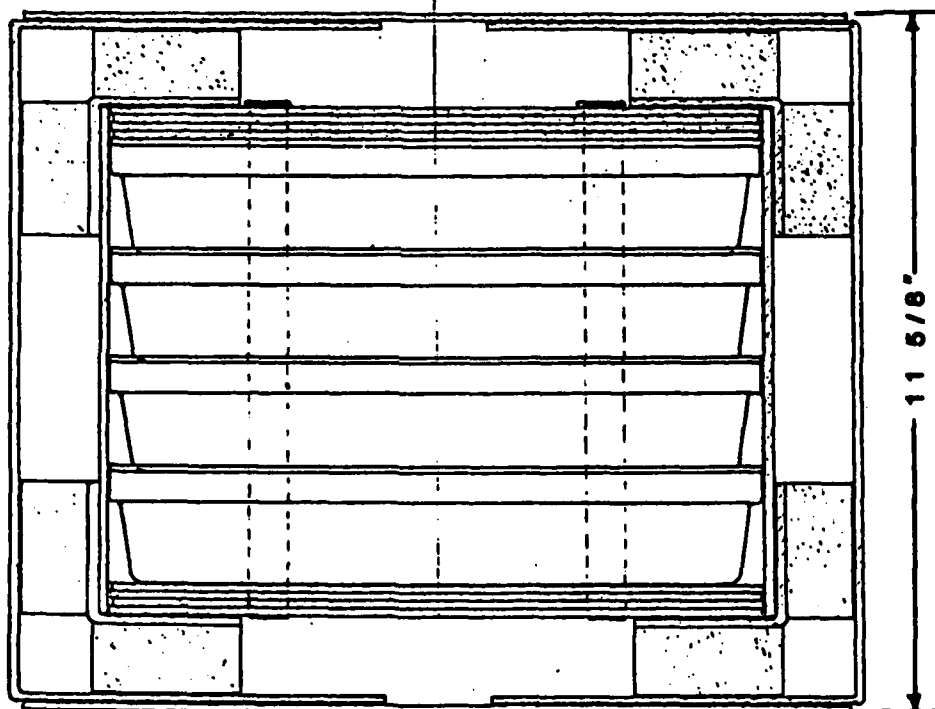
The bundle concept, shown in Figure 15, performed quite well under evaluation testing and was therefore included in our Acceptance Testing Program. As can be seen from Figure 15, this concept requires more parts and a larger box than the baseline shipping container concept. Consequently, its cost is greater as shown in Table 14. The cost is increased per filled Tray Pack by 8.3%

Figure 15a. Tray Pack bundle concept shipping container

Figure 15b. Tray Pack bundle concept shipping container

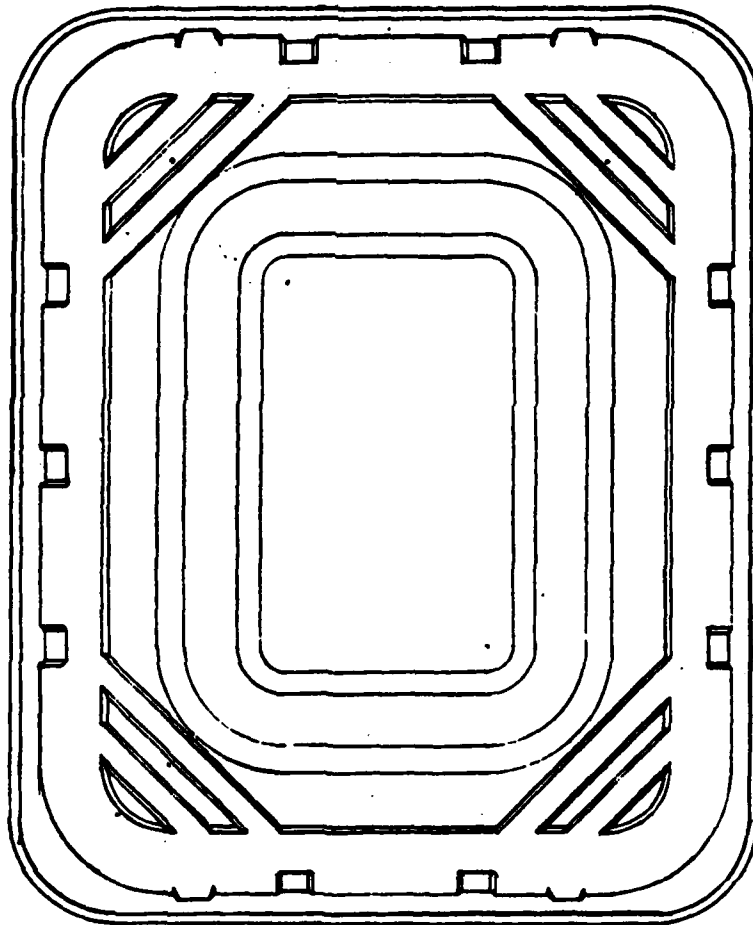
Table 17 is a summary of the prefailure vacuum levels achieved by each of the sample types tested. The sample concepts are depicted in Figures 18, 19, 20, 21. Each succeeding concept represents a greater degree of reinforcement. Each succeeding concept also is capable of withstanding a greater degree of vacuum. The last two concepts incurred panels which developed quite slowly, in a very controlled manner, as opposed to the instantaneous change incurred by the first two concepts indicating that the paneling is induced by means of a different mechanism.

**Figure 19. Cross reinforced Tray Pack**

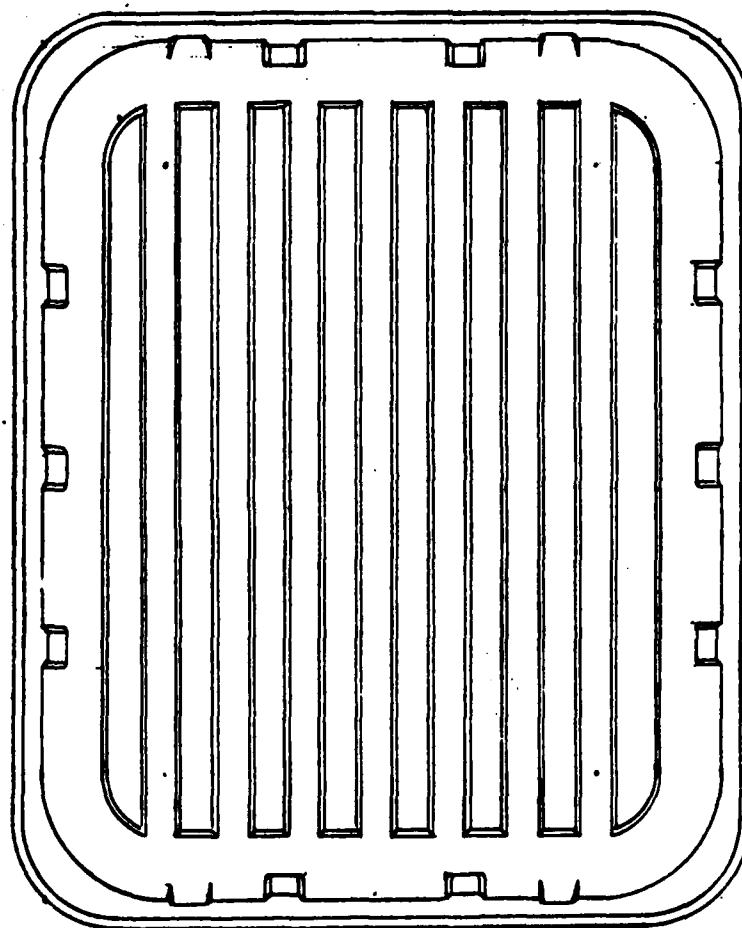
Figure 20. Tray Pack with bottom reinforced  
to within 3/4" of edge

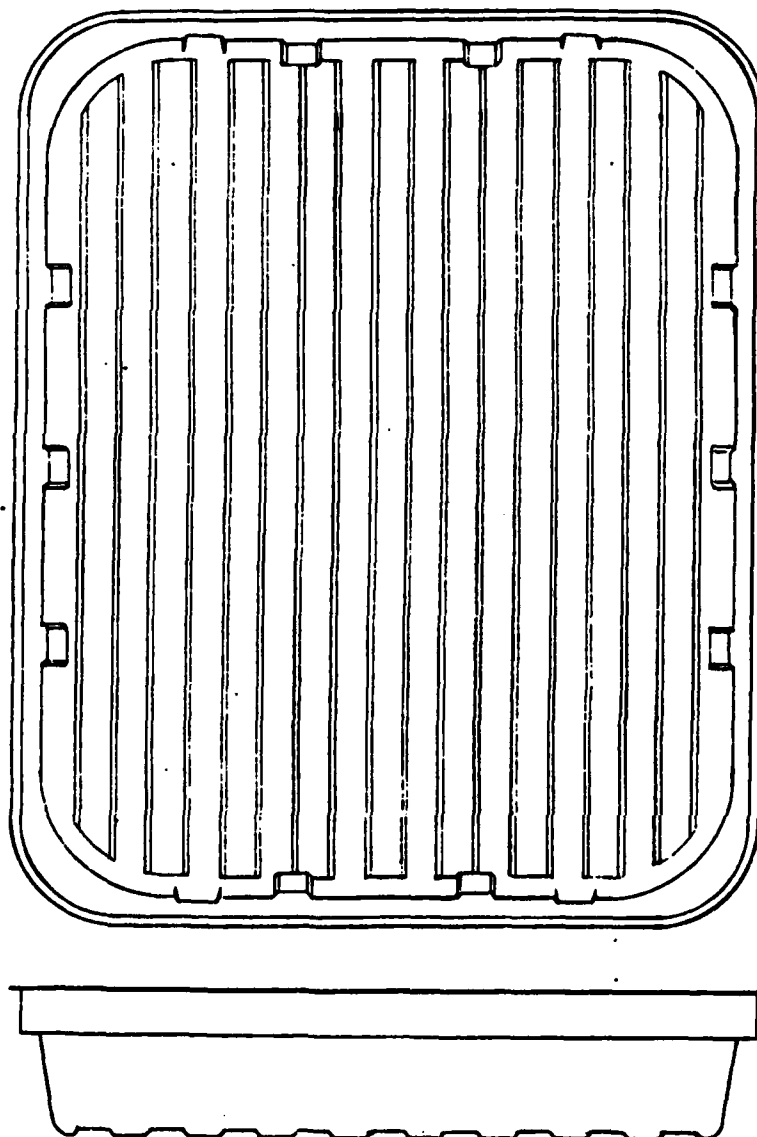
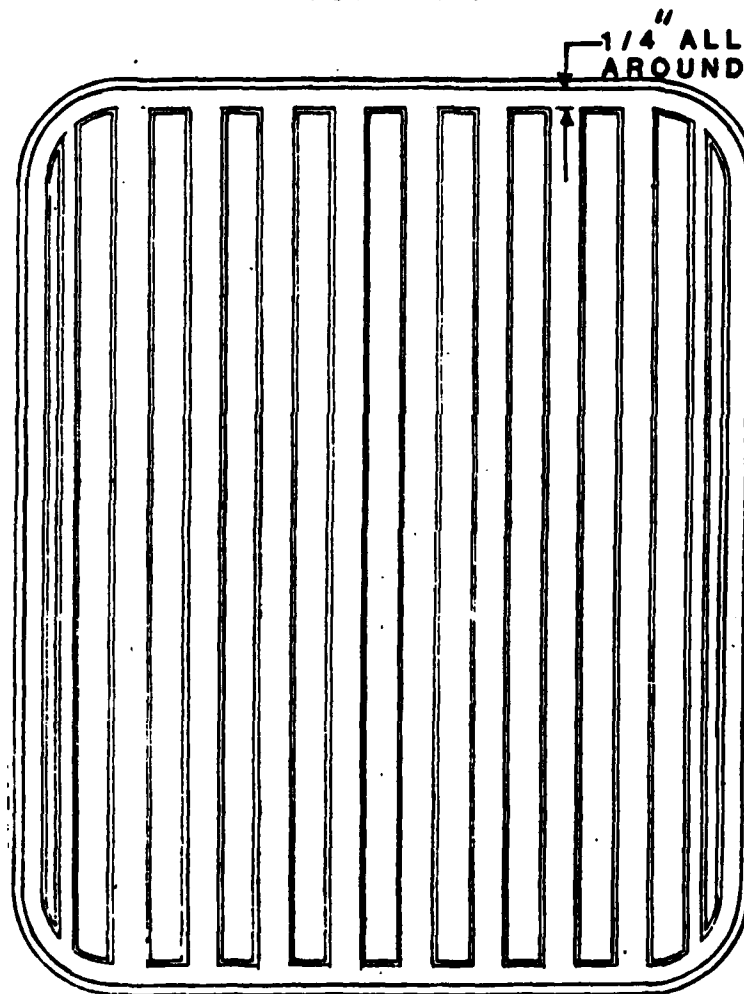
Figure 21a. Tray Pack with top and bottom  
reinforced to edge

Figure 21b. Tray Pack with top and bottom  
reinforced to edge
