FINAL REPORT  
QUALITATIVE EROSION AND  
SEDIMENTATION INVESTIGATION  
MALINE CREEK  
CITY AND COUNTY OF ST. LOUIS, MISSOURI

Submitted to  
St. Louis District  
Corps of Engineers  
210 Tucker Boulevard, North  
St. Louis, MO 63101-1986

Prepared by  
Simons, Li & Associates, Inc.  
3555 Stanford Road  
P.O. Box 1816  
Fort Collins, CO 80522

July 30, 1985

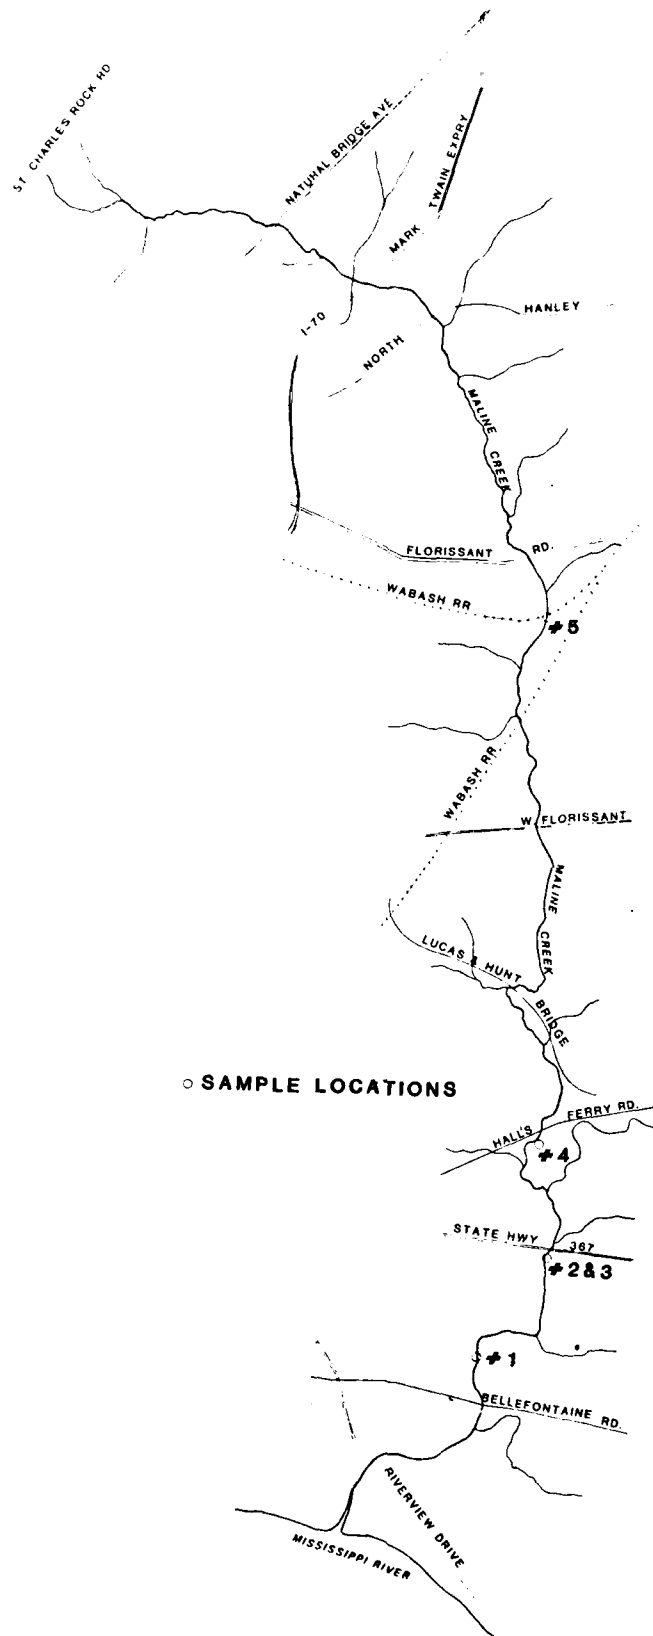
Figure 4.1. Locations of soil samples in Maline Creek watershed.

Soil samples of bed and bank material were taken at five locations along Maline Creek during the site visit. Figure 4.1 shows the approximate location where samples were taken. Analysis of the samples was made to determine their size distribution. Hydrometer analysis was utilized to determine the distribution of material passing the 200 sieve (.075 mm). Gradation curves developed for each sample are presented on Figure 4.2.

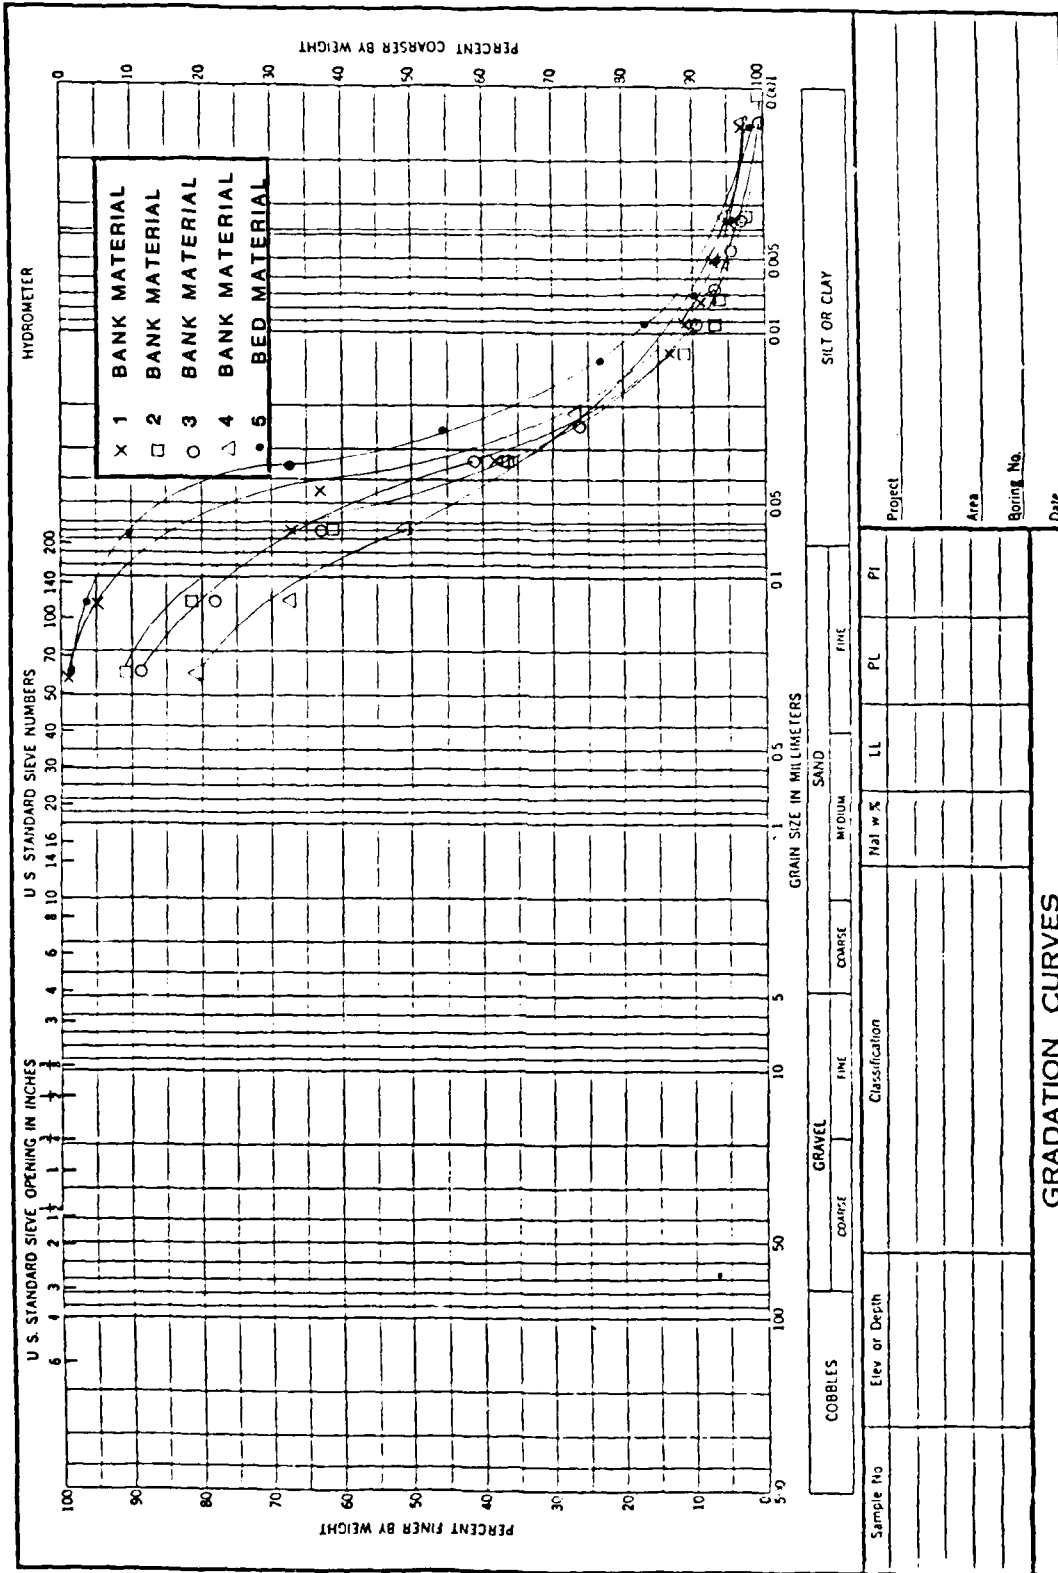
Figure 4.2. Gradation curves of soil samples.

The gradation curves for all the samples show that they are composed of approximately 70 to 90 percent by weight of material finer than the No. 200 sieve (.075 mm). Sample numbers 1, 2, 3, and 4 were taken of bank material along the creek. Sample No. 5 was taken of the stiff erosion resistant clay found in the bed of the channel. This may be correlative with the lower loess formation, the Roxana Loess, discussed in Section 4.3. Sample No. 5 was found to be composed of the finest material.

The clay content determined for each sample was found to be between 4 to 7 percent by weight. From field observations, it is believed that the clay

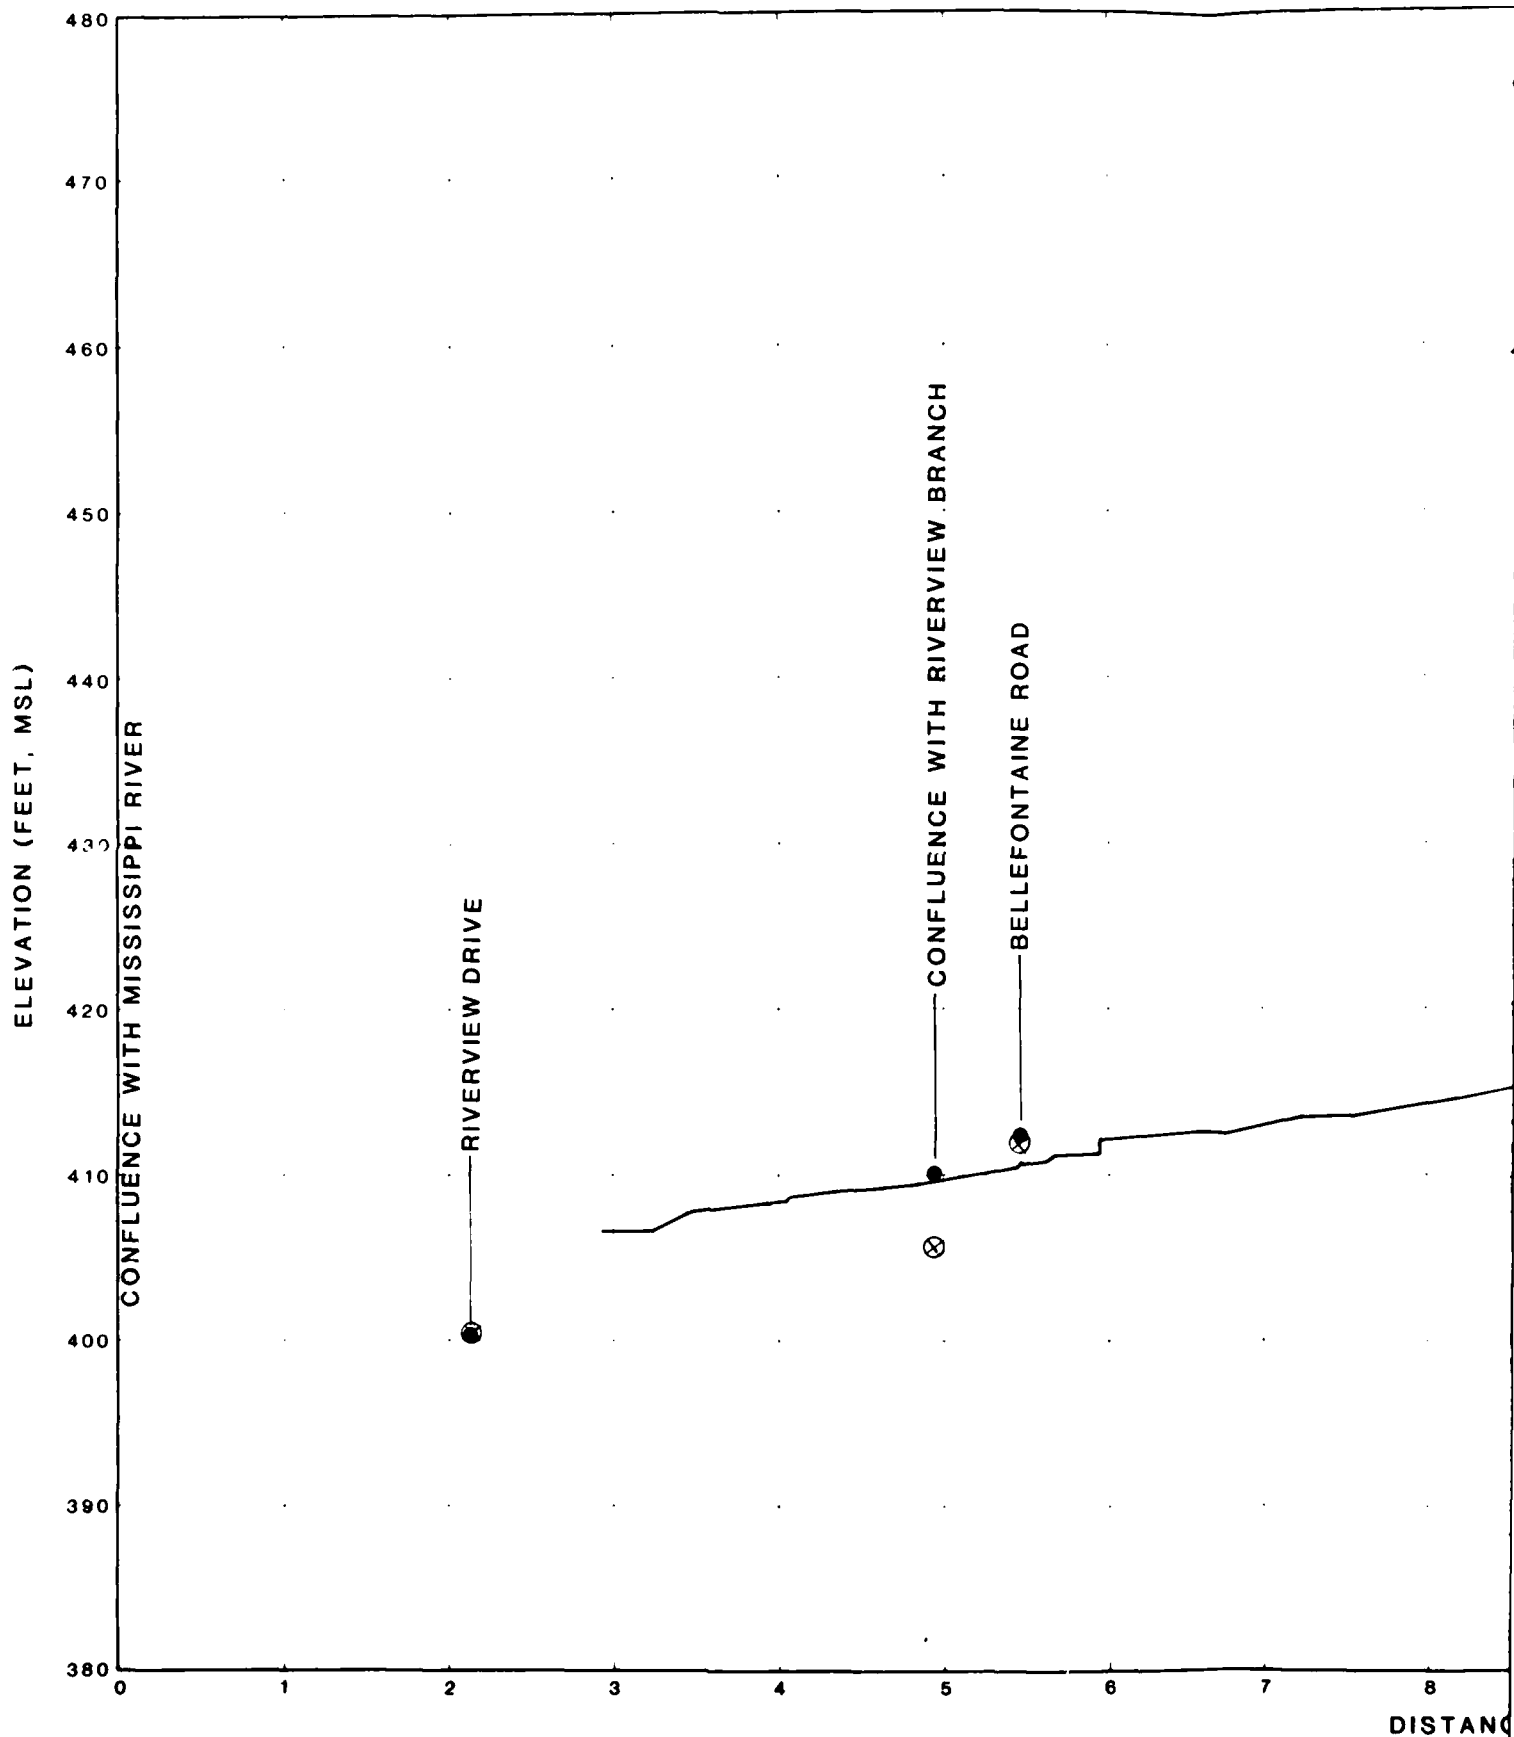
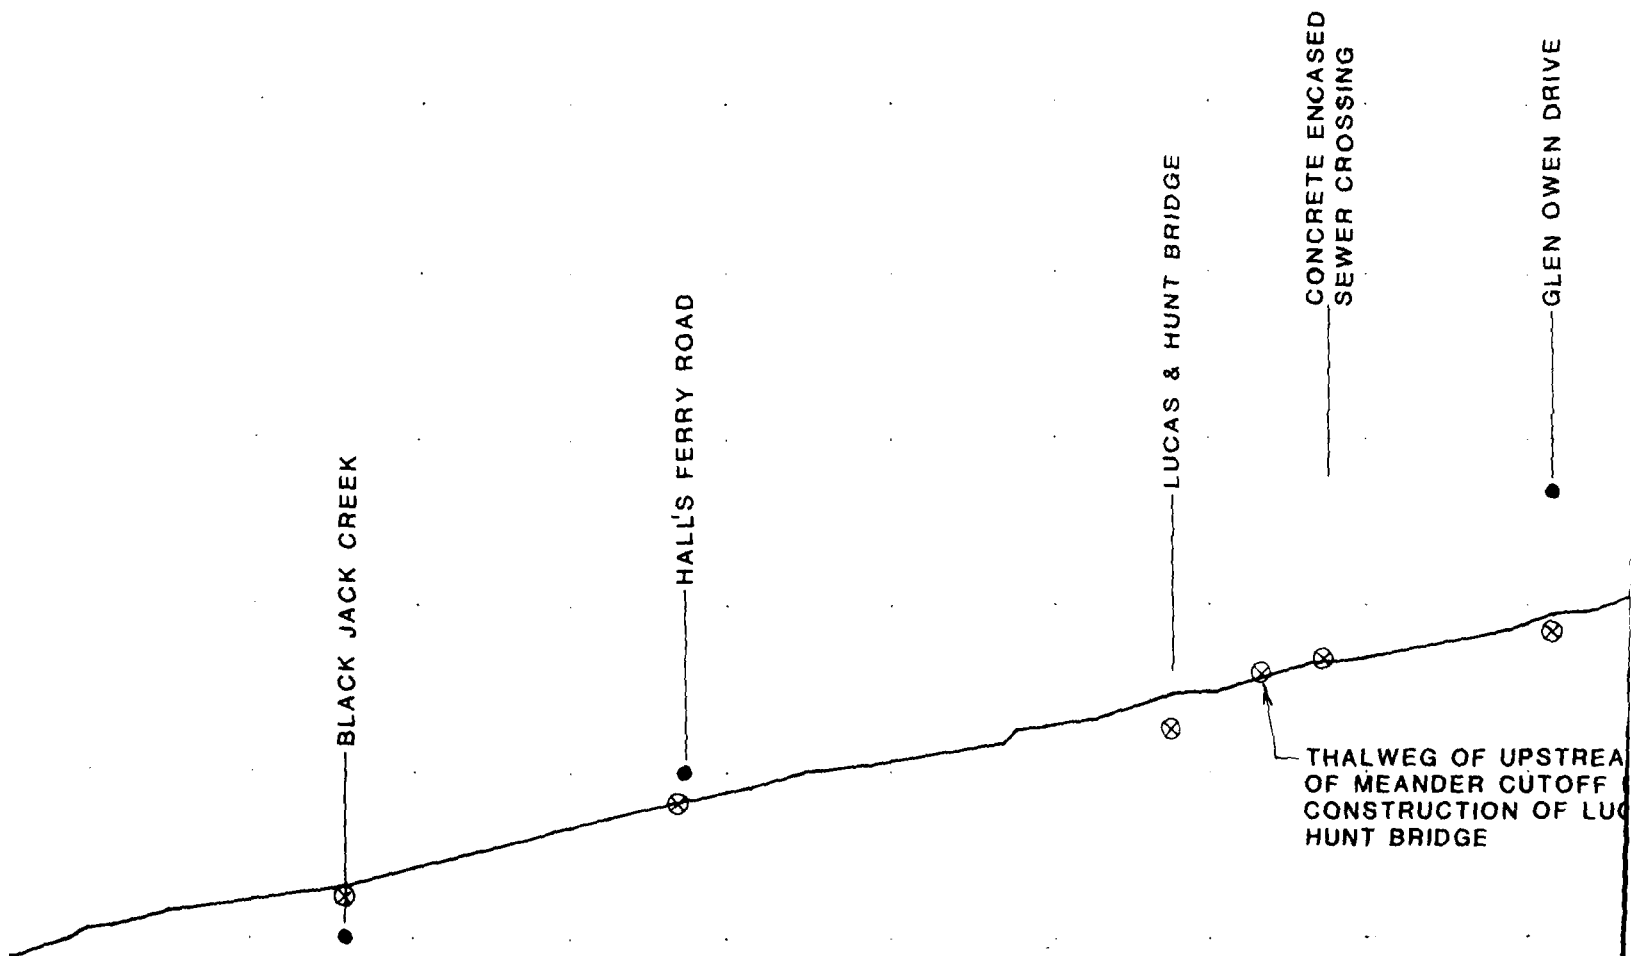
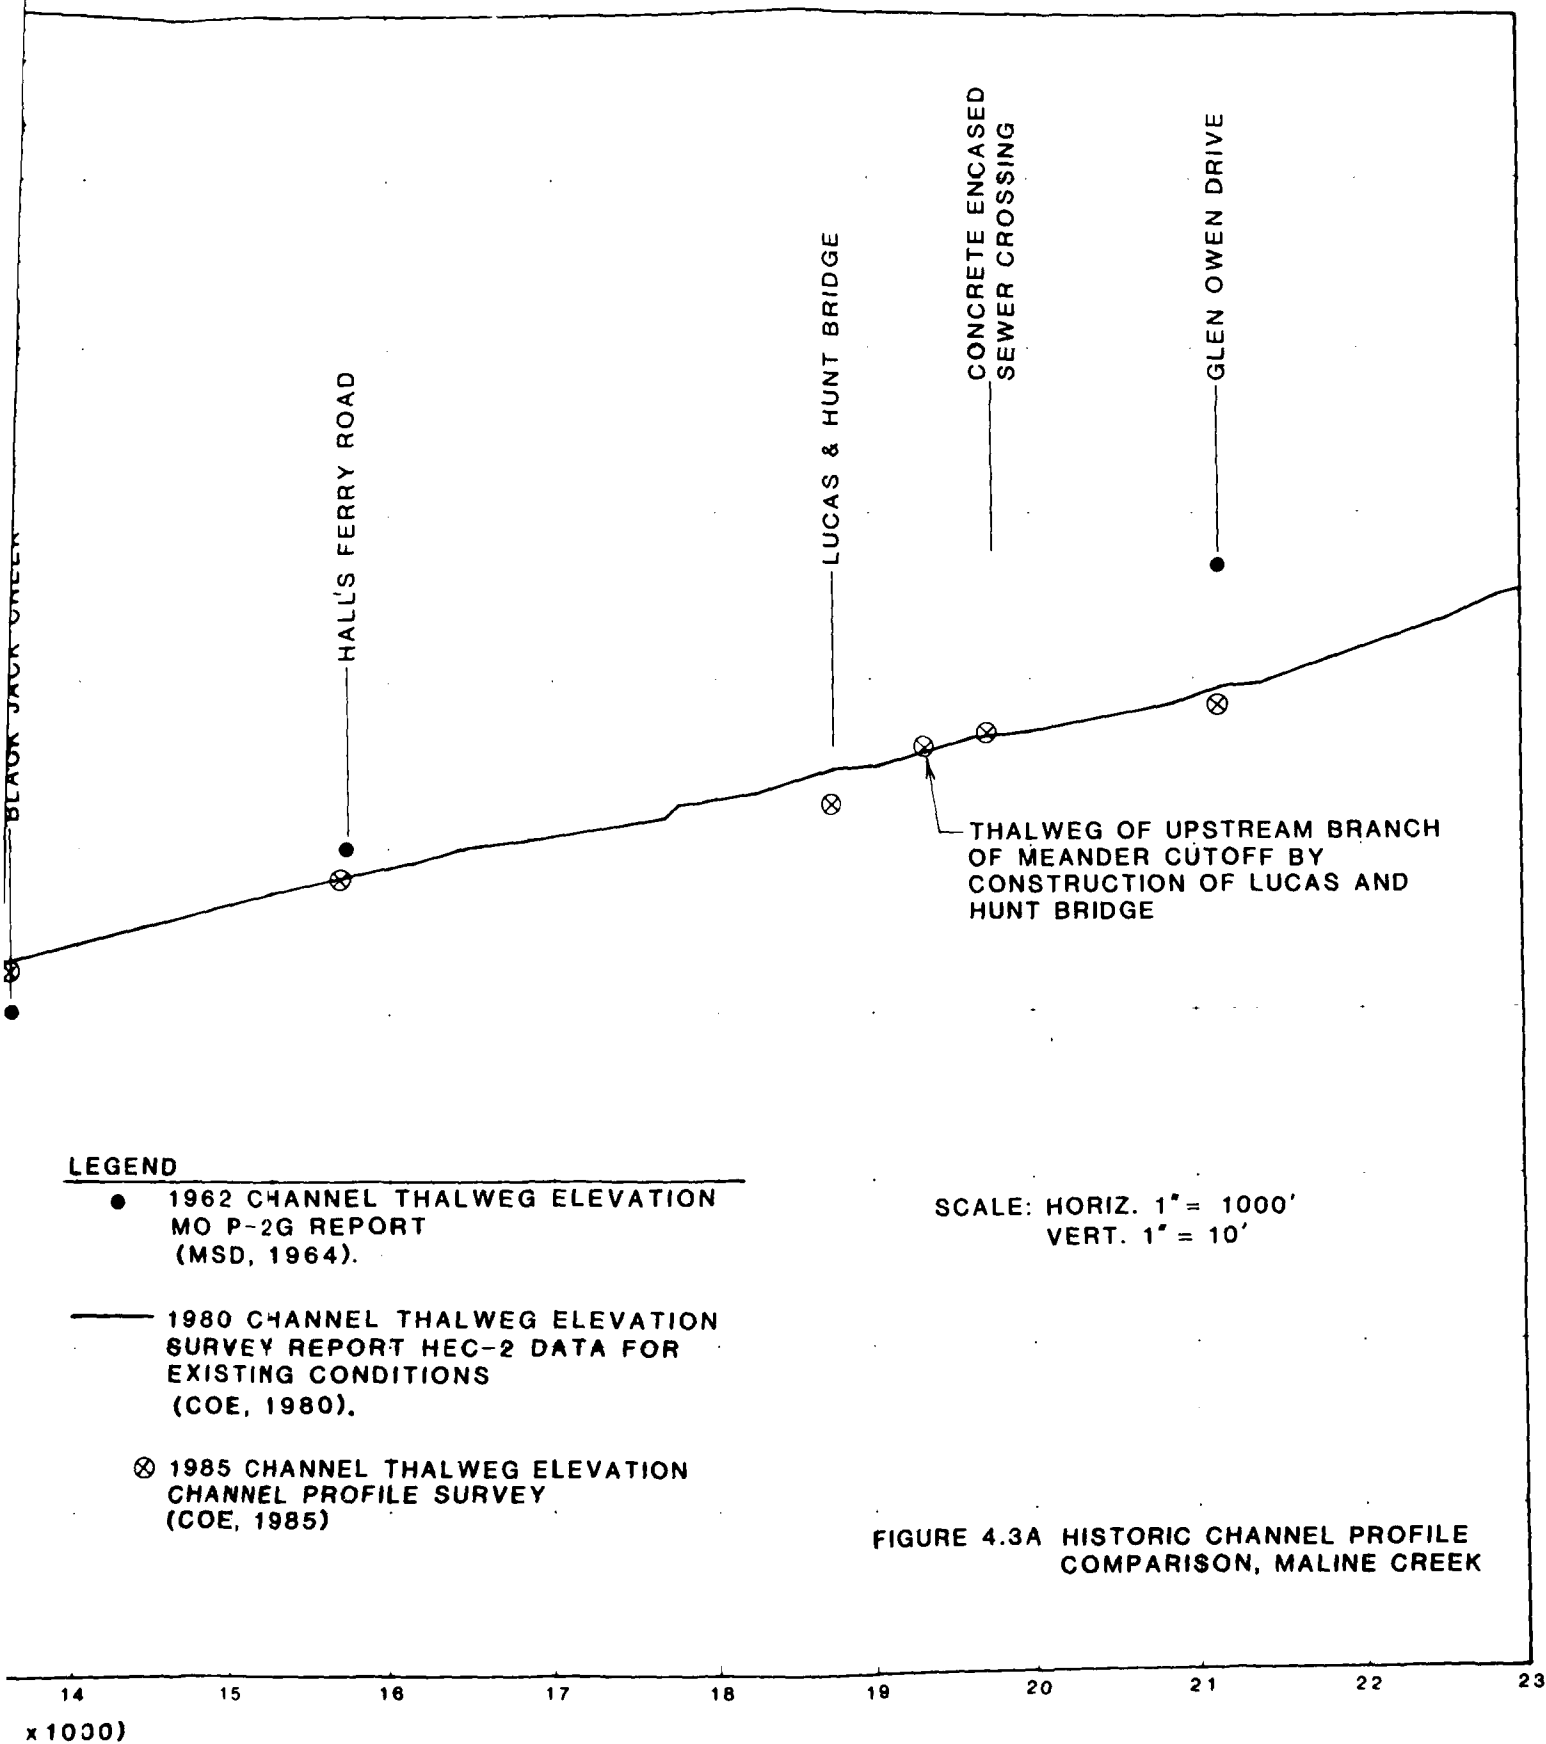
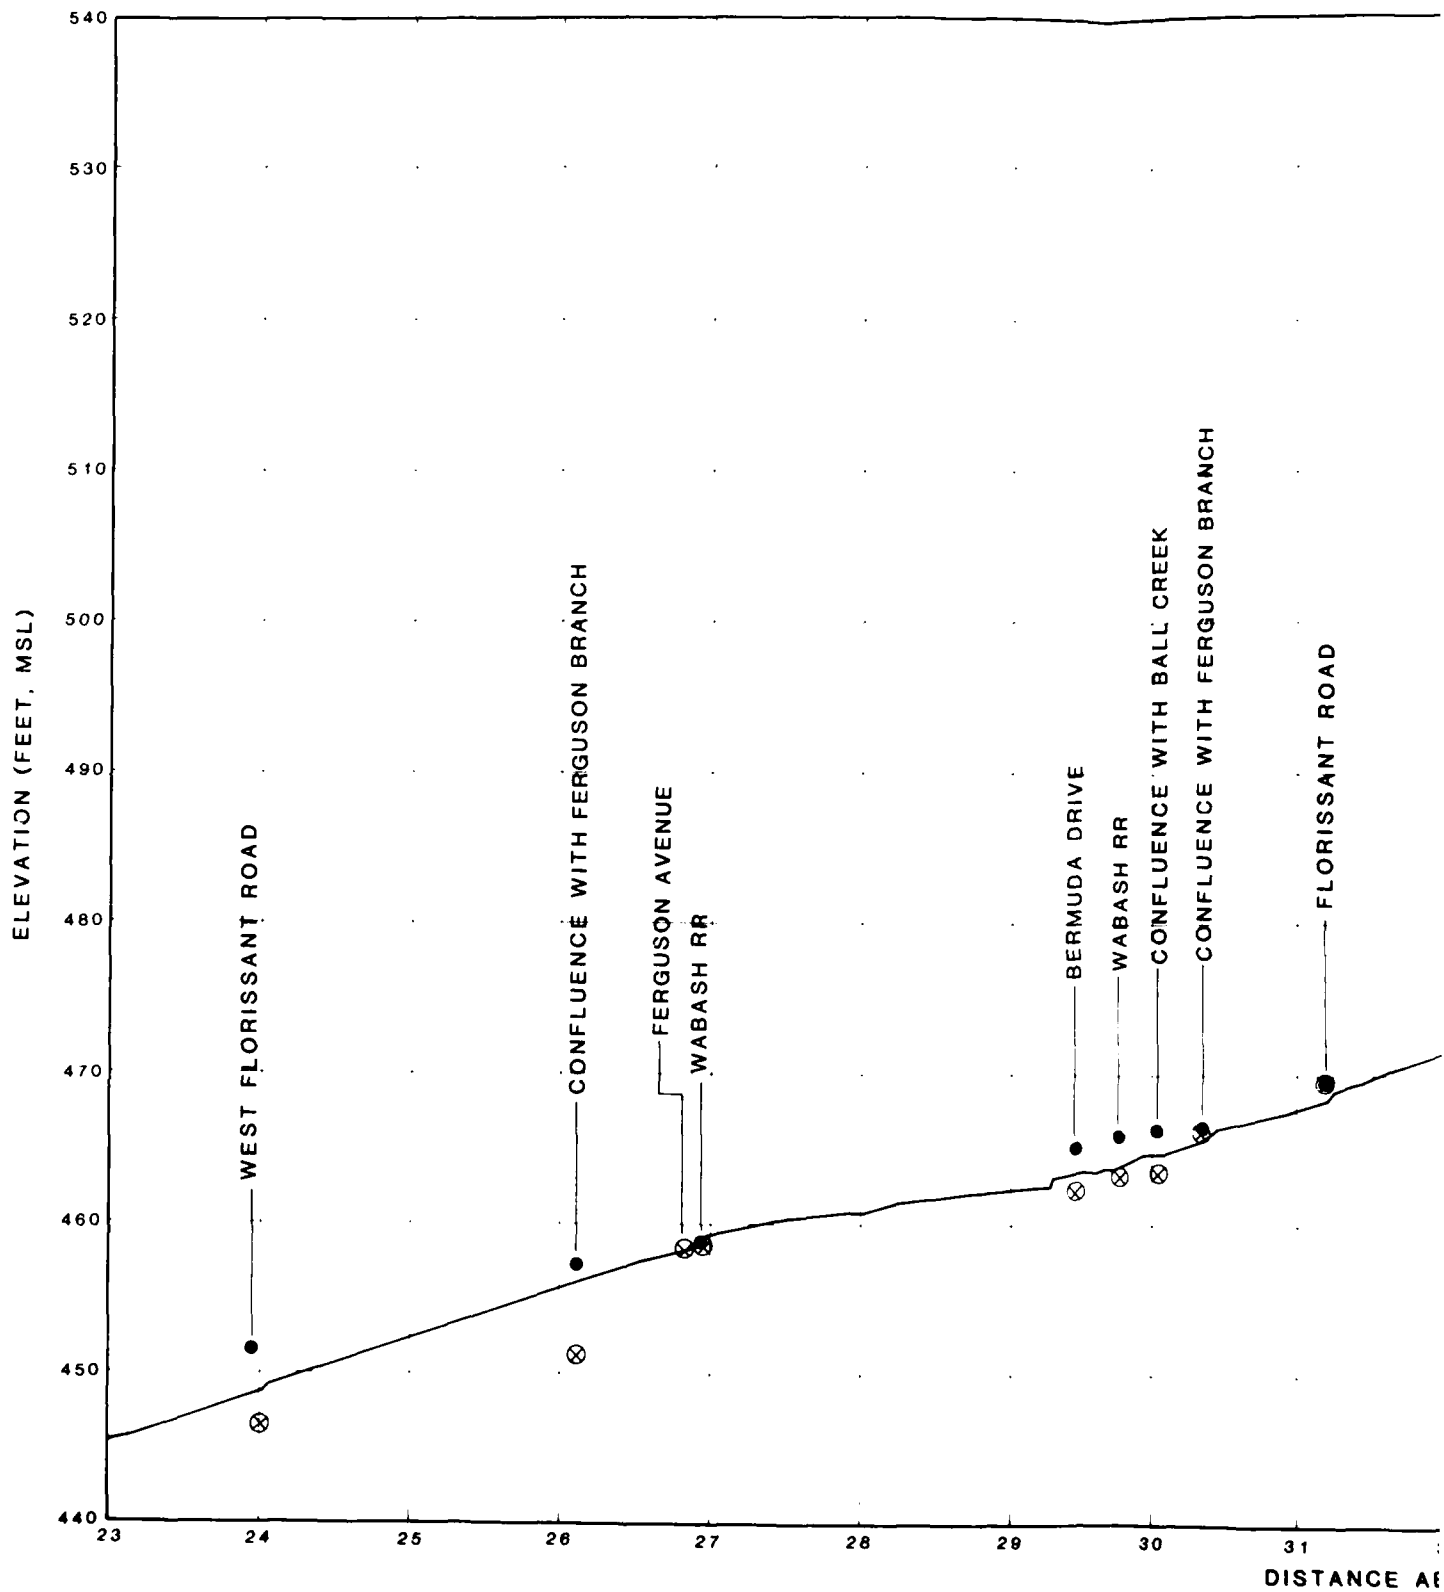
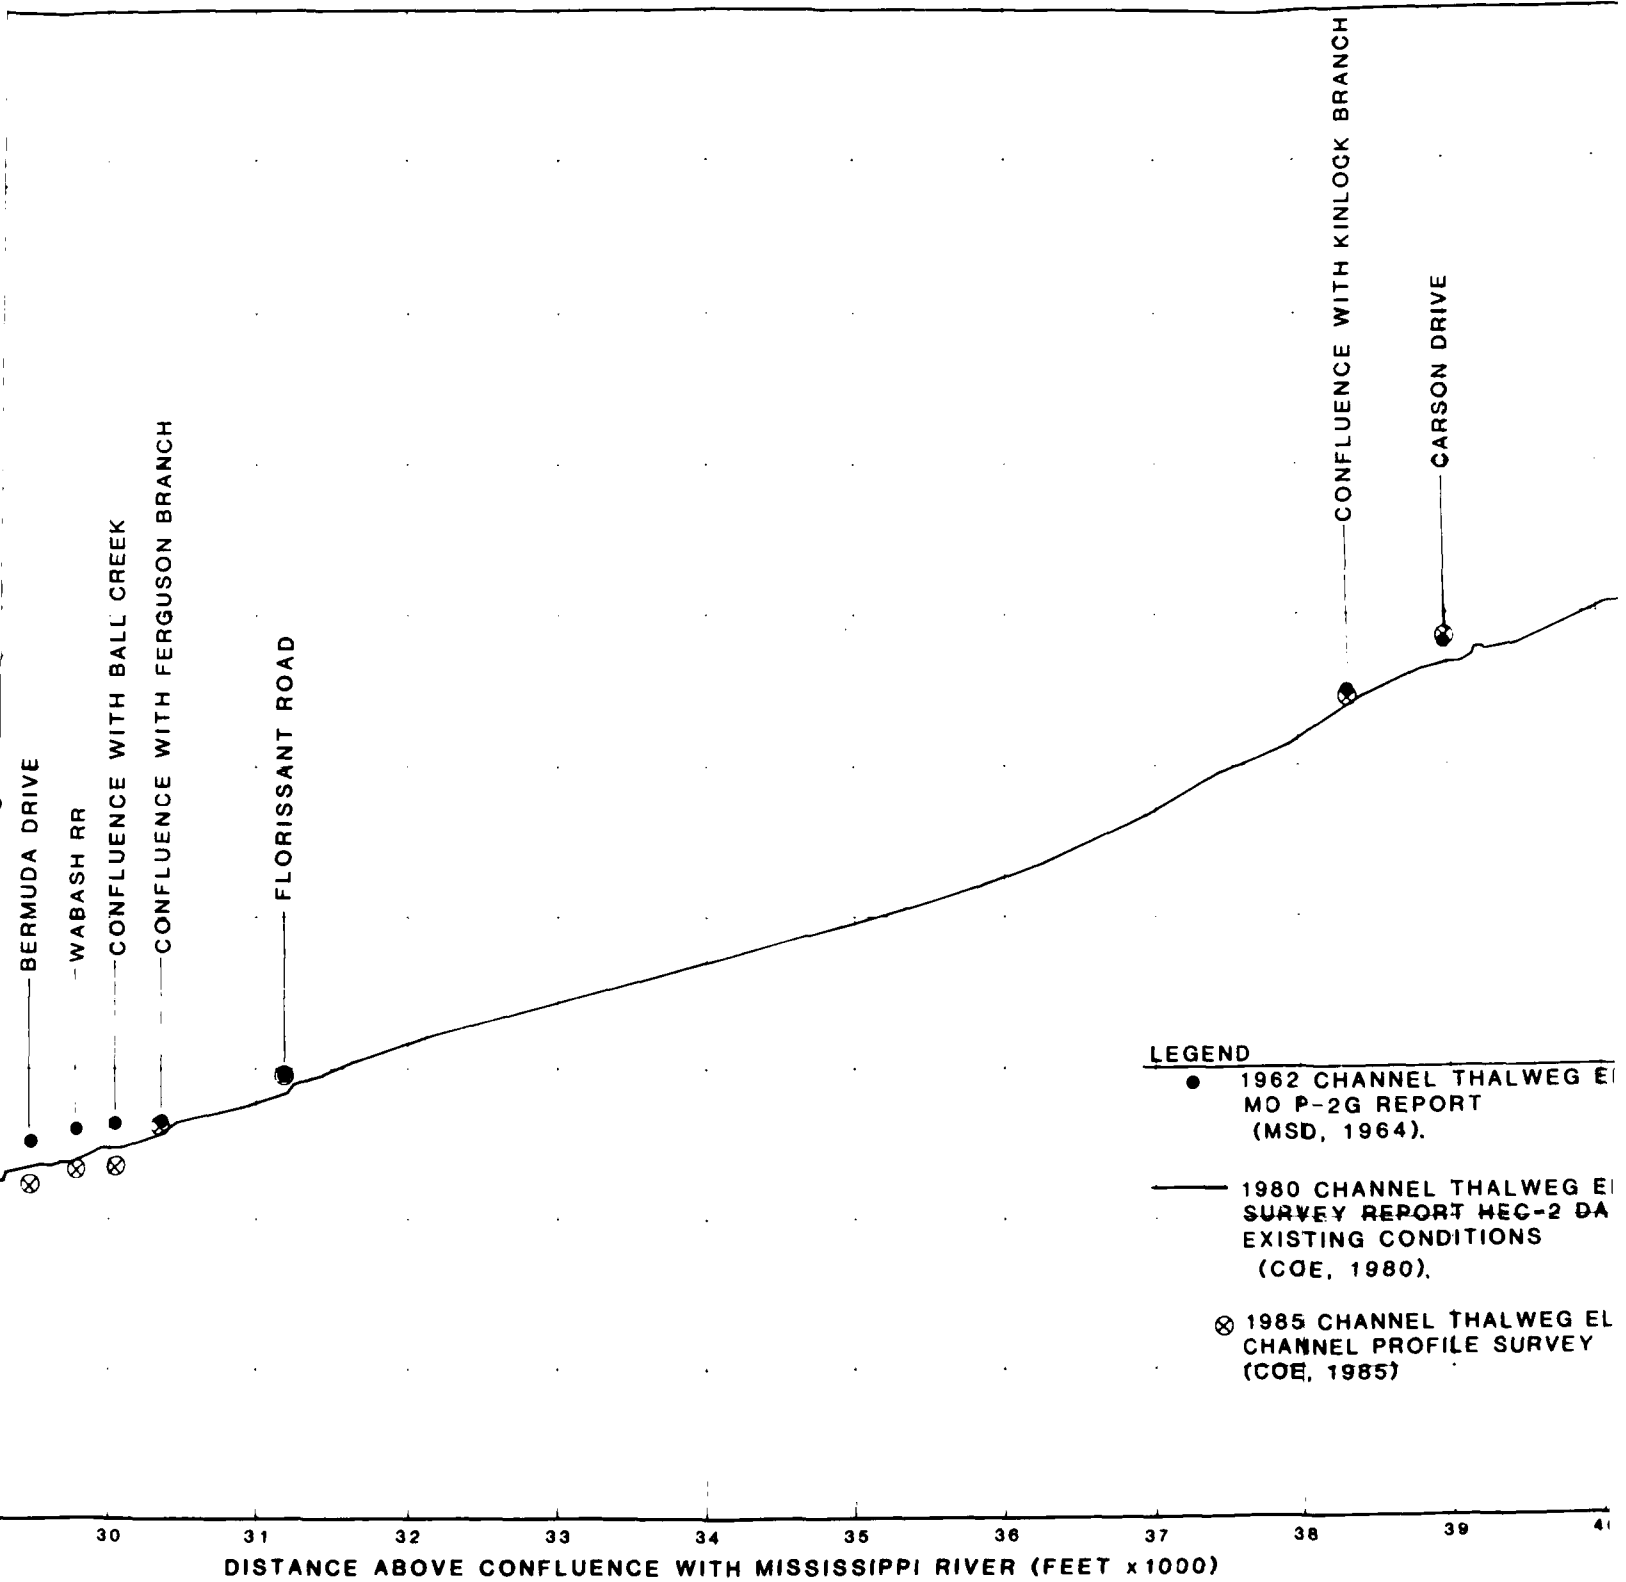
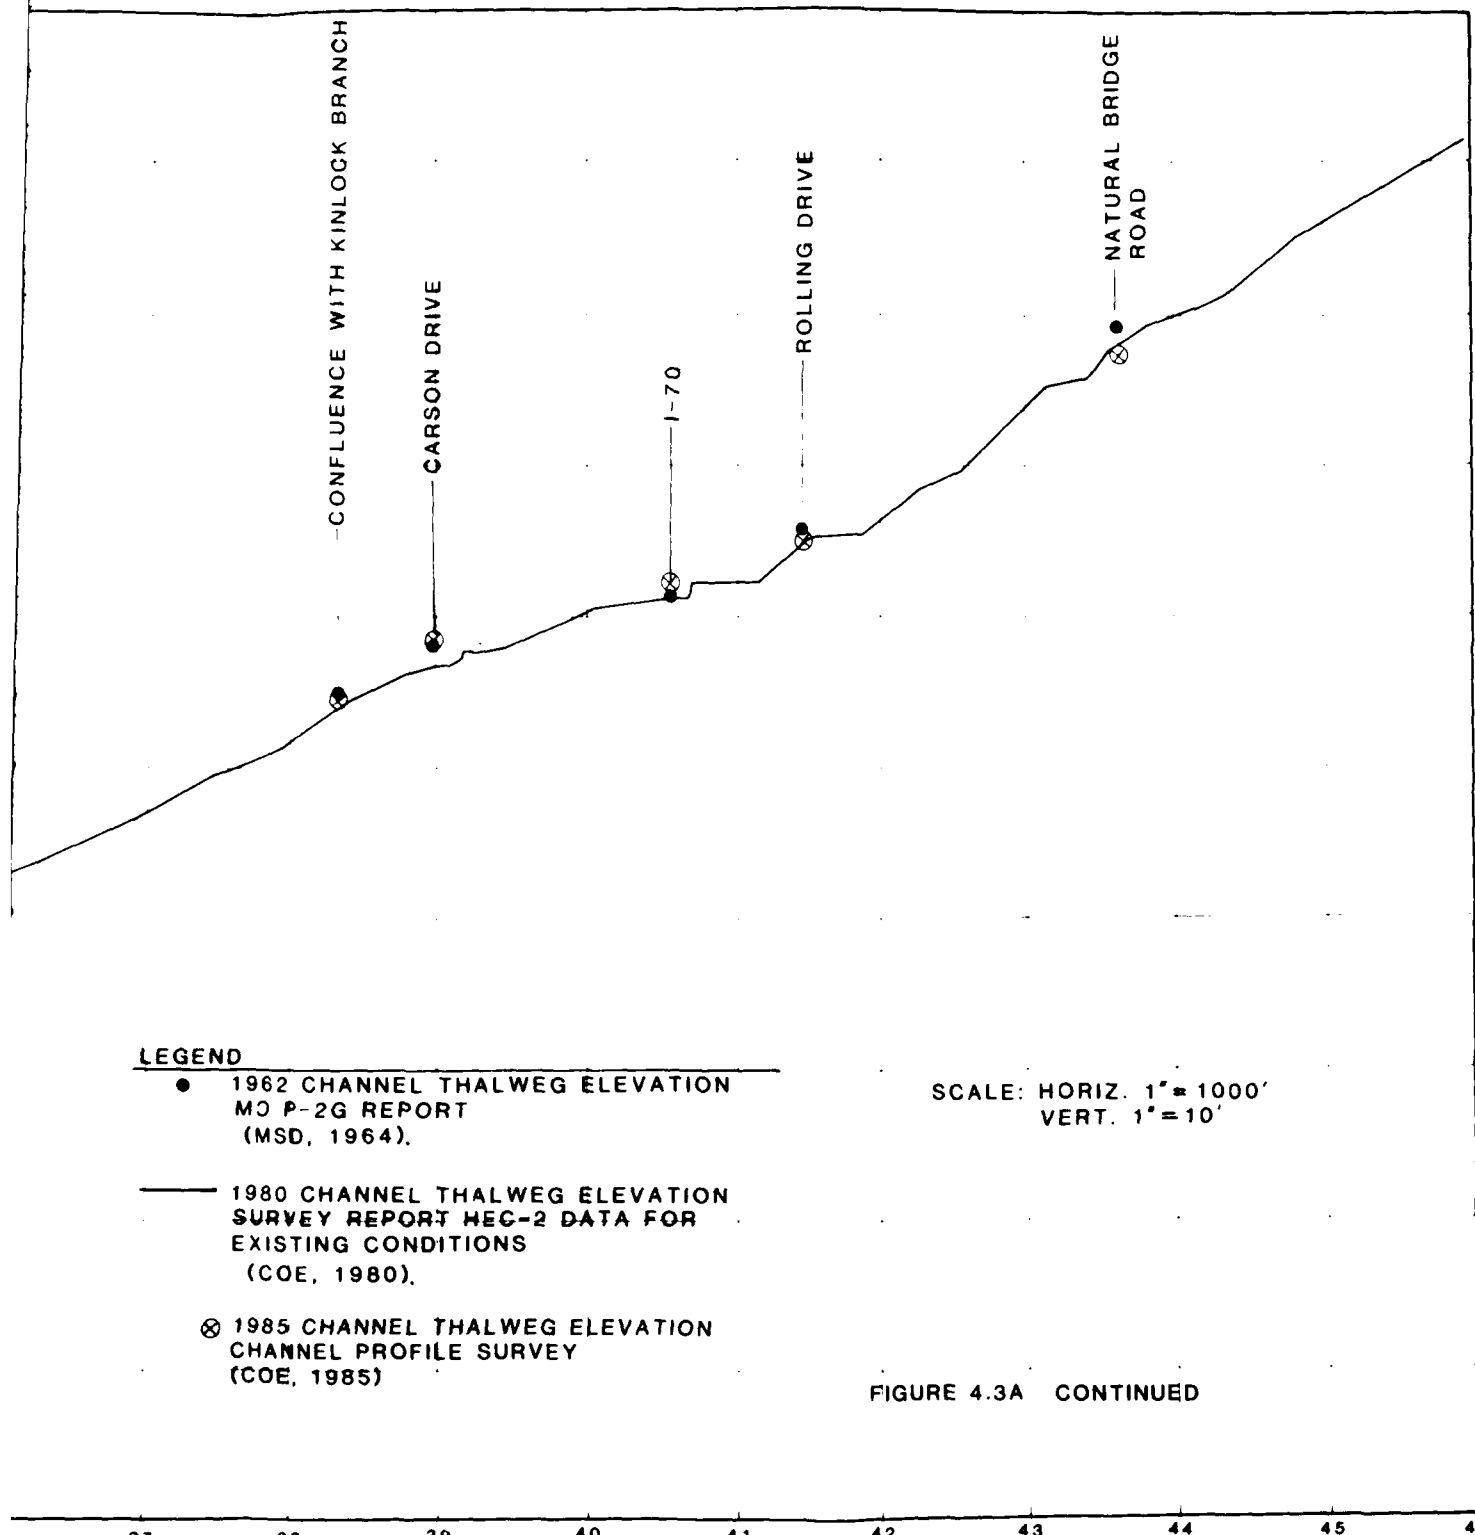
FIGURE 4.3A HISTORIC CHANNEL  
COMPARISON.

As can be seen in Figure 4.3a, the general trend of Maline Creek is an overall degradation of the channel profile. The channel bed has eroded between one to three feet over most of its length. The overall erosion of the channel profile indicates a deficit of available sediment compared to the transport capacity of the stream. The large amount of urban area in the watershed has reduced available sediment and increased the runoff and consequent sediment transport capacity of the stream.

At Glen Owen Drive the channel bed has degraded approximately twice as much as was generally observed throughout the profile. The 1980 channel was seen to be approximately seven feet lower than that observed in 1963. This change is due to the cutoff downstream of a meander bend made during construction of the Lucas and Hunt Road extension. The length of the channel in this reach changed from a natural length of 3,600 feet to a channelized length of 1,800 feet. The shortening of the channel has steepened the slope causing higher channel velocities and increased erosion of the channel.

Field observations made during the site visit confirm this situation. The natural channel at the upstream end of the cutoff is perched approximately three feet higher than the active channel bed elevation. Another drop of approximately three feet was also seen a short distance upstream at a concrete

encased sewer line crossing. A drop of about two feet was seen at an exposed pipeline crossing on the downstream side of Glen Owen Drive.

The 1985 channel profile data (COE, 1985) was also plotted on Figure 4.3a. As can be seen, it generally agrees with the observations made from comparison of 1962 and 1980 channel data. Overall, degradation of between 1 to 3 feet has occurred over most of the channel. At the confluence with tributaries, the largest amount of degradation was observed.

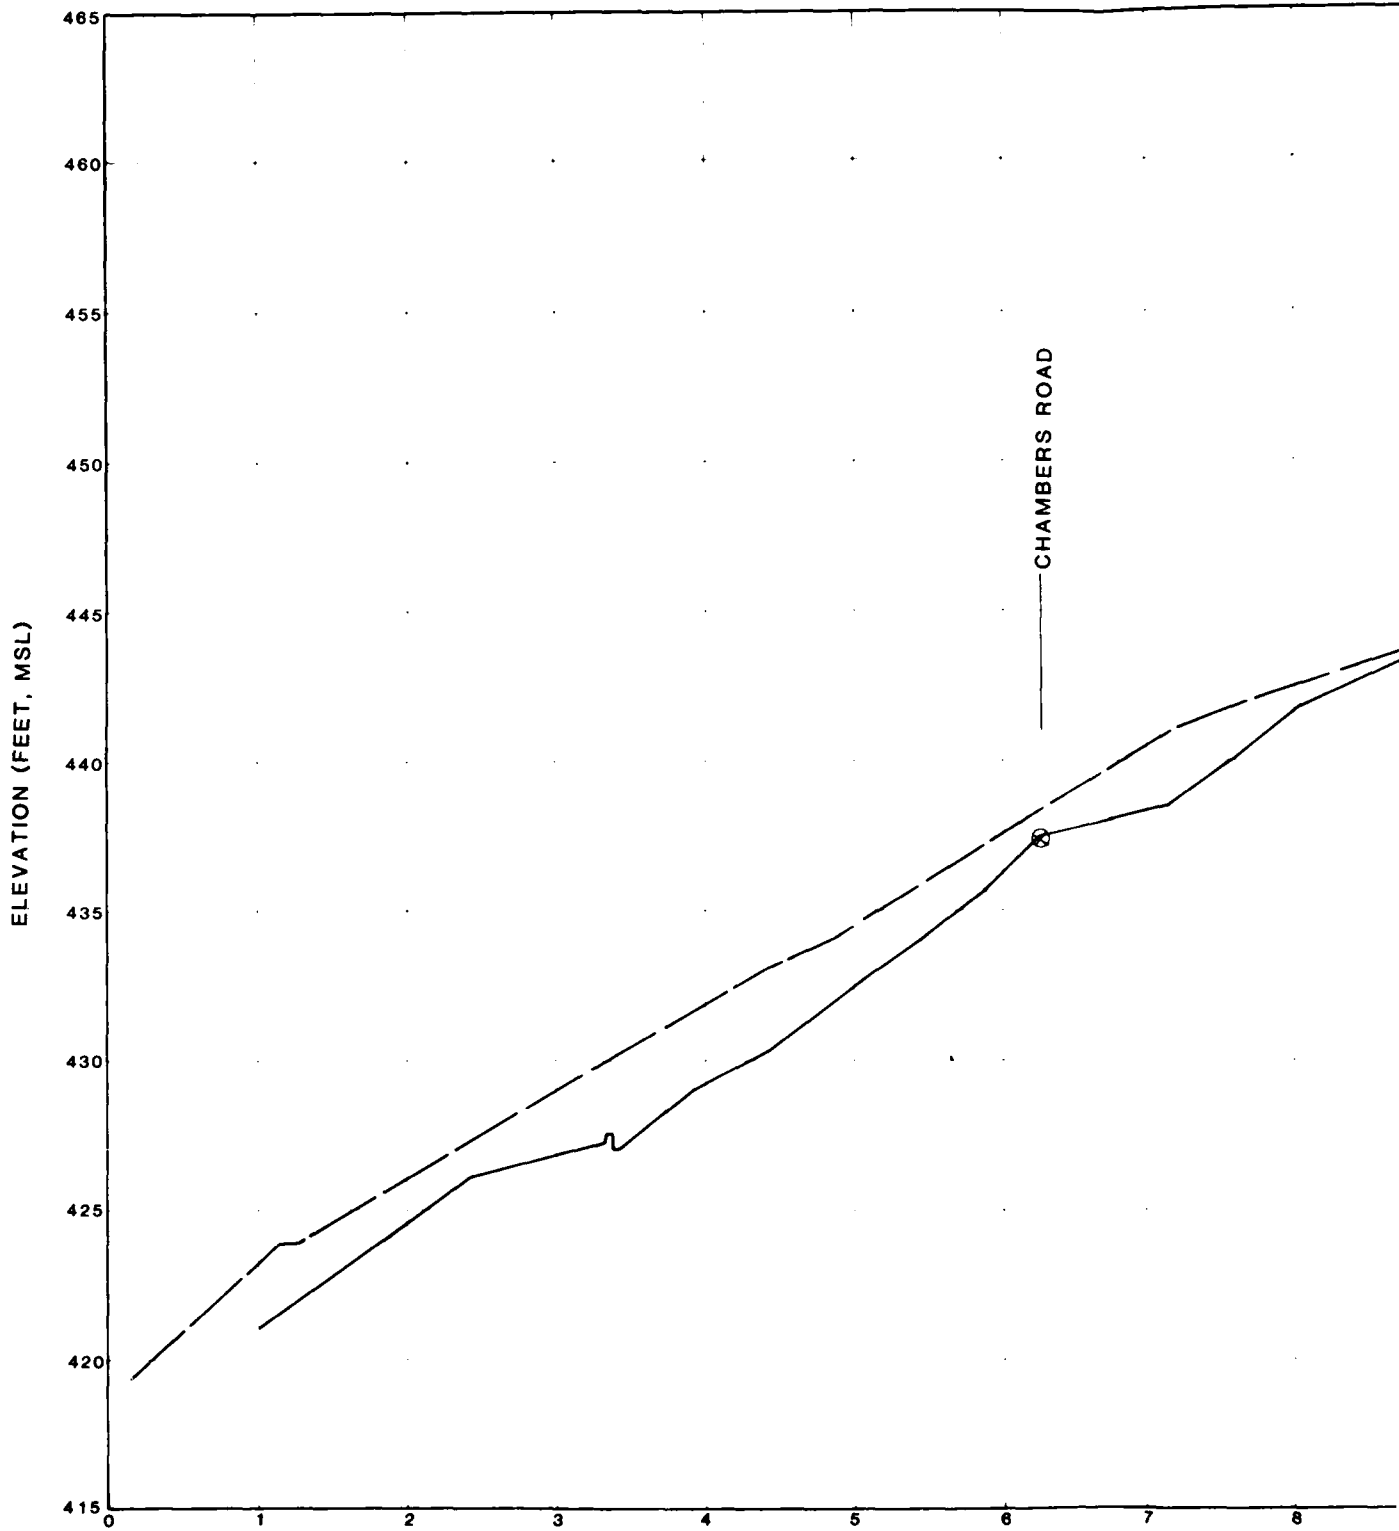
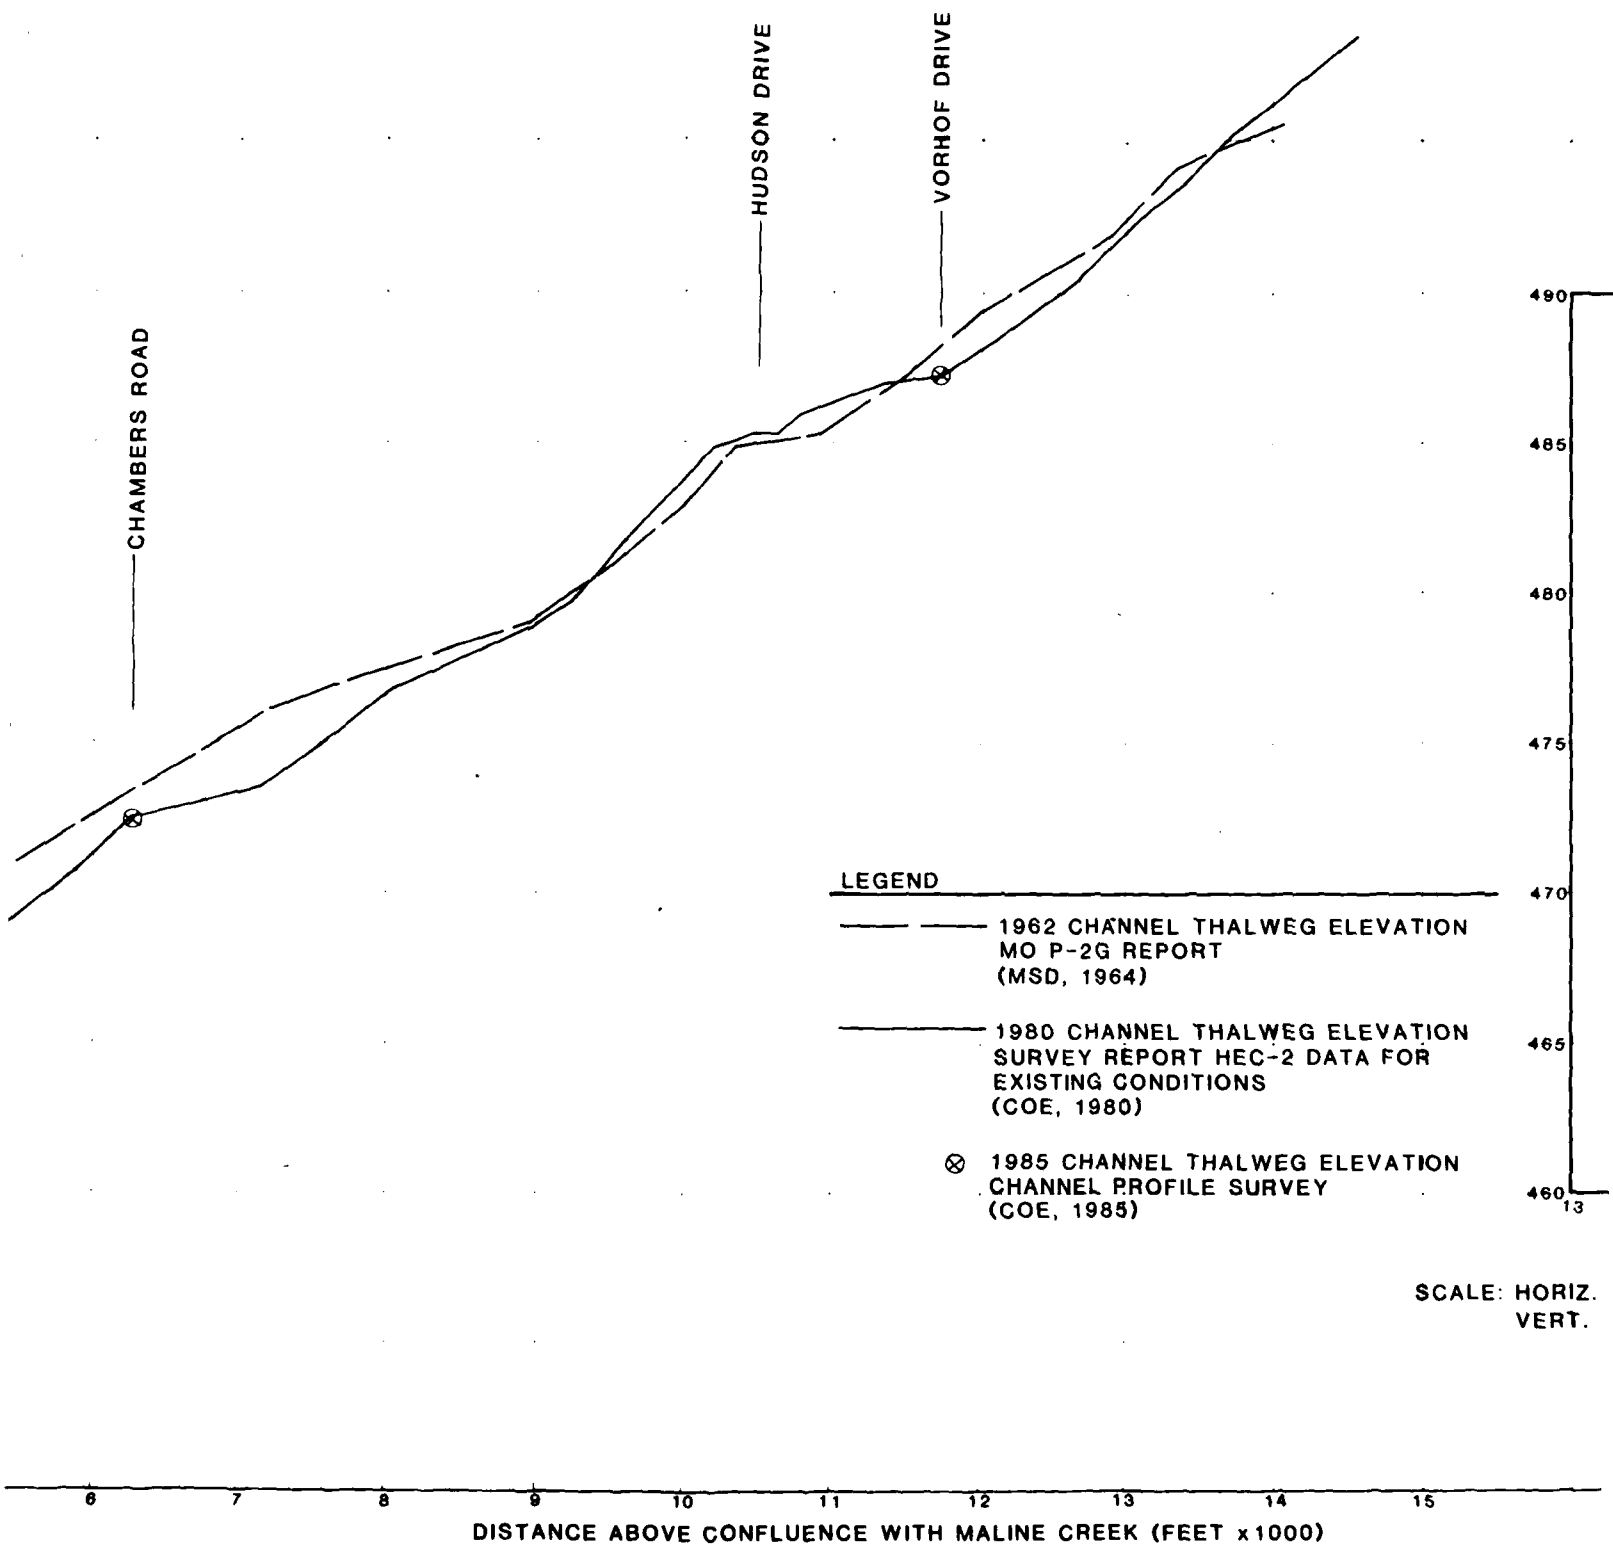
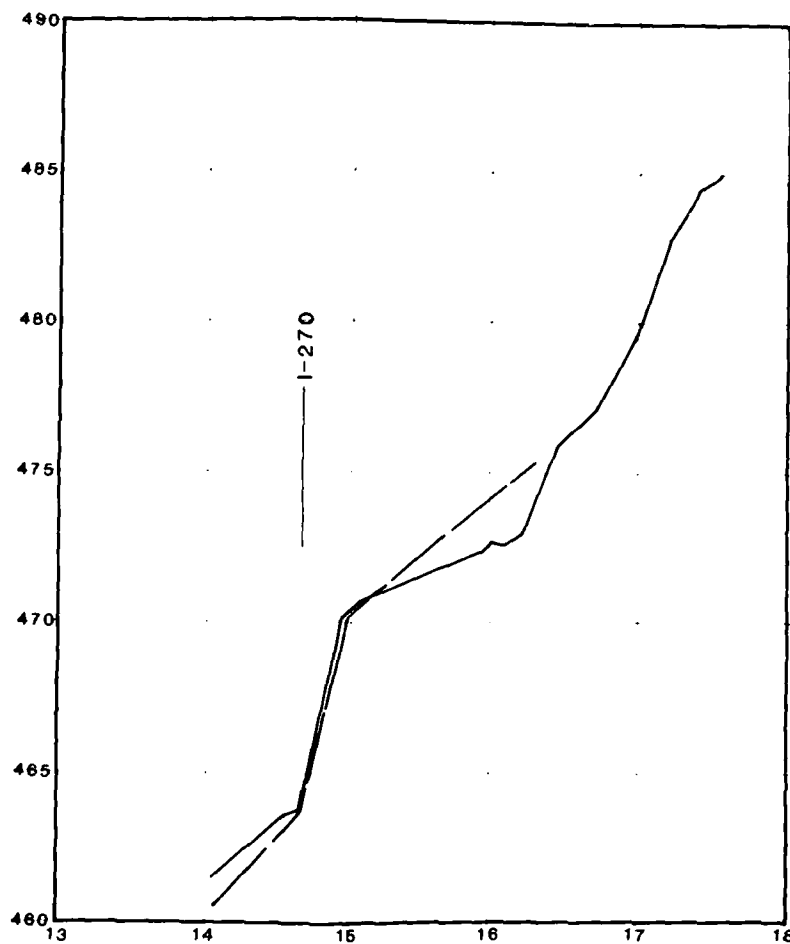
FIGURE 4.3B HISTORIC CHANNEL PROFILE COMPARISON  
BLACKJACK CREEK

As can be seen in Figure 4.3b, the general trend of Blackjack Creek is an overall degradation of the channel profile. Similar to Maline Creek, the channel bed has eroded between one to three feet over most of this length. The overall erosion of the channel profile indicates a deficit of available sediment compared to the transport capacity of the stream.
