**EVALUATION OF THE EFFECTS OF A PLASTIC BEAD  
PAINT REMOVAL PROCESS ON PROPERTIES OF  
AIRCRAFT STRUCTURAL MATERIALS**

Materials Integrity Branch  
Systems Support Division

December 1985

Final Report for Period October 1984 to August 1985.

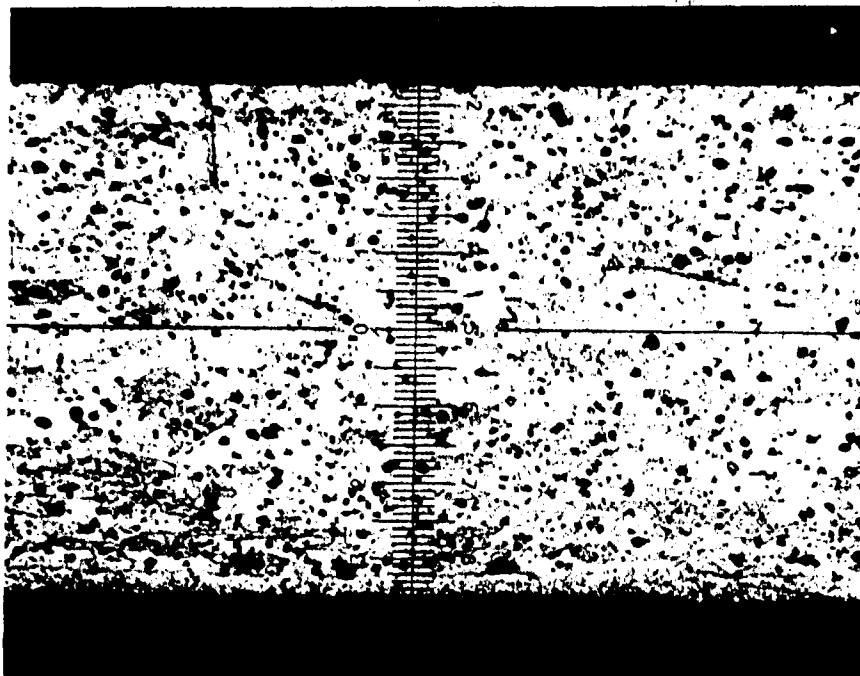
Figure 8. Baseline Alclad 7075-T6. Total thickness 0.016 inch, minimum cladding thickness 0.0005 inch. Kellers etch. MAG: 160X

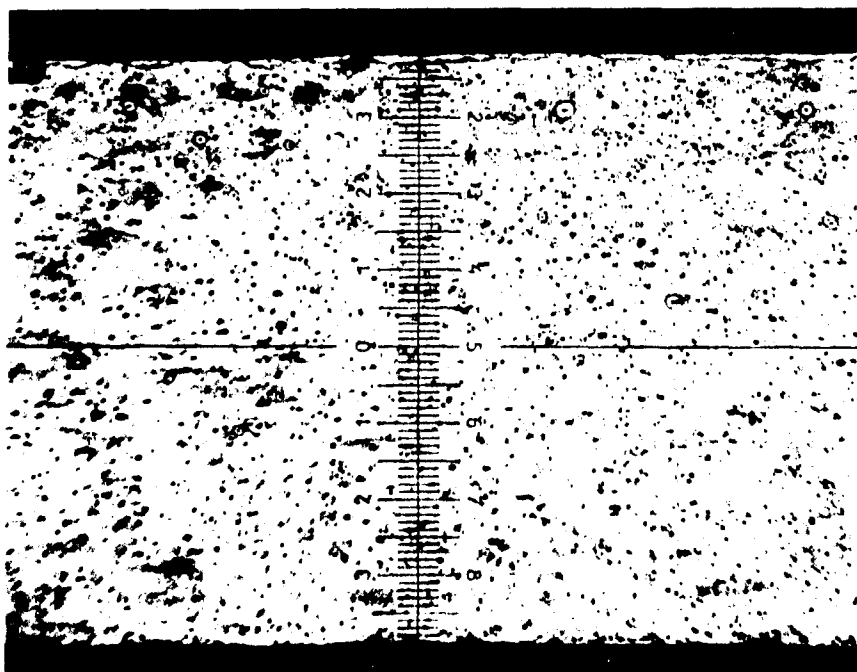
Figure 9. Baseline Sulphuric Acid Anodized 7075-T6, .063 inch thick. Kellers etch. MAG: 100X

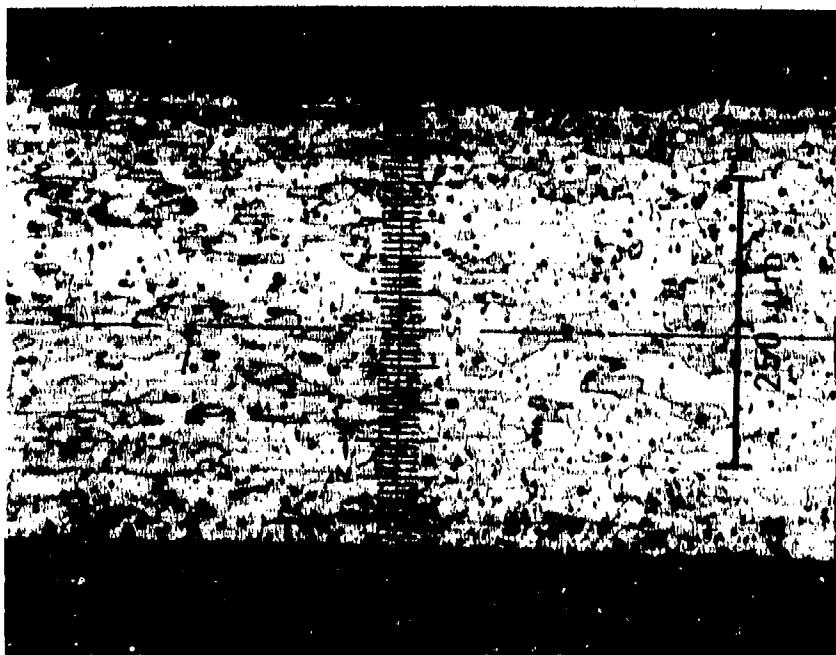
Figure 12. Alclad 7075-T6 After the Third Paint Removal. (a) Specimen 24B, 38 psi nozzle pressure (b) 60 psi nozzle pressure. MAG: 160X

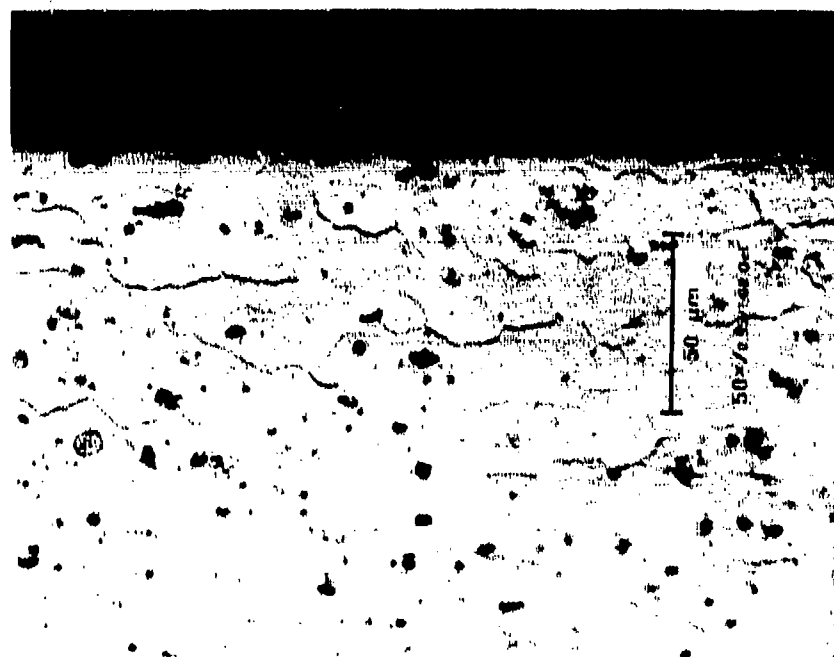
Figure 16. Baseline Sulfuric Acid Anodized 7075-T6. MAG: (a) 100X, (b) 500X

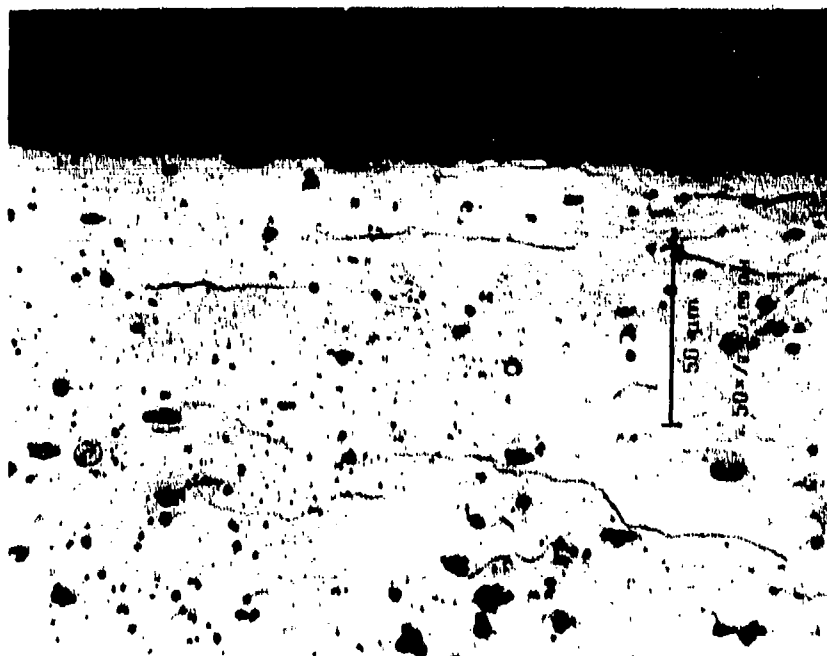
Metallographic analysis indicated that plastic bead paint removal damaged the surface of the sulfuric acid anodized 7075-T6 for either nozzle pressure (Figures 16-18). Some surface pits were detected which measured approximately 0.5 mils across and 0.08 mils deep (Figure 17). Since the unclad 7075-T6 is substantially harder than the alclad 7075-T6 surface, the unclad 7075-T6 was less susceptible to damage by plastic bead paint removal. If anything, it is believed that plastic bead blasting might improve the fatigue properties by peening, thus creating residual

Figure 17. Sulfuric Acid Anodized 7075-T6 Blasted with a Nozzle Pressure of 38 psi.  
MAG: (a) 100X, (b) 500X
