## **EXPLOSION DAMAGE ASSESSMENT AND STRUCTURAL INTEGRITY EVALUATION**

**MILAN ARMY AMMUNITION PLANT  
LOAD ASSEMBLY AND PACK  
BUILDING A2**

HNDTR 85-70-SD-SE  
OCTOBER 1985

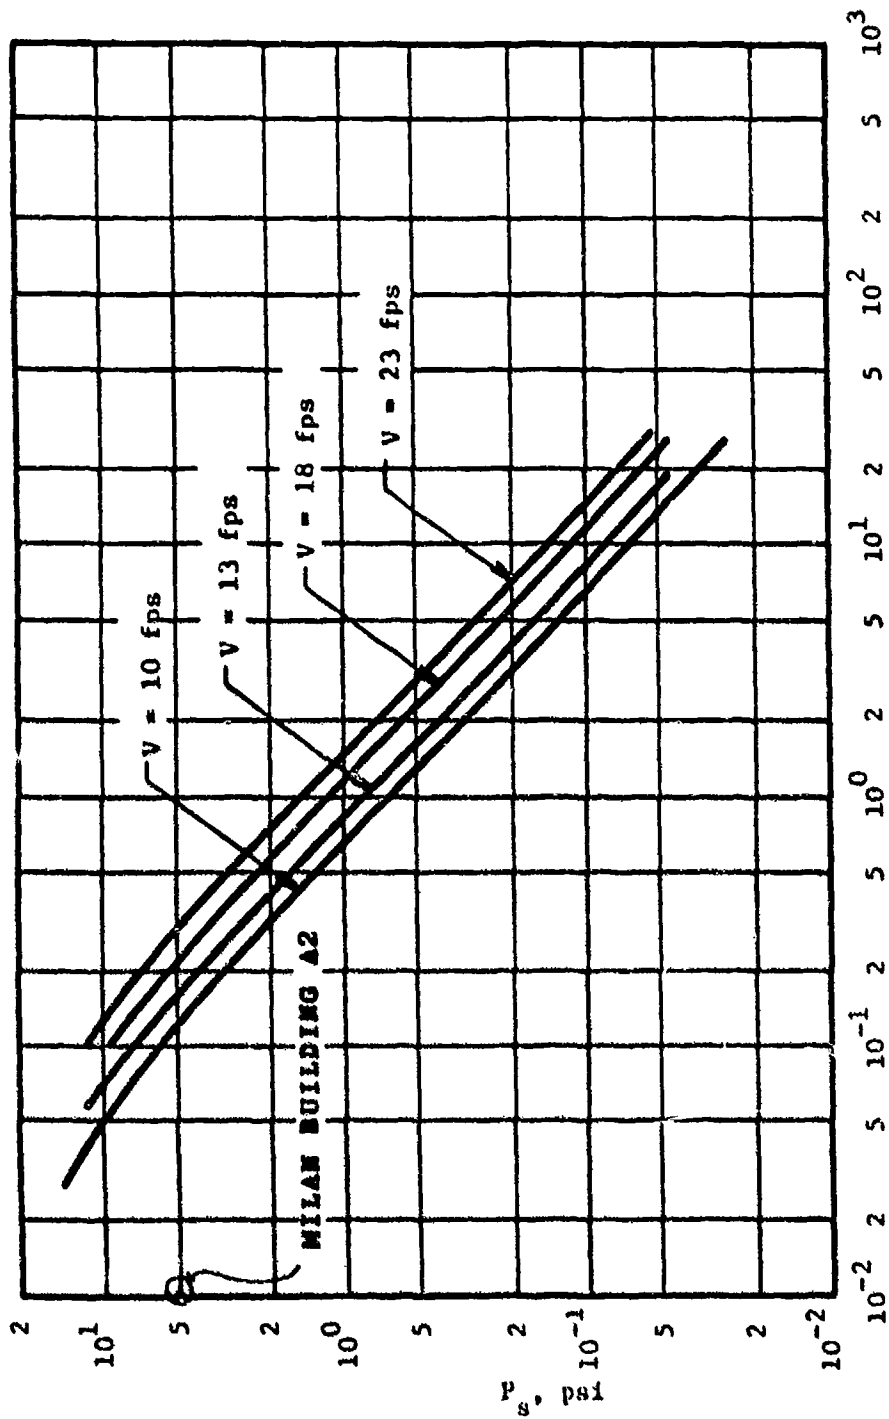
Figure 5-2. Skull Fracture Risk (reference 8)

The term tertiary blast injury refers to injuries resulting from whole body displacement. Tables 5-1 and 5-2 present criteria for risk of injury to either the skull or the whole body due to impact at the velocities shown. Although the skull injury tolerance is generally lower, both criteria have the same lower limit "mostly safe" velocity. Figure 5-2 presents the critical velocities in table 5-1 in terms of incident overpressure and impulse. Plotted on this figure is again the upper bound data from table 3-2. Results show clearly that translational forces for the Milan incident appear to be well below those needed to reach a critical velocity.

Scaled Impulse  $\bar{I}_s = i_s / m^{1/3}$ , psi-sec/lb<sup>1/3</sup>  
 Milan Building A2  $P_s=5.0$   
 $\bar{I}_s=0.0037$

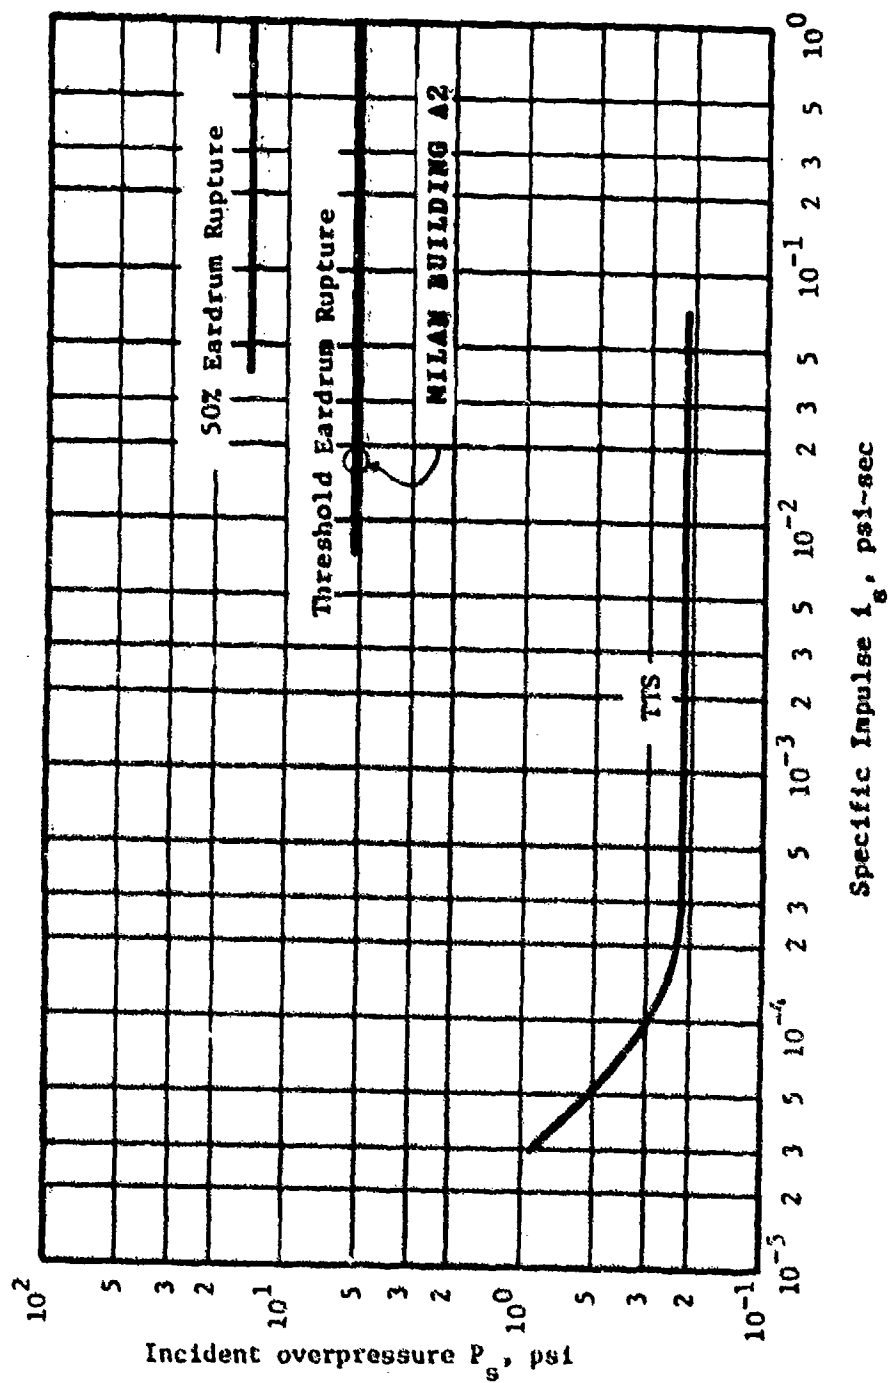
Figure 5-3. Human Ear Damage Risk for Normal Incidence Blast Waves  
 (reference 8)

The human ear is the most sensitive part of the body when considering the effects of a blast wave. An incident overpressure of 5 psi arriving normal to the ear represents the threshold for eardrum rupture. Even lower pressures can cause temporary loss of hearing. The generally accepted "Temporary Threshold Shift" (TTS) is about 2.3 psi (reference 8). These values and the 50-percent rupture pressure are plotted on figure 5-3 in terms of incident overpressure and impulse, along with the upper bound data from table 3-2. This indicates that a risk of at least temporary hearing loss and the onset of eardrum rupture existed at Milan if the head were oriented sidelong to the blast wave.

Milan Building A2  $P_s=5.0$   
 $I_s=0.0189$

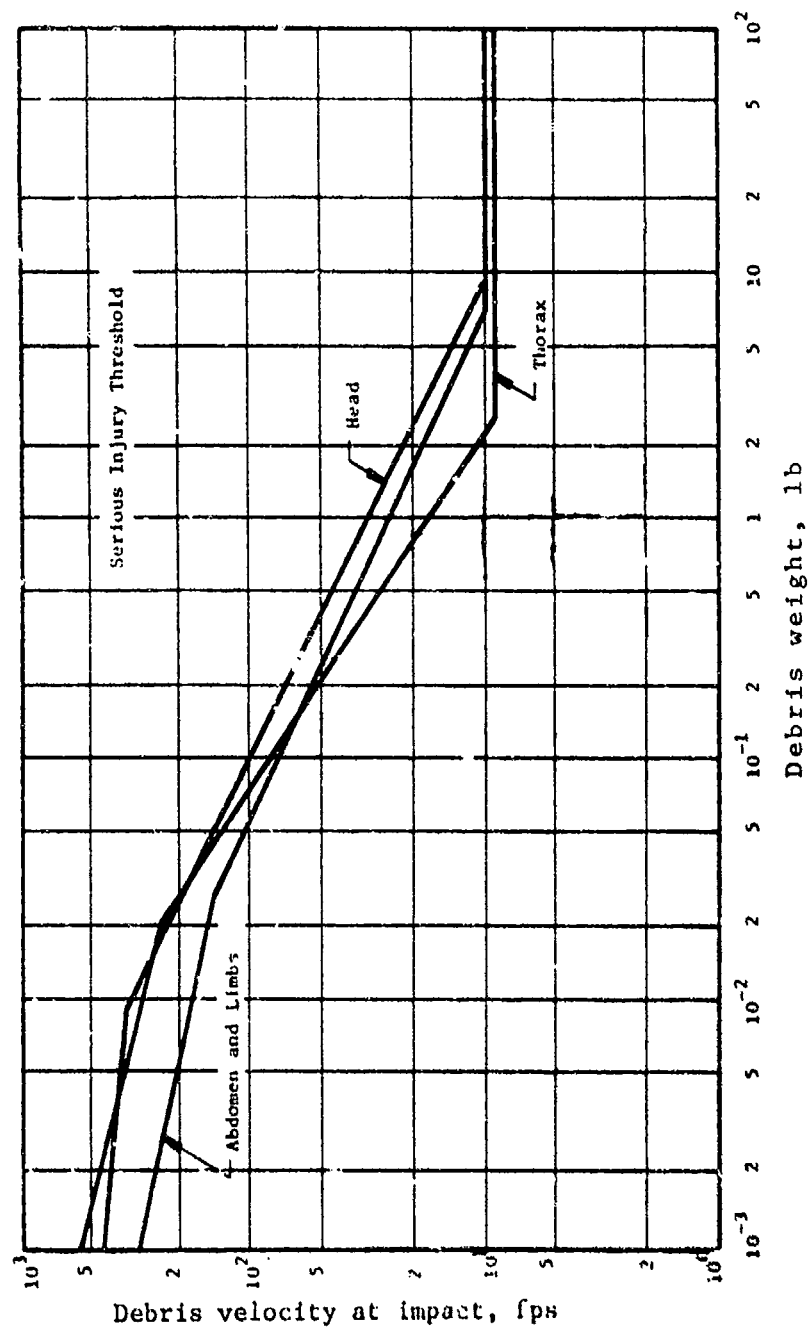
Figure 5-4. Personnel Response to Fragment Impact (Serious Injury Threshold)  
(reference 8)

Risks of injuries due to secondary fragment effects at Milan were due almost entirely to the breakup of the transite roof decking which fell into the work area behind the cubicle. Figure 5-4 presents an index, developed in reference 9, of injuries to personnel from secondary fragments. Risk of injury is based on impact velocity and fragment mass. It should be noted that the lower threshold for injuries from fragments greater than 3 pounds is identical to that for tertiary injury given earlier in figure 5-2. The height of the transite roofing above the work area floor varies from about 11 feet at the exterior walls to 21 feet at the center of the building. Assuming unobstructed free fall and neglecting drag, table 5-3 presents free fall time and velocity from the roof to the floor and to 5 feet 6 inches above the floor, respectively. Although a great percentage of the roofing broke into small pieces less than 2 or 3 pounds, there was a sizeable number of larger fragments present. Based on the potential free fall velocities from table 5-3 and the criteria in figure 5-4, there appears to have been a risk of injury from secondary fragments. The minimum risk existed for personnel in the upright position which reduces both the abdominal, thorax, and limb exposure, as well as reducing the probable head injury velocity. Based on the velocities calculated, any fragment larger than 2 pounds would pose a risk. It is interesting to note that a fragment falling from the highest elevation of the roof would have to weigh at least 3.7 pounds to exceed the 58 foot-pound hazardous fragment as defined in DOD 6055.9 (reference 10), which is the most current reliable safety criteria. It should also be noted that the space below the roof and above the work area is very congested with ventilation ducting, piping, conduit, and other items, none of which fell. These items would tend to obstruct the unimpeded free fall of fragments, particularly large ones. This effect may have contributed to the lack of actual fragment impact injuries.
