NAVAL AIR STATION  
ALAMEDA, CALIFORNIA  
FPO-1-82(20)

**UNDERWATER FACILITIES  
INSPECTIONS  
AND  
ASSESSMENTS  
AT**

**NAVAL AIR STATION  
ALAMEDA, CALIFORNIA**

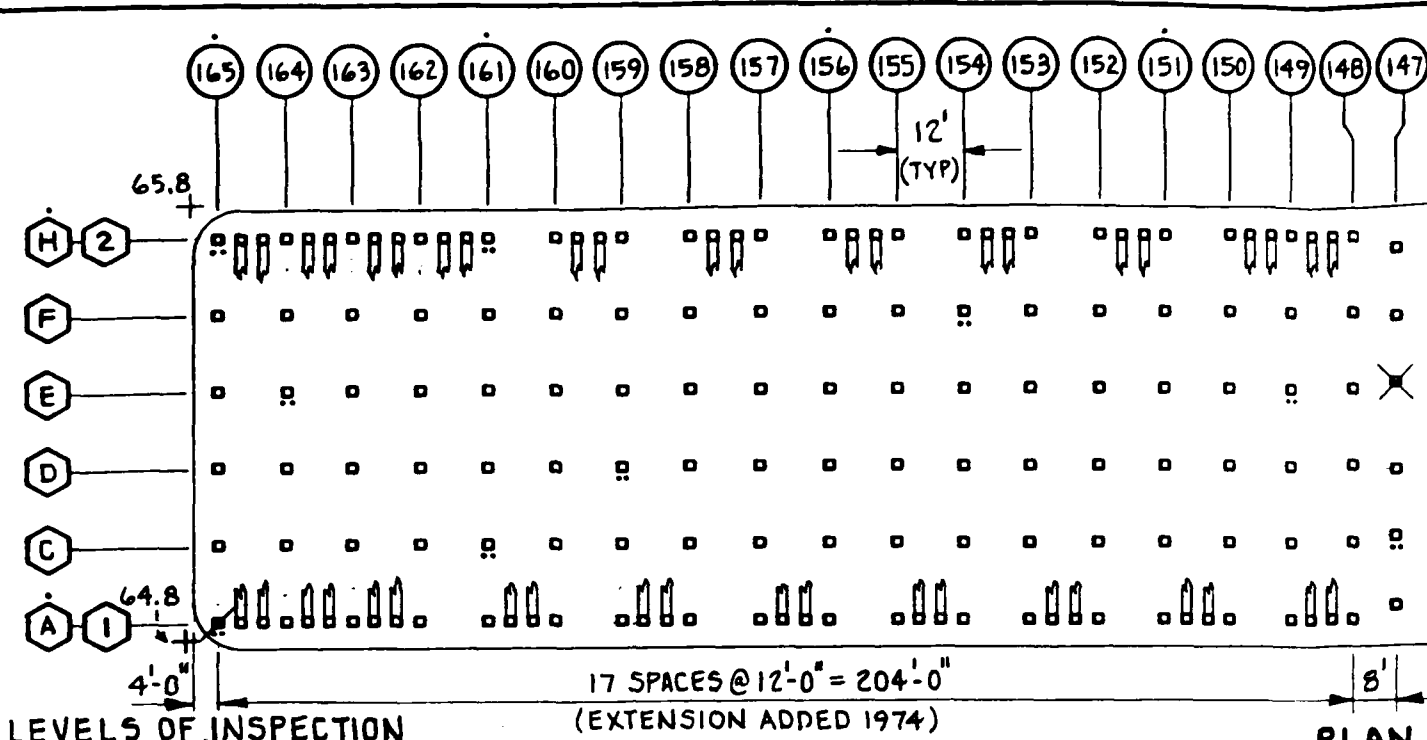
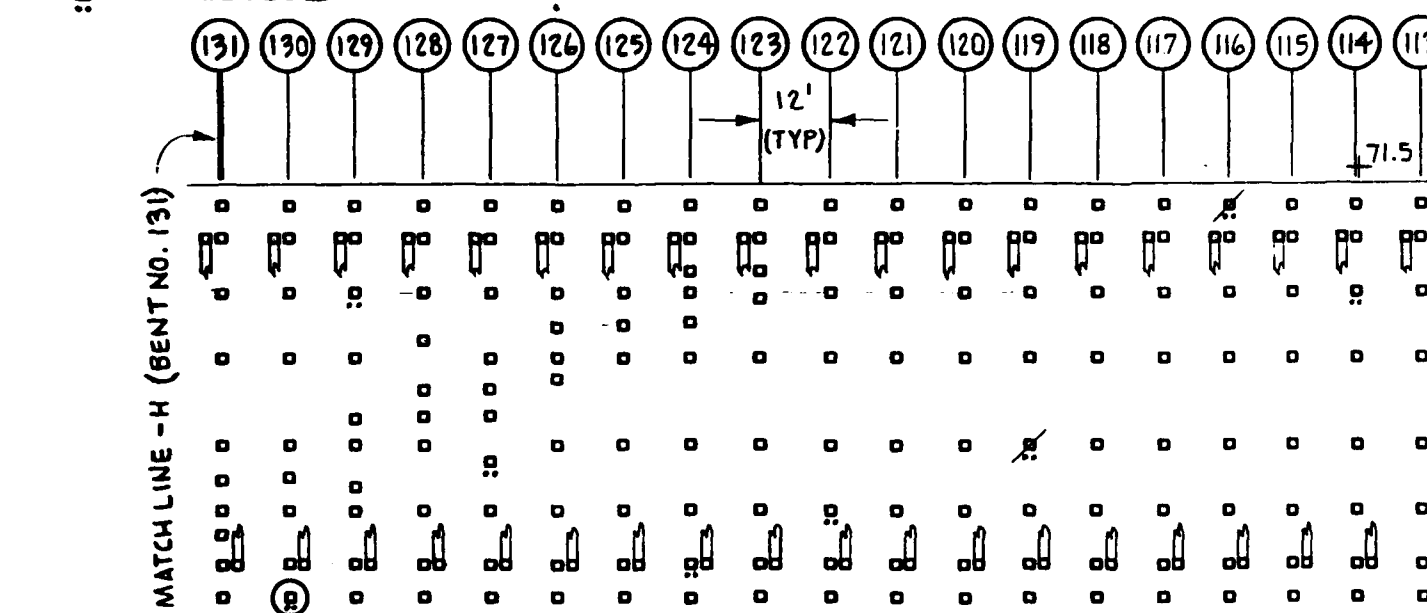
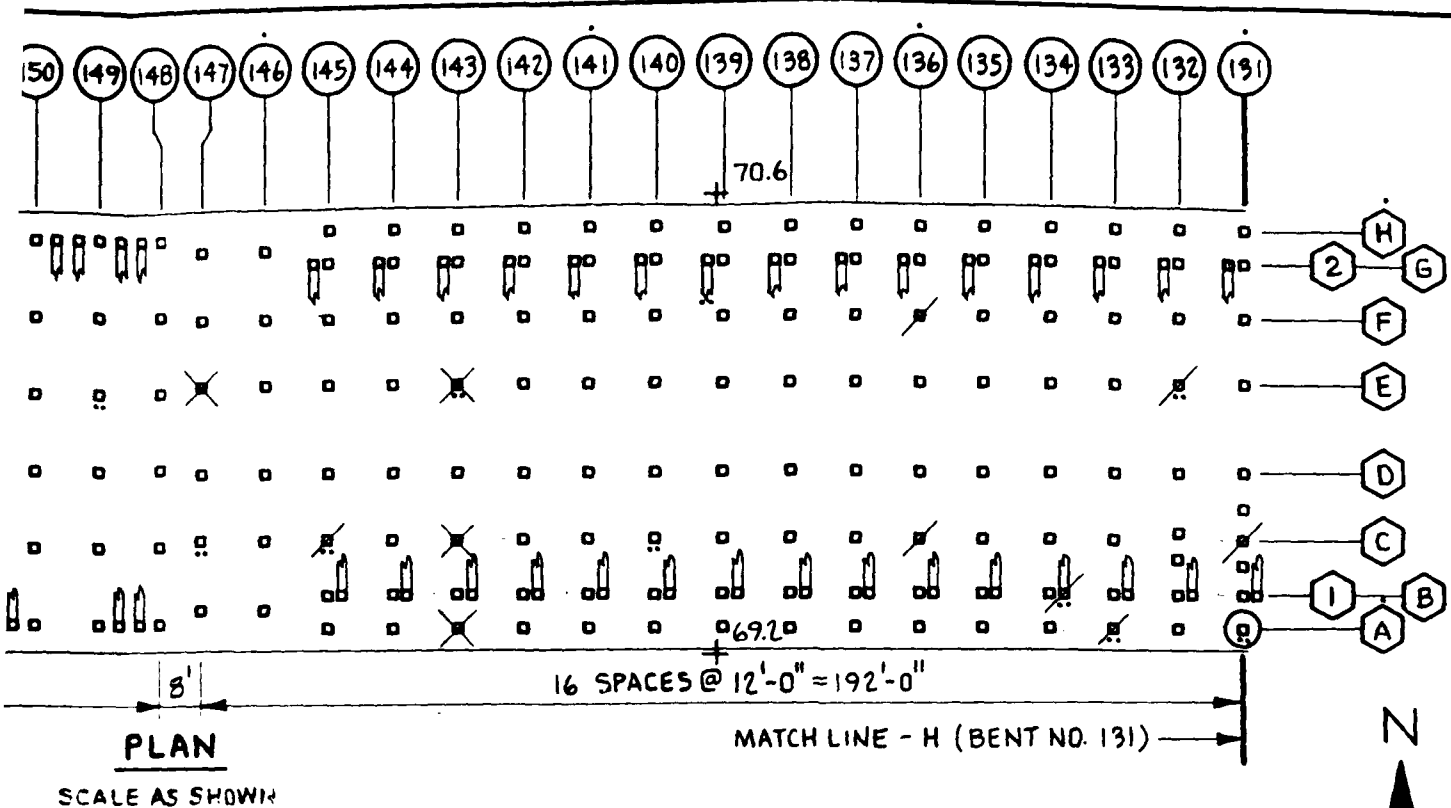
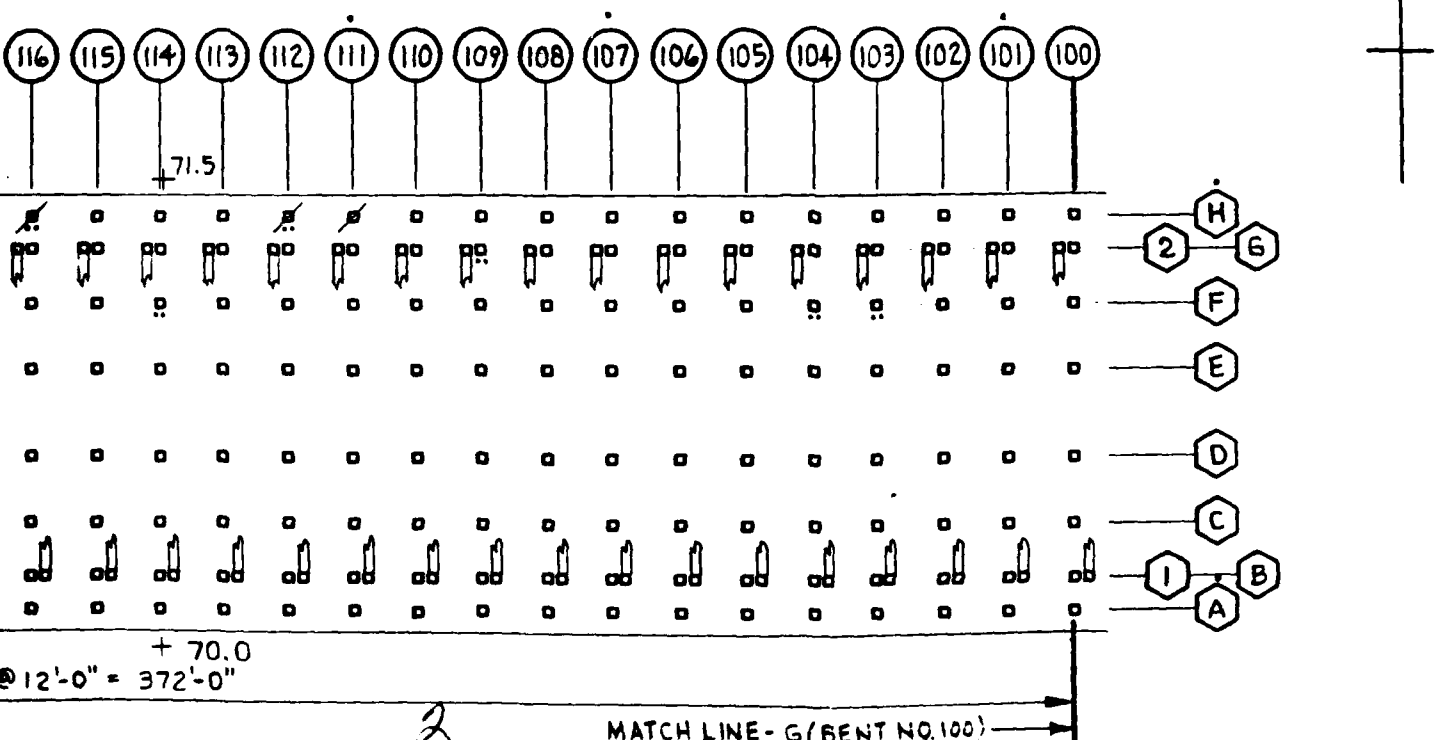
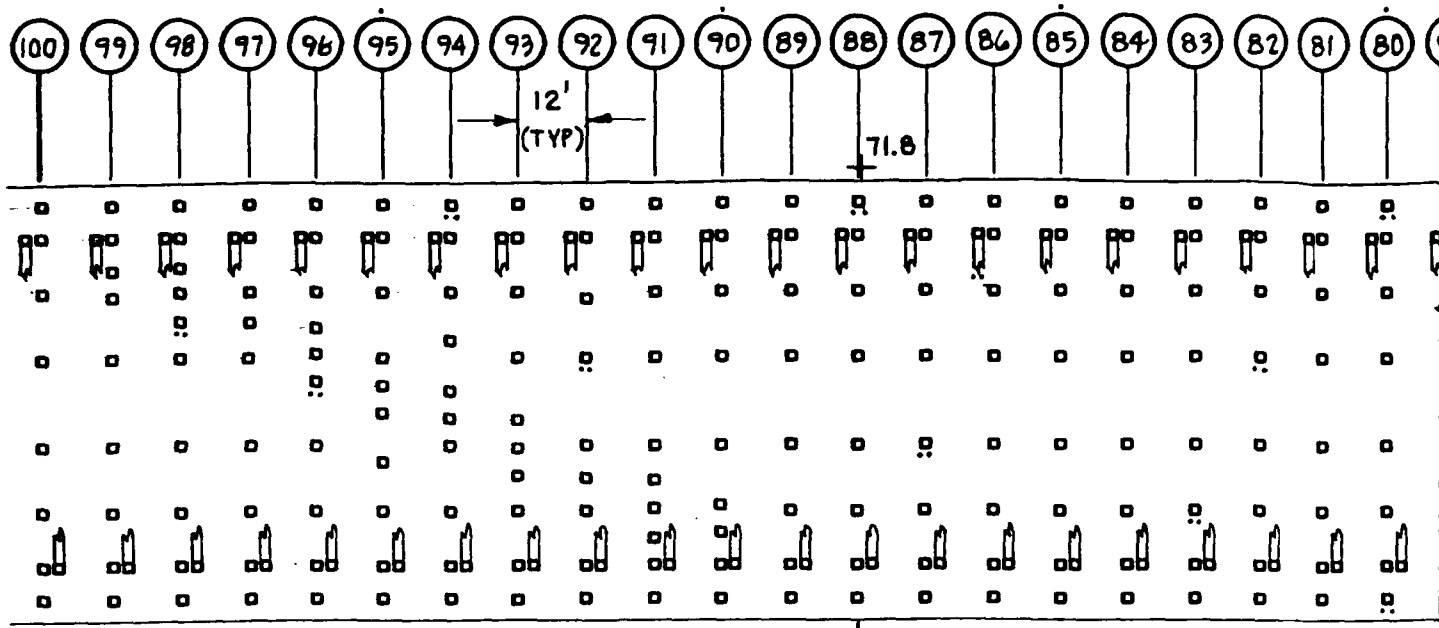
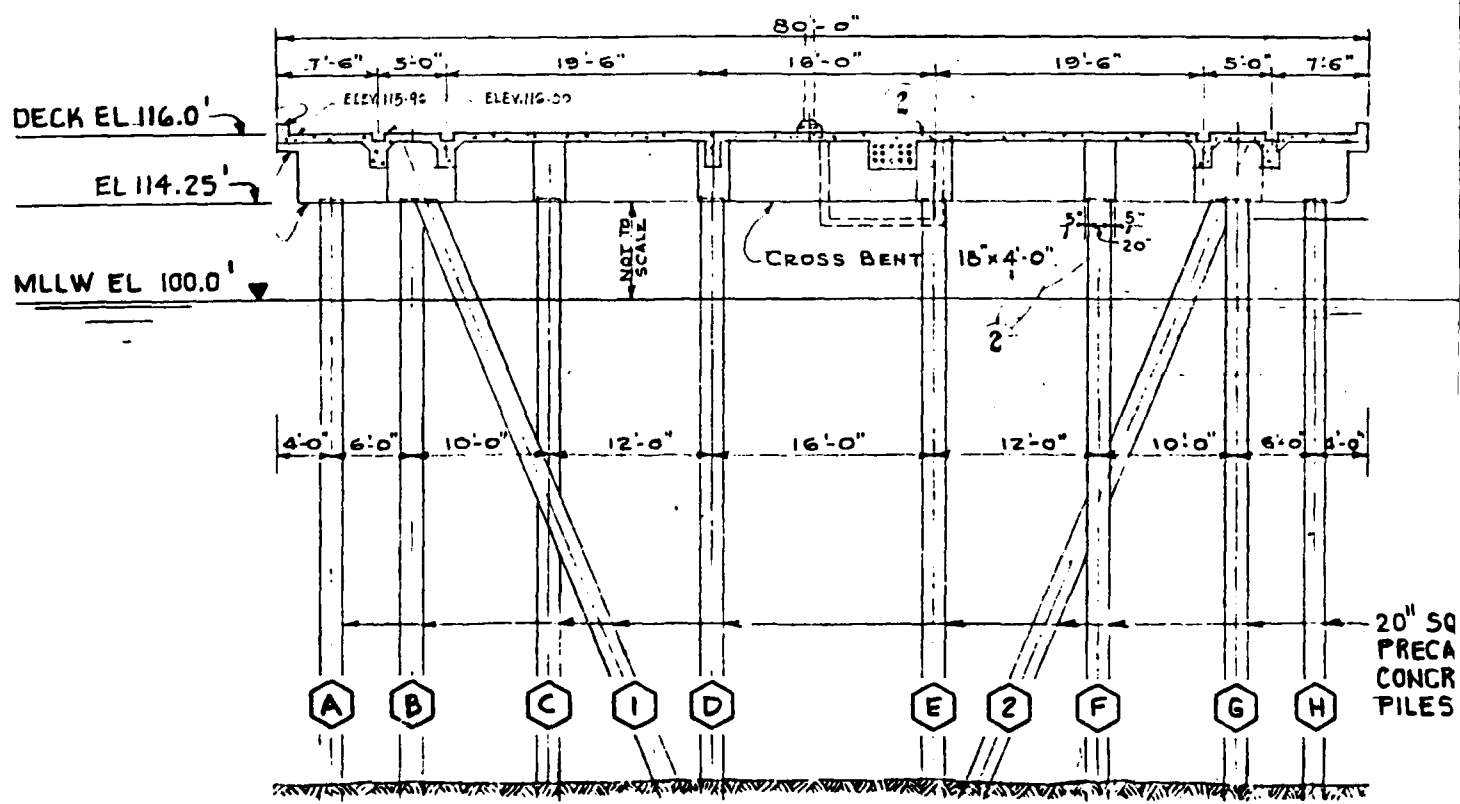
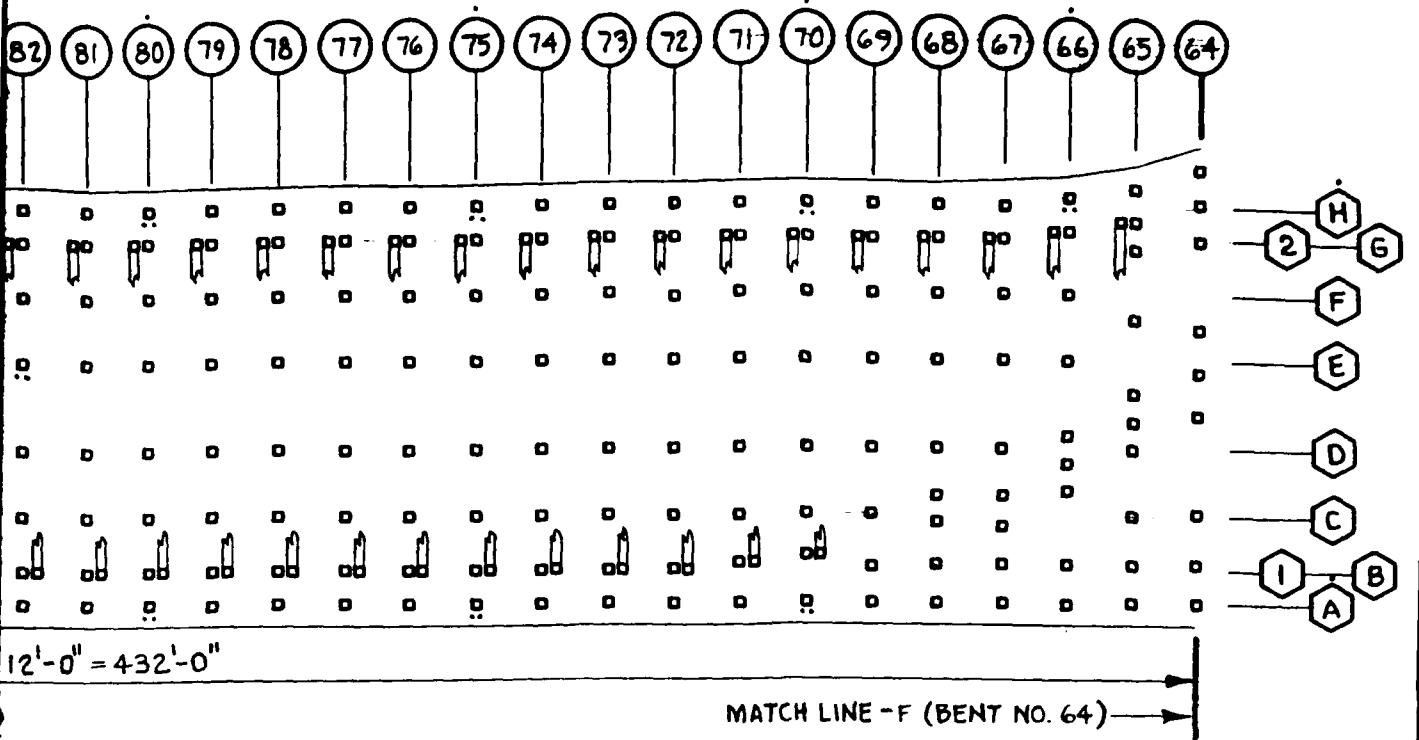
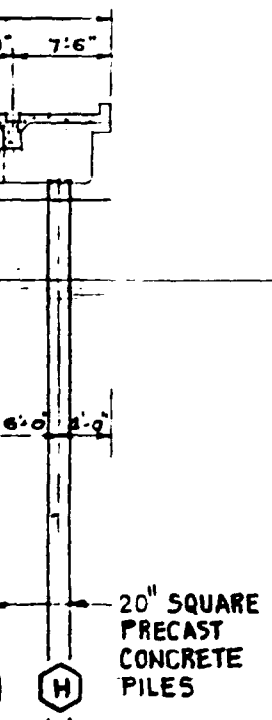
CHESAPEAKE DIVISION  
NAVAL FACILITIES ENGINEERING COMMAND  
WASHINGTON, D.C.  
NAVAL AIR STATION ALAMEDA, CA  
**PIER #2**  
FIG. NO. **13**

Piles in the older section of the pier (Bents 147 through 64) are generally in good condition. Two piles, Pile A Bent 131 and Pile A Bent 130, have suffered severe structural damage (see Photos #8 and #9). These piles are cracked at the pile cap and at various locations along their length. They appear to have been hit by either a vessel or a camel and broke as a result of the impact.

Eleven of the piles inspected exhibited light spalling (see Photos #10 and #11). The light spalling appears to be cosmetic and of no structural significance.

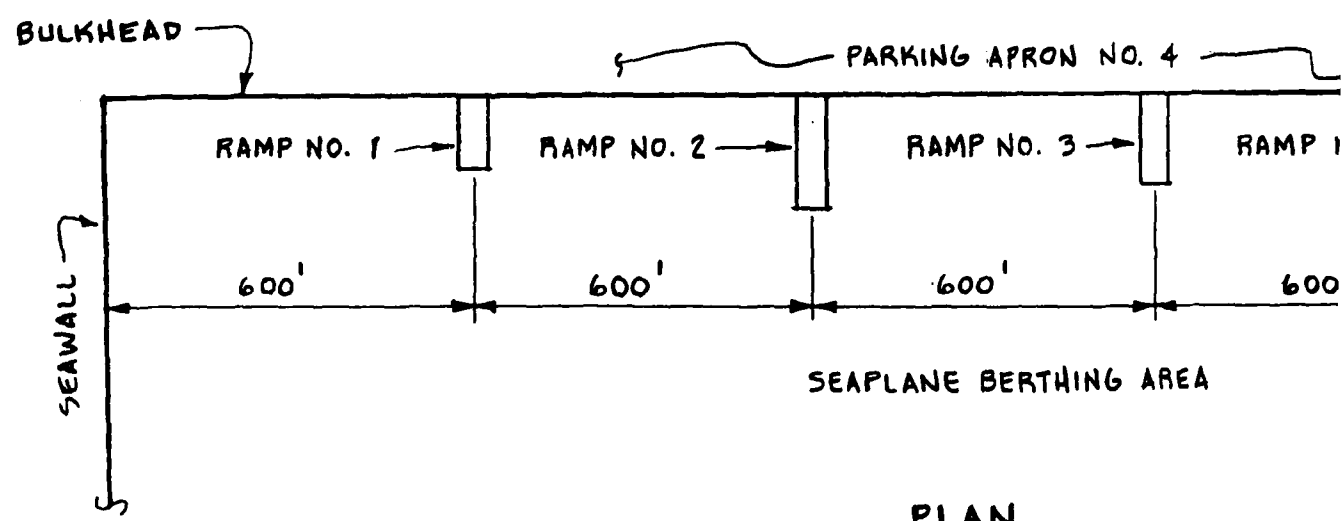
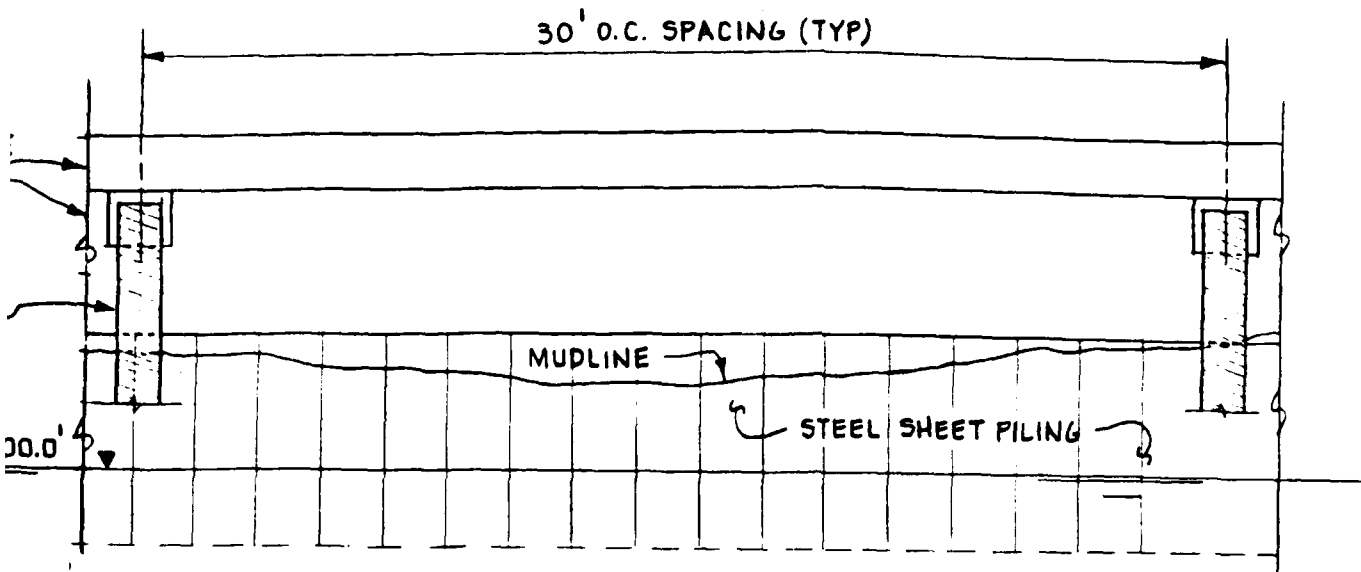
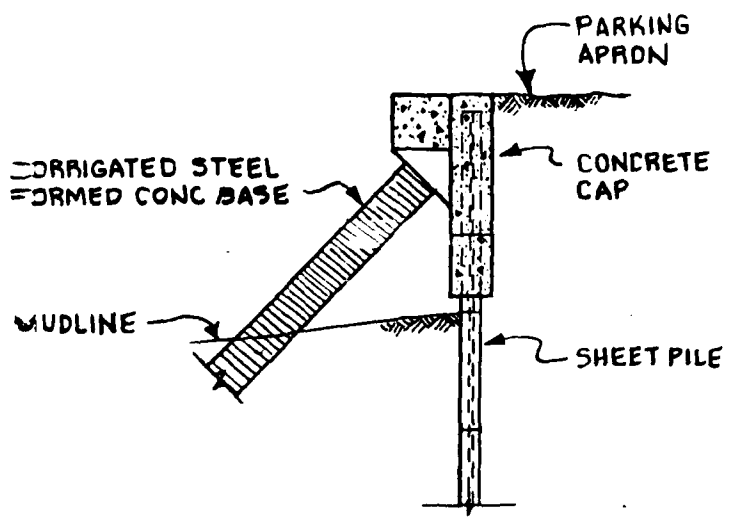
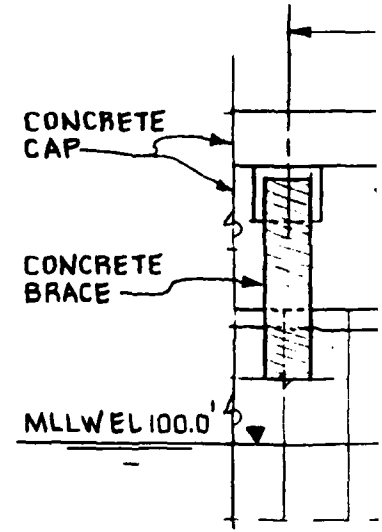
<p>GRAPHIC SCALE</p> <p>300' 200' 100' 0 300'</p>	<p>CHILDS ENGINEERING CORPORATION BOX 333 MEDFIELD, MA</p>	<p>CHESAPEAKE DIVISION NAVAL FACILITIES ENGINEERING COMMAND WASHINGTON, D.C.</p>	
		<p>NAVAL AIR STATION ALAMEDA, CA</p> <p><b>BULKHEAD</b></p>	<p>FIG. NO <b>17</b></p>

The bulkhead is located north of and parallel to Pier 1 and includes Seaplane Ramps 1, 2 3 and 4 (see Figure 2). Presently, the seaplane ramps are not being utilized by seaplanes, they are being used as a storage and deployment area for oil booms. Originally, the bulkhead was constructed in 1939. Sometime after that, an addition in the form of an extended pile cap and batter piles appeared on the bulkhead (see Figure 17).

In general, the bulkhead appears to be in good condition. There does not appear to be any significant misalignment along the bulkhead which would indicate yielding of the wall. The concrete encasement around the steel sheet piling is in good condition and shows little sign of deterioration. The encasement concrete is sound.

Thickness measurements of the steel sheet piling indicate metal loss of less than 10%. This is probably attributable to the fact that the original design called for backfilling in front of the sheeting about halfway up the concrete encasement. The fill in front of the wall would have served as a barrier against corrosion. At present, there are several locations (approximately 50% of the length) along the wall where the steel sheeting is exposed. Maximum exposure is approximately 2 feet (see Photo #18).

The batter piles are corrugated steel shells filled with concrete. The condition of the shells is poor since much of the metal is corroded, however, the concrete within the shells appears sound.

The wall cap extension which is used to tie in the batter piles is in fair condition. The upper and lower edges of the concrete have spalled in many locations. In some instances, rebar is exposed in the spall areas and is corroded.

The bulkhead is in good condition. No major structural anomalies were found which would detract from its capacity.

The deterioration of the concrete wall cap should be stopped to prevent weakening of the batter pile system.

The spalled corners of the concrete wall cap should be repaired by cleaning to sound concrete, cleaning and/or replacing deteriorated rebar and patching with pneumatically applied concrete. This will prevent deterioration of the batter pile support system.

Fill should be placed in front of the wall to original design levels. This will eliminate corrosion of the steel sheet pilings.

The estimated cost of repairing the wall cap is \$18,000.00 and filling in front of the wall is \$43,000.00.

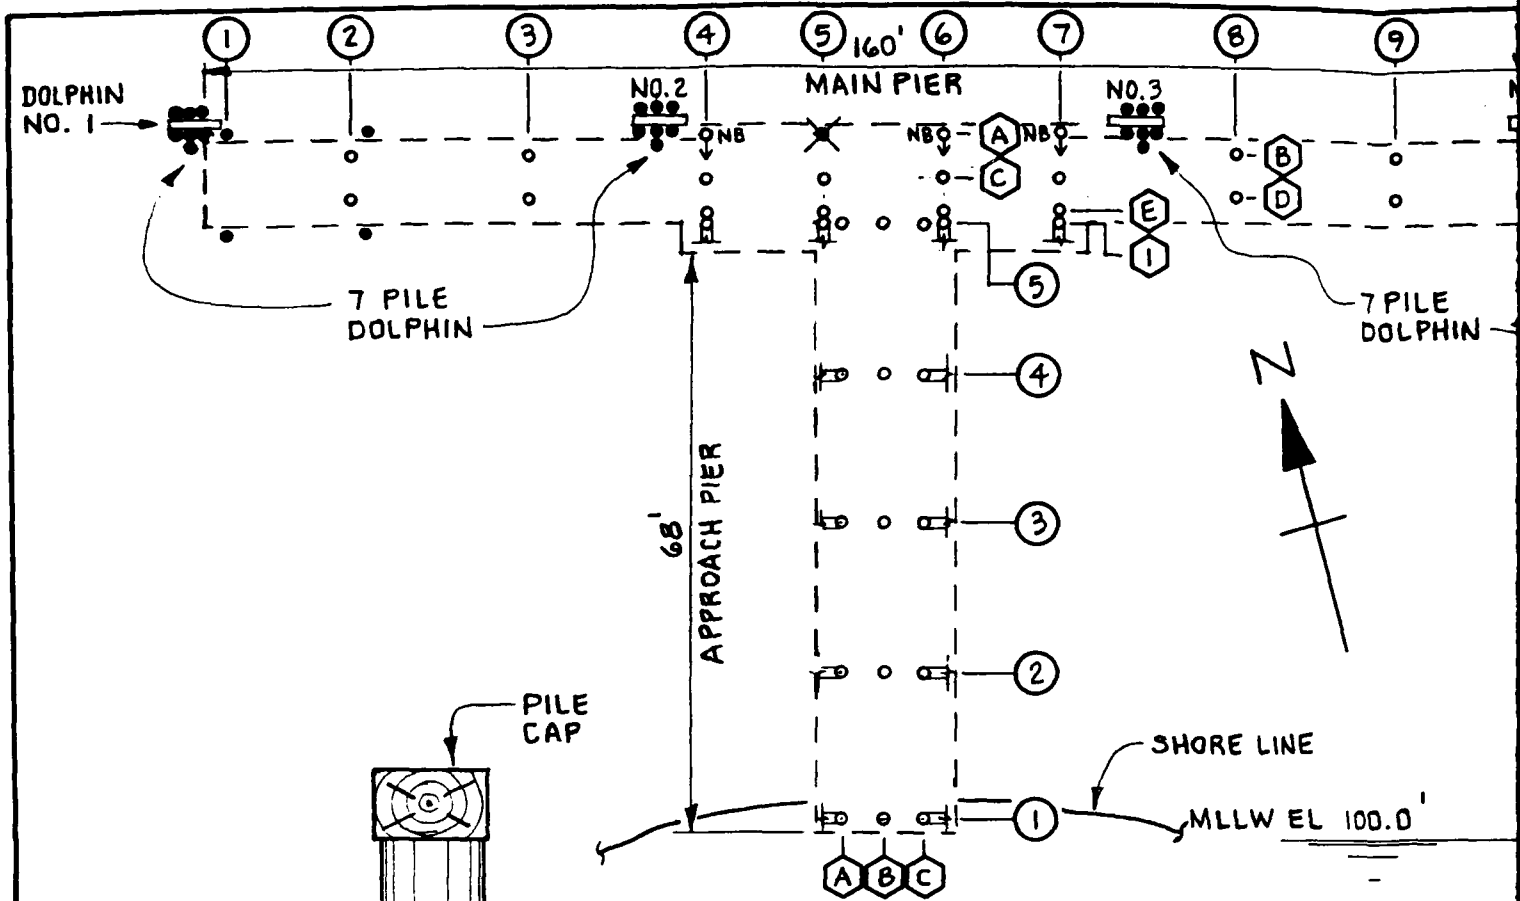
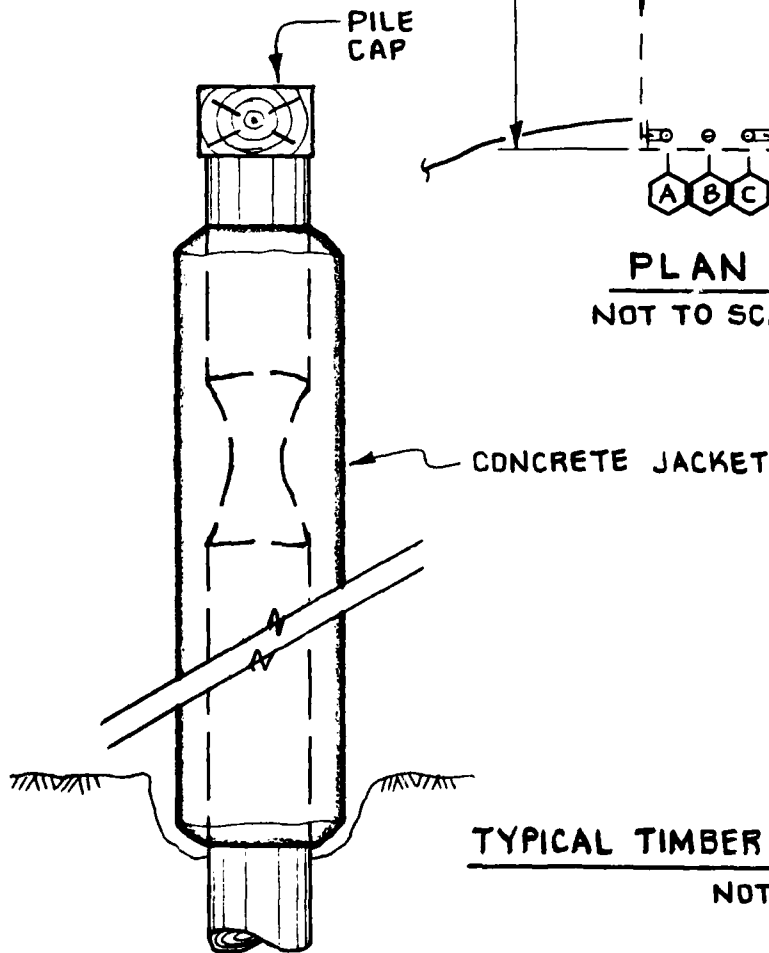
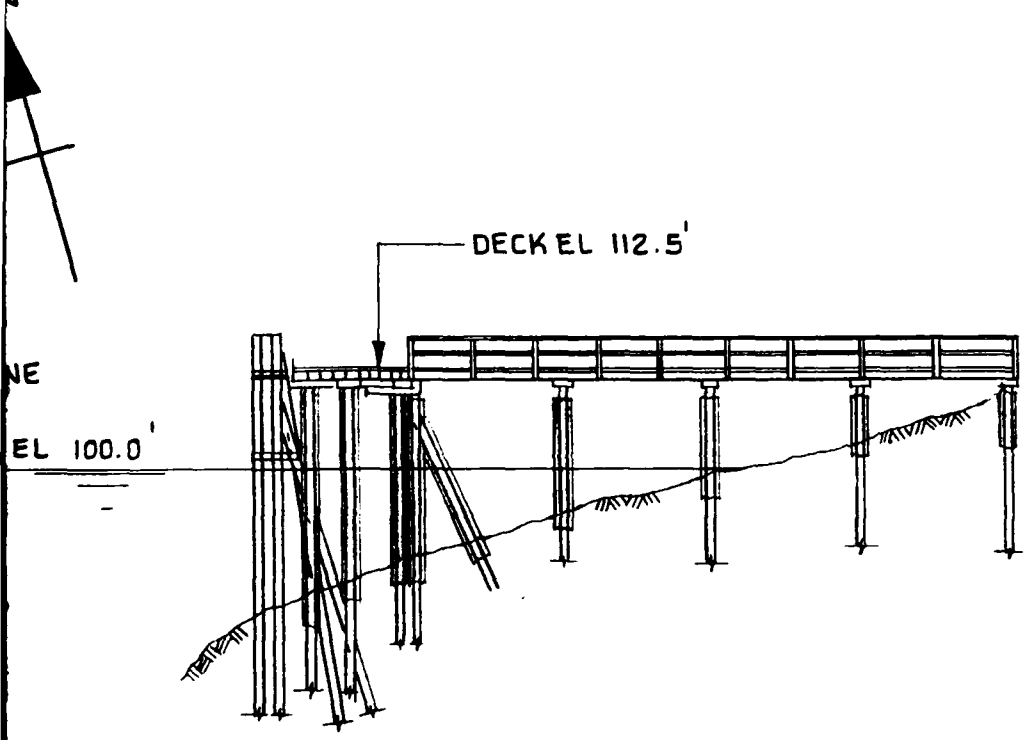
**PLAN**  
NOT TO SCALE

Pier 4 is located on the northernmost boundary of the NAS Alameda, in the area of the Fuel Supply Point (see Figure 2). Presently it is being used as a fuel pier. It is a "T" shaped pier that extends approximately 100' outshore. The outshore end of the pier is 160' long and 5' to 15' wide while the inshore section is 13' wide, (see Figure 18). The wooden plank decking is supported by 48 timber piles. Concrete jackets have been placed on 41 piles for their full length. The pier was built in 1953.
