UNDERWATER FACILITIES INSPECTIONS & ASSESSMENTS

HIGH POINT PIER

ANTIGUA, W.I.

NOVEMBER 1982

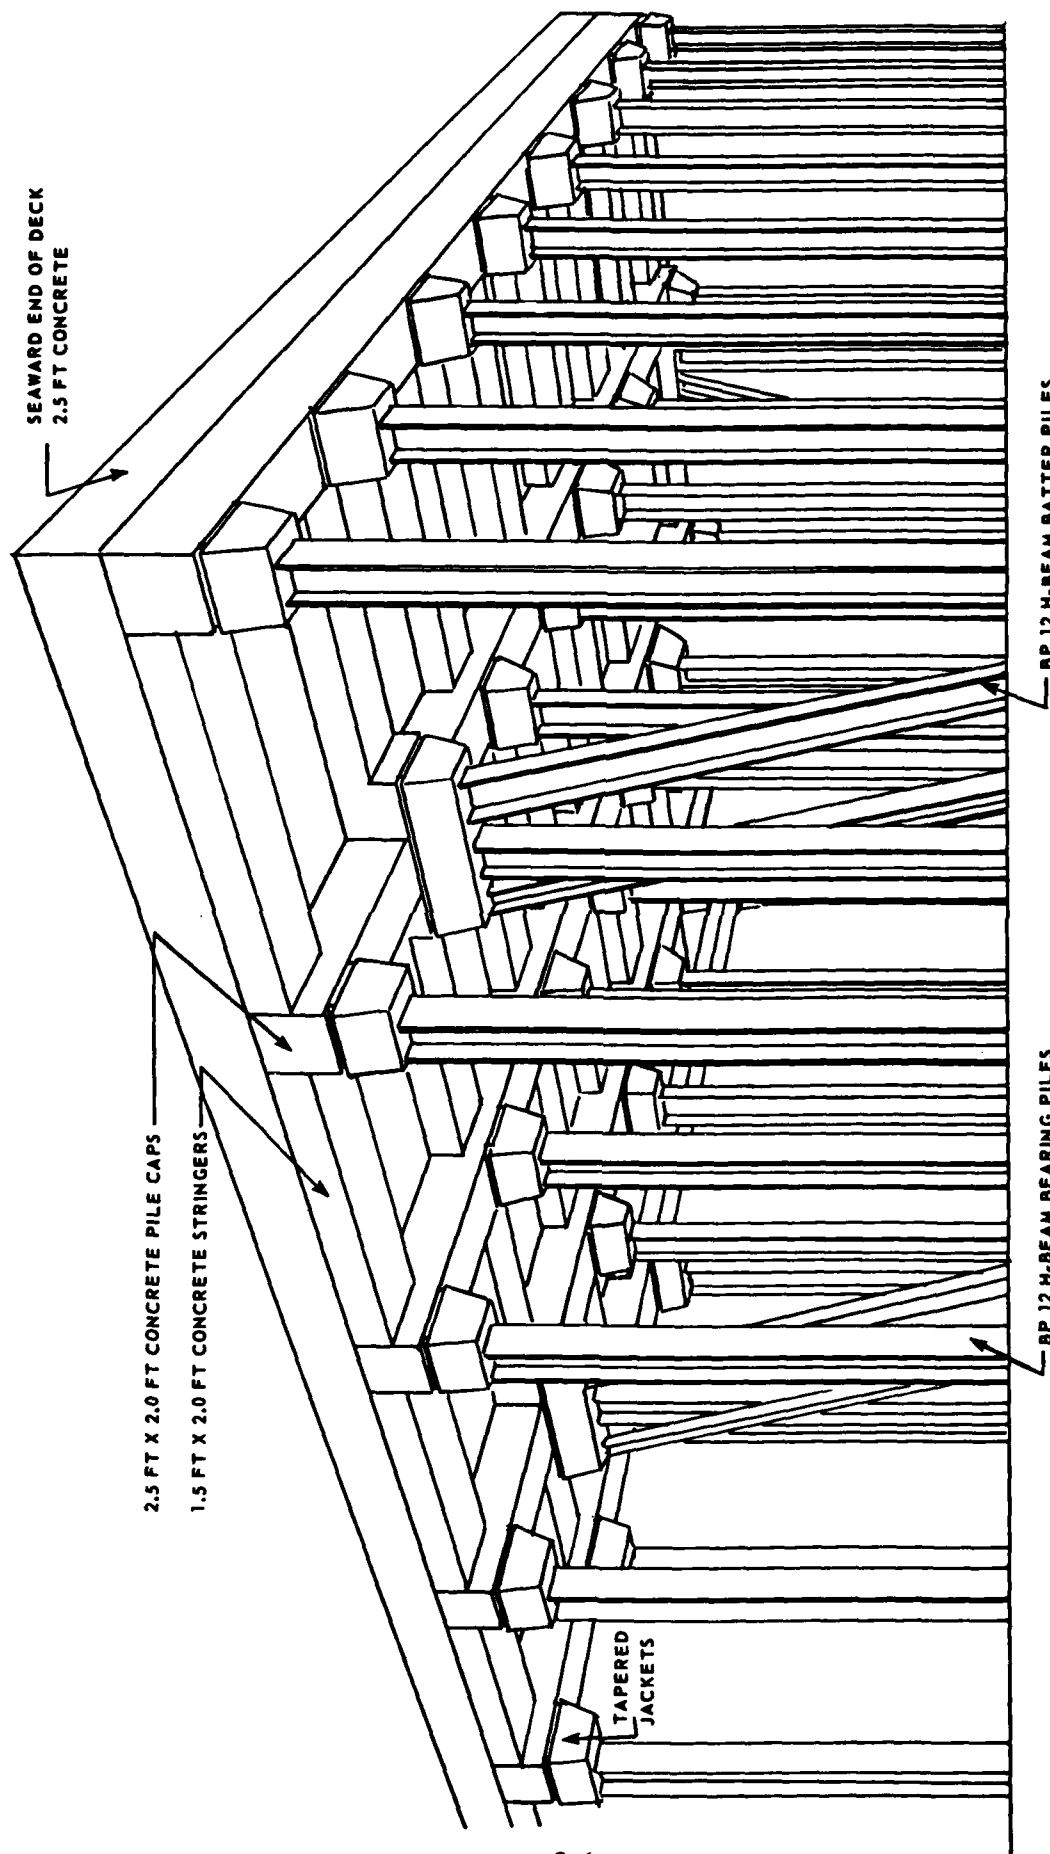
FIGURE 2-4

52 feet in length by 2.5 feet in depth by 2.0 feet in width. The intercoastal stringers are 1.5 feet in depth by 2.0 feet in width with a center spacing of 7.1 feet. Two pairs of steel H-beam batter piles, of the type shown in Figure 2-3, are installed on 6 of the 18 bents to provide lateral sway bracing. Figure 2-4 shows an overall perspective view of the underside of the pier structure.

HIGH POINT PIER - VIEW FROM UNDERSIDE

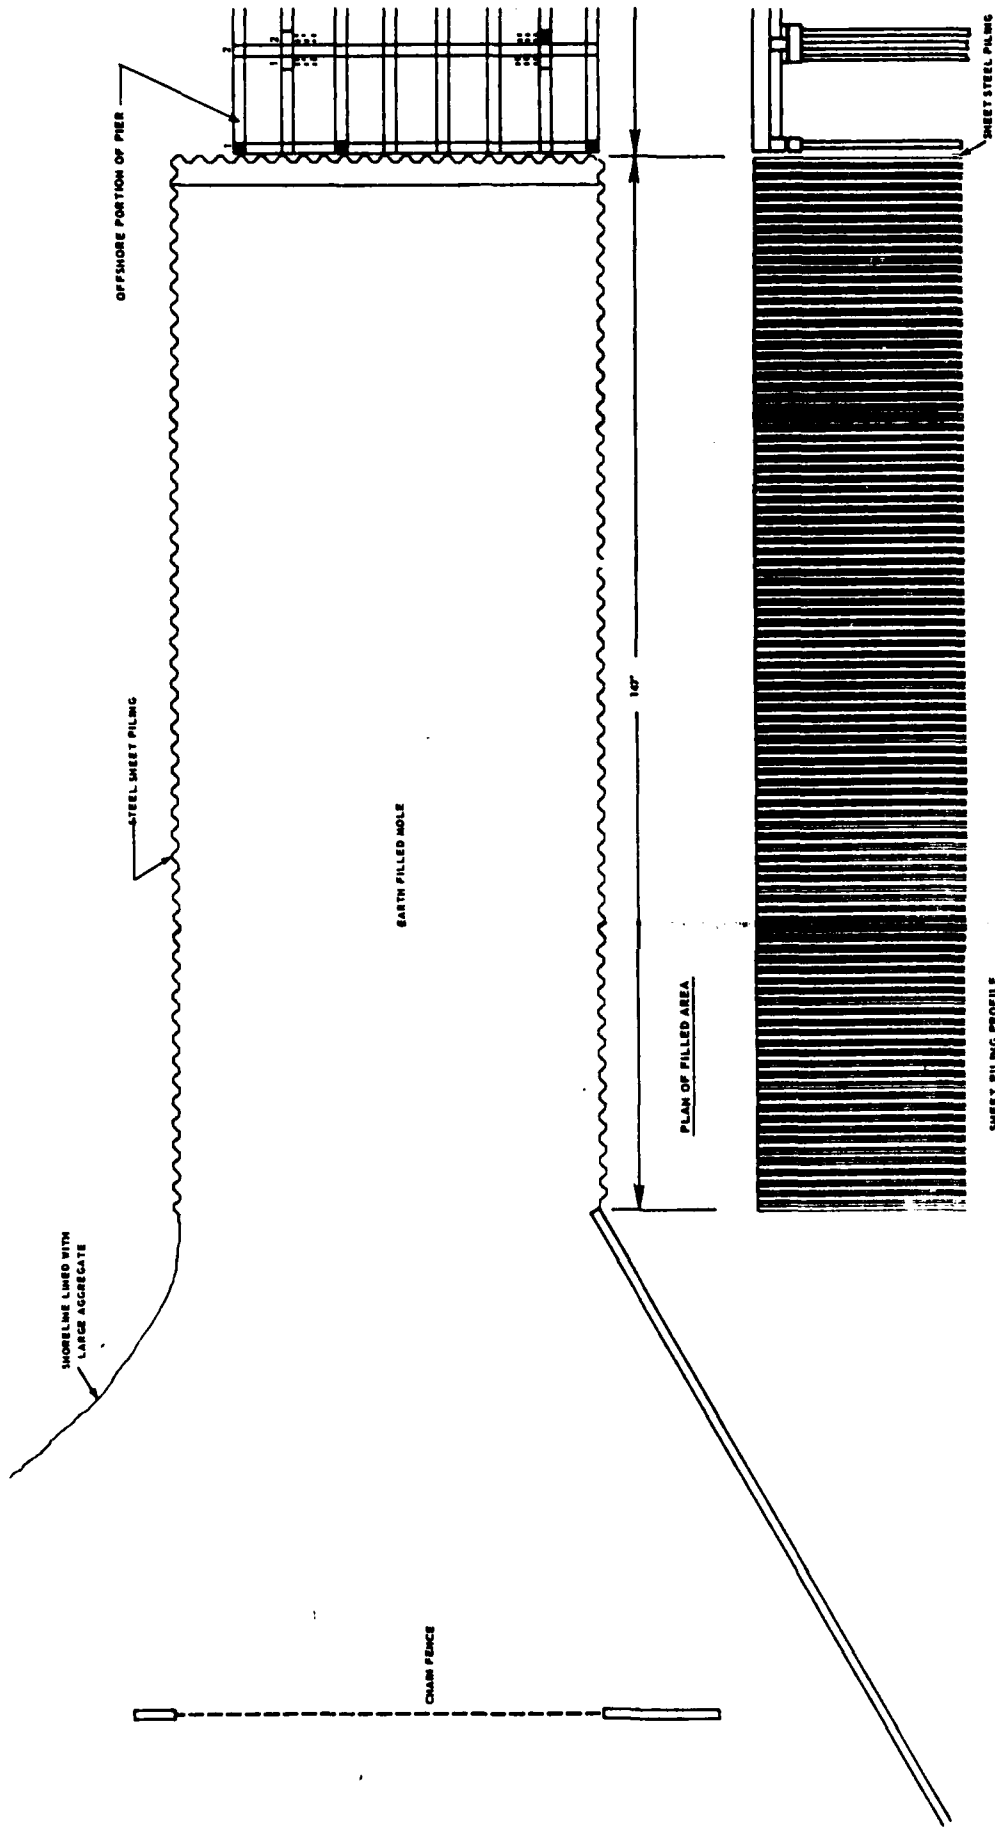
FIGURE 2-5

The onshore portion of the pier is essentially an earth-filled mode surrounded by steel sheet piling to provide level access to the surface of the offshore portion of the pier. The configuration of the sheet piling is illustrated in the plan view and profile of Figure 2-5. The mating plan view and profile of the offshore portion is given in Figure 2-6 which also indicates the numbering system for the piles and the piles on which a Level II inspection was conducted.

ONSHORE PORTION OF HIGH POINT PIER
ANTIGUA, W. I.

The deterioration of the sheet piling leading out to the pier structure from the shore is such that complete replacement is recommended. It appears impractical to remove the old piling and it is therefore recommended that new piling be driven completely surrounding the old piling, spaced a foot or more outboard of the old piling, with the space between filled with an inert
