# FIELD EVALUATION OF THE WATER WEDGE FOR CUTTING PORTLAND CEMENT CONCRETE PAVEMENTS FOR REPAIR AND RESTORATION OF PAVED SURFACES (REREPS)

David M. Coleman

Waterways Experiment Station, Corps of Engineers  
PO Box 631, Vicksburg, Mississippi 39180-0631

January 1986  
Final Report

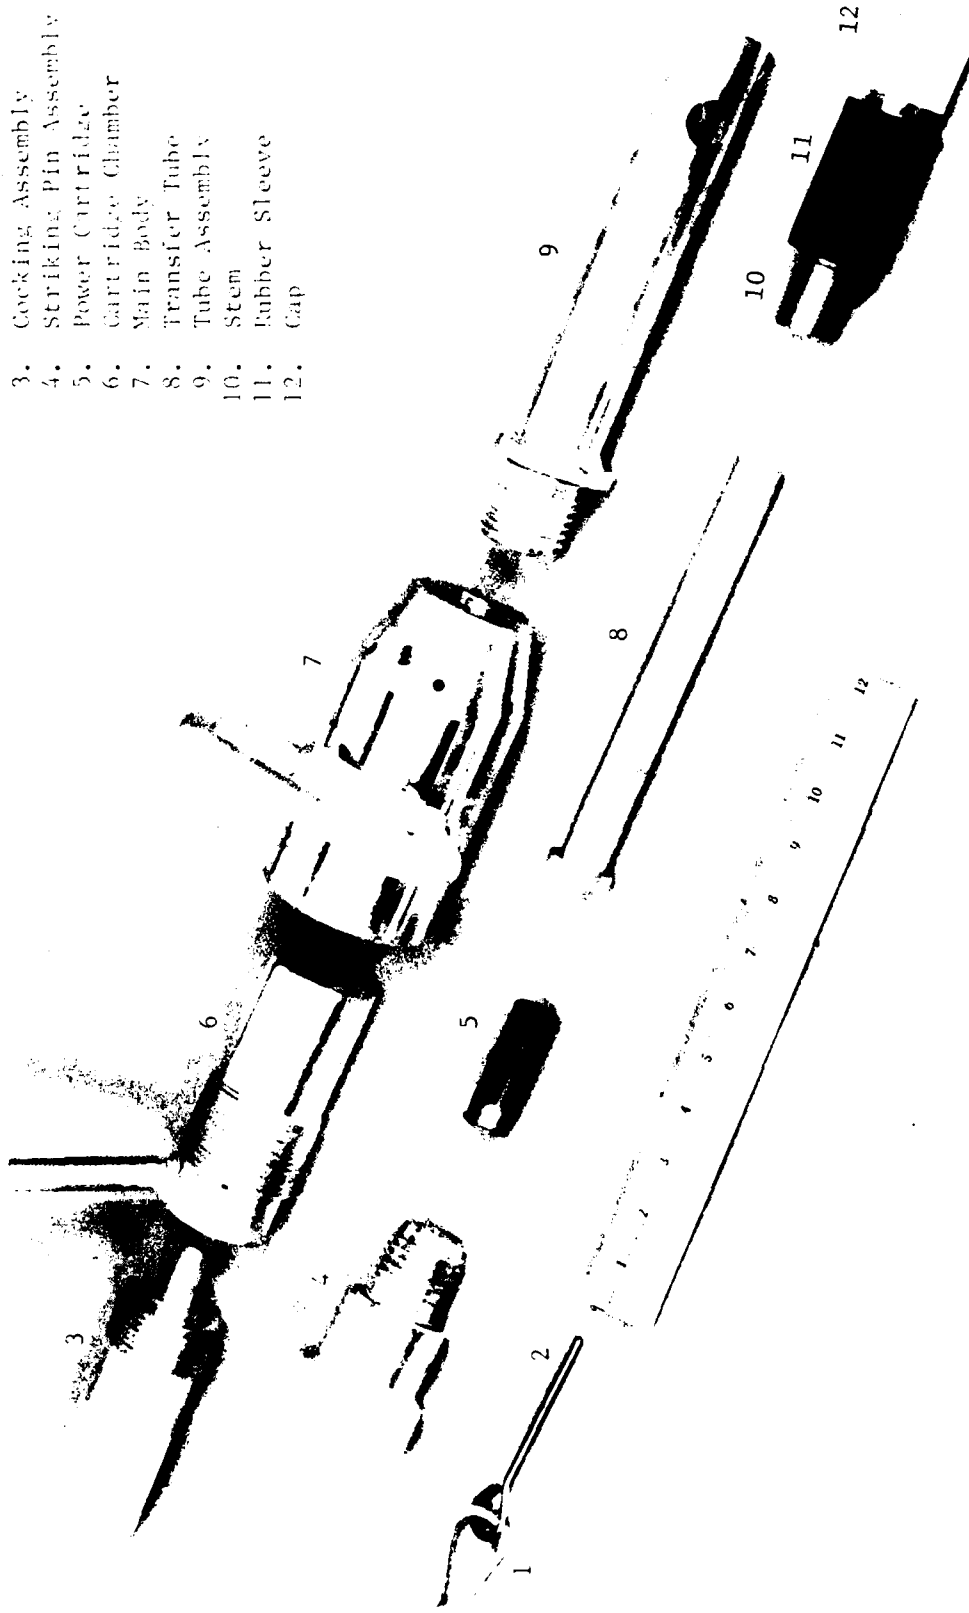
Photo 2. Exploded view of Water Wedge device

\*\* Numbers refer to part number shown in Photo 2.

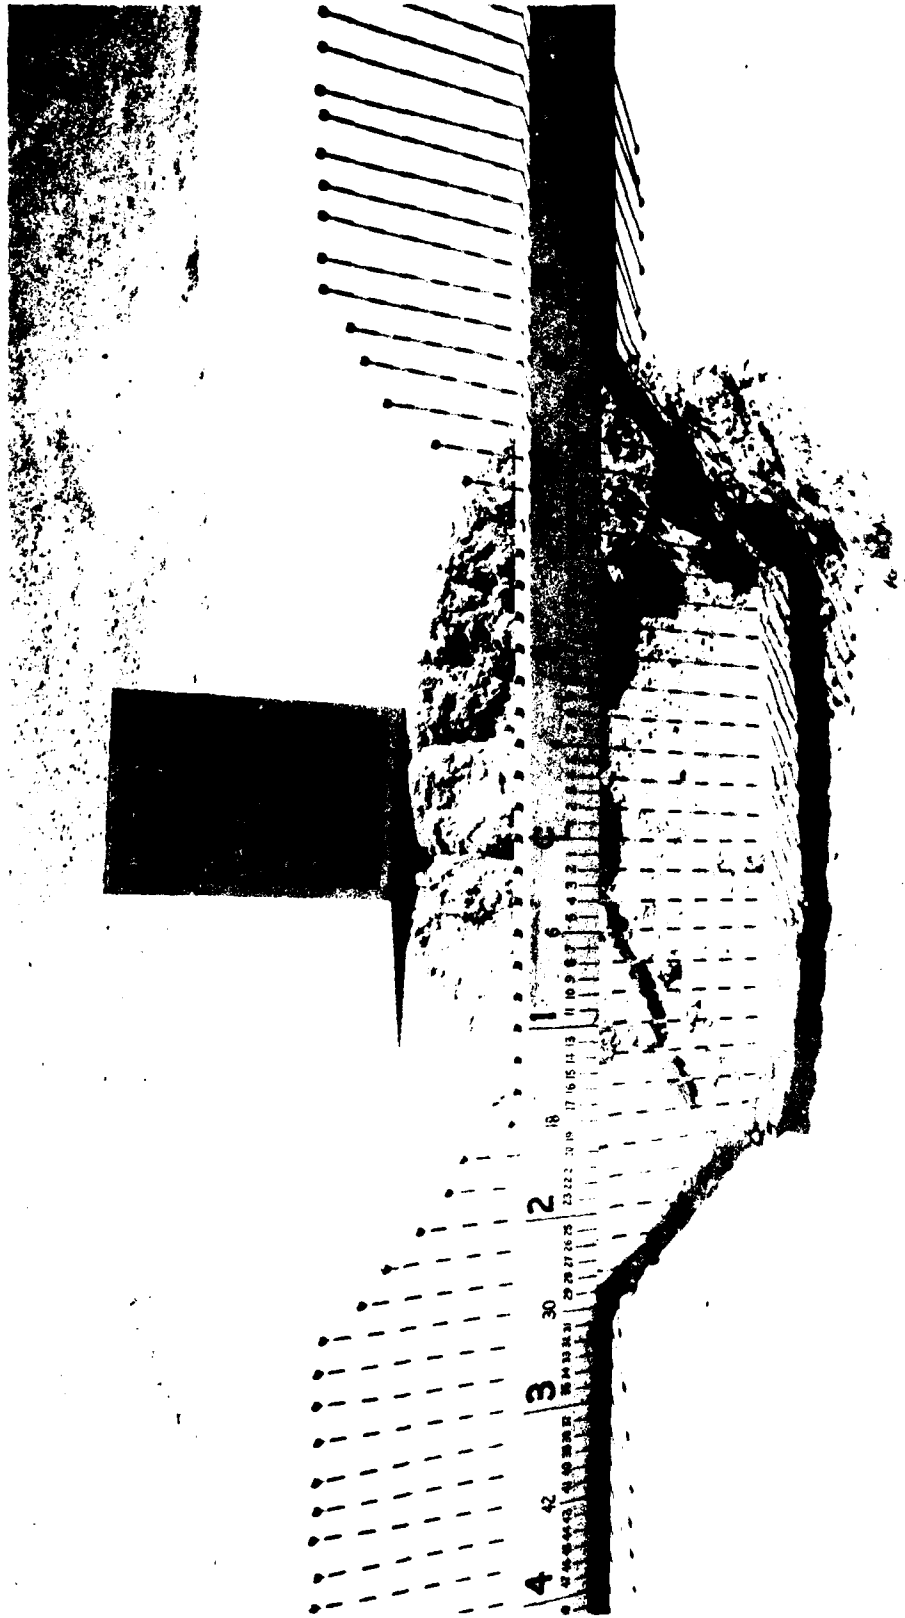
14. Phase II of this study was conducted to determine the best method for producing a straight crack in the PCC pavement. The Phase II testing was performed on a section of 12-in.-thick PCC built in April 1983 as part of a bomb damage repair test section. The pavement section consists of 12-in. non-reinforced PCC pavement over a sand subgrade. Laboratory test performed on the PCC at the time of construction indicated a 28-day compressive strength of 4,955 psi. Six-in.-diameter concrete cores taken in September 1983 indicate a split tensile strength of 549.5 psi which corresponds to 5,610 psi compressive strength and flexural strength of 771 psi. (See Table 1.) The tests of Phase II were conducted on the PCC slab adjacent to a 5-ft-diam crater cut in the slab. Photo 13 shows a typical crater used in these tests.

Photo 13. Typical crater

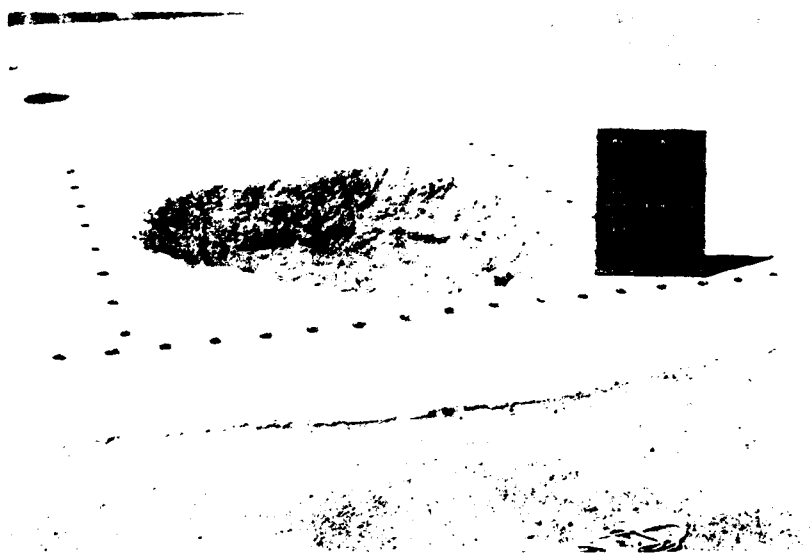
15. Test 1 of Phase II was designed to determine the amount of cracking produced by a 100 percent charge fired in a series of holes along the edge of a crater. The holes were spaced 6 in. center-to-center with hole 0 located 6 in. from the edge of the crater as shown in Photo 14. The first shot was discharged in hole 0, but no cracking or spalling occurred because the water had drained out of the hole. Shot 2 was discharged in hole 1L with no results; once again the water had run out. In Shot 3 hole 1L was then plugged with a heavy clay (CH) soil to prevent the water from escaping and the device fired again. The results of this firing were hairline cracks extending from hole 1L to hole 2L and approximately halfway to hole 0. In Shot 4 the device was once again fired in hole 1L with additional hairline cracks formed between holes 2L and 3L, 1L and 0, and 0 and 1R. No significant growth in the existing cracks was observed. Photo 15 shows the extent of cracking after Shot 4. Shot 5 was discharged in hole 2L causing hairline cracks to extend from hole 3L to 4L and approximately 4 in. toward hole 5L. Spalling, averaging 1/4 in. deep, extended out approximately 1 in. from the edge of hole 2L as seen in Photo 16. In Shot 6 the device was discharged in hole 0 resulting in spalling

Photo 14. Overall view of test 1 prior to shot

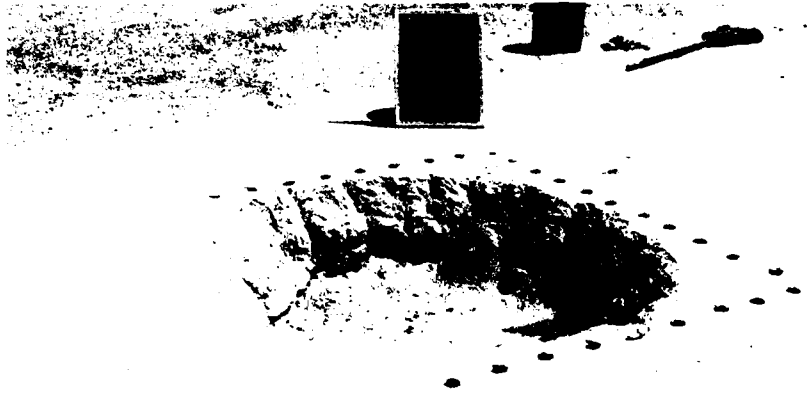
20. Test 4 was performed on Crater 2. A series of holes were drilled at 6 in. center-to-center spacings with the hole nearest the crater 3 in. from the crater edge as shown in Photo 26. The purpose of the test was to determine the effort required to make a straight cut along the edge of the crater, break the PCC mass adjacent to the crater away from the slab, and reveal the condition of the resulting edge. The first three shots were discharged in holes 0, 1R, and 1L, respectively. The first shot resulted in cracking of the slab from hole 0 toward the crater edge and from hole 0 to 1R. The second shot resulted in additional cracking between hole 0 and hole 3L and from hole 1R to hole 4R as shown in Photo 27. Additional shots in holes 2L, 3L, and 4L resulted in additional cracking and a moderate amount of spalling. At this time, the cracks had extended to hole 1W with a crack branching out from 3L toward the crater edge. Photo 28 shows the extent of the cracking and spalling existing at this time. Additional shots were discharged in holes 2R and 4R which resulted in additional cracking from hole 4R to 5R. A series of shots were discharged in holes 5W, 4W, and 3W to produce cracks along the west side of the crater. Another series of 0 shots were discharged in holes 0, 1L, 1R, and 2L. Each of these shots resulted in increased spalling and increases in crack width. Photo 29 shows the cracking and spalling existing at this time. Additional shots discharged in holes 2R, 3R and 4R resulted in some widening of the existing cracks with extensive spalling. With each of these shots, a moderate amount of debris was thrown into the air. Shots in holes 0, 2L, 3L, and 2R resulted in extensive spalling with several cracks visible in the sides of the crater (Photo 30). This final series of shots removed the top 2 in. of concrete between the line of holes and the crater from hole 2L to hole 3R as shown in Photos 31 and 32.

Photo 26. Crater 2, test 4 site
