HOLY LOCH  
FLEET MOORINGS  
INSPECTION REPORT

FPO-1-82(22)

# **HOLY LOCH FLEET MOORINGS INSPECTION REPORT**

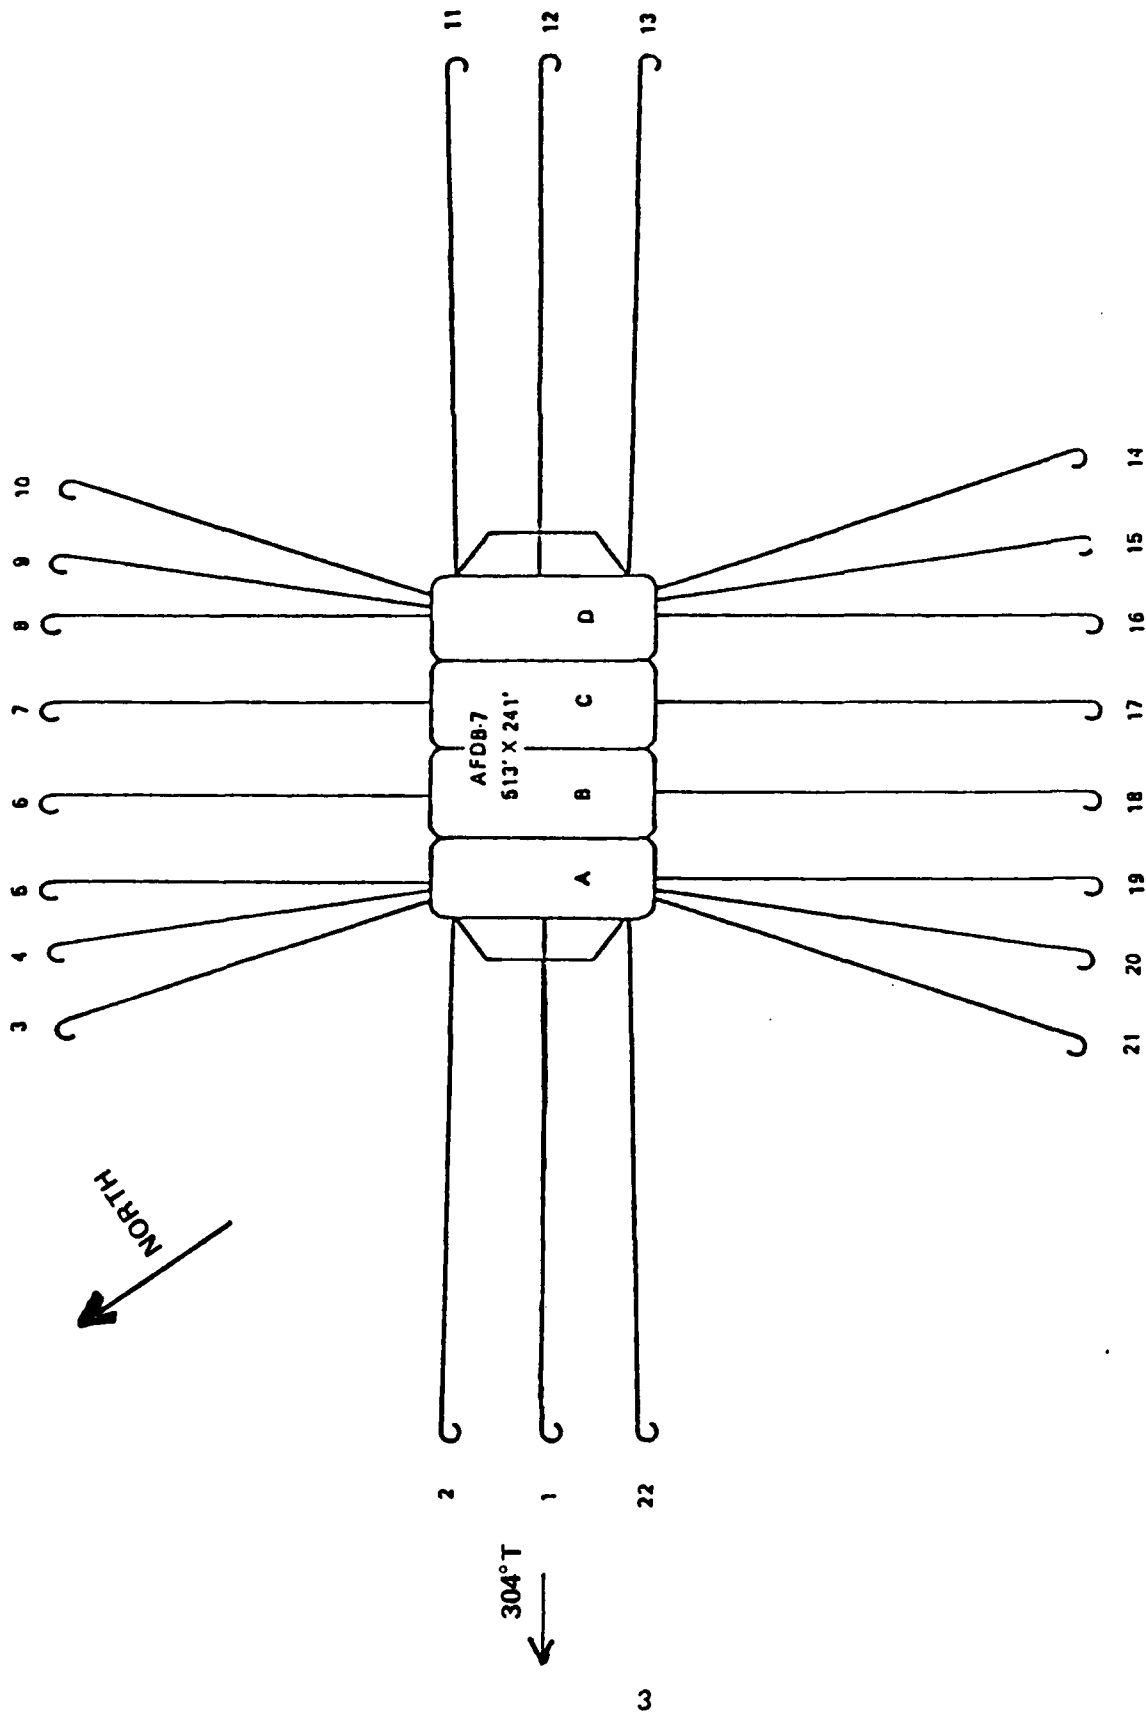
Figure 2. Schematic of AFDB-7 Mooring, Showing Ground Leg Numbers

The dry dock is routinely used by fleet ballistic missile (FBM) submarines. Because of the strategic importance of this facility and the possibility of severe winter weather, the material condition of the mooring is a continuing concern. Between 1973 and 1981, 19 of the 22 ground legs were inspected by the British Ministry of Defense (M.O.D.). During this period, only one of the ground legs was determined to contain a chain link which has worn to less than 80% of the original wire diameter; the length which contained this link was replaced in 1981. In April 1982, divers from USS HUNLEY (AS-31) visually inspected 21 of the 22 ground legs. All chain was reported to be in good condition, although some legs were observed to have little or no catenary.

**4.1 AFDB-7.** The fact that over 70% of the ground legs had measurements of less than 90% of original wire diameter at some point along their length indicates that the mooring may be in need of overhaul. It is recommended that at least the first two shots of chain in each leg be replaced with new chain, unless a thorough engineering analysis indicates that fewer legs are required. Some legs may require additional new chain depending on the specific location and extent of the wear zone. A cost estimate for new chain and associated hardware is presented in Annex D. Pending results of the analysis to specify the mooring requirements of AFDB-7, it is recommended that only the segment of Leg #22 previously identified be replaced immediately.

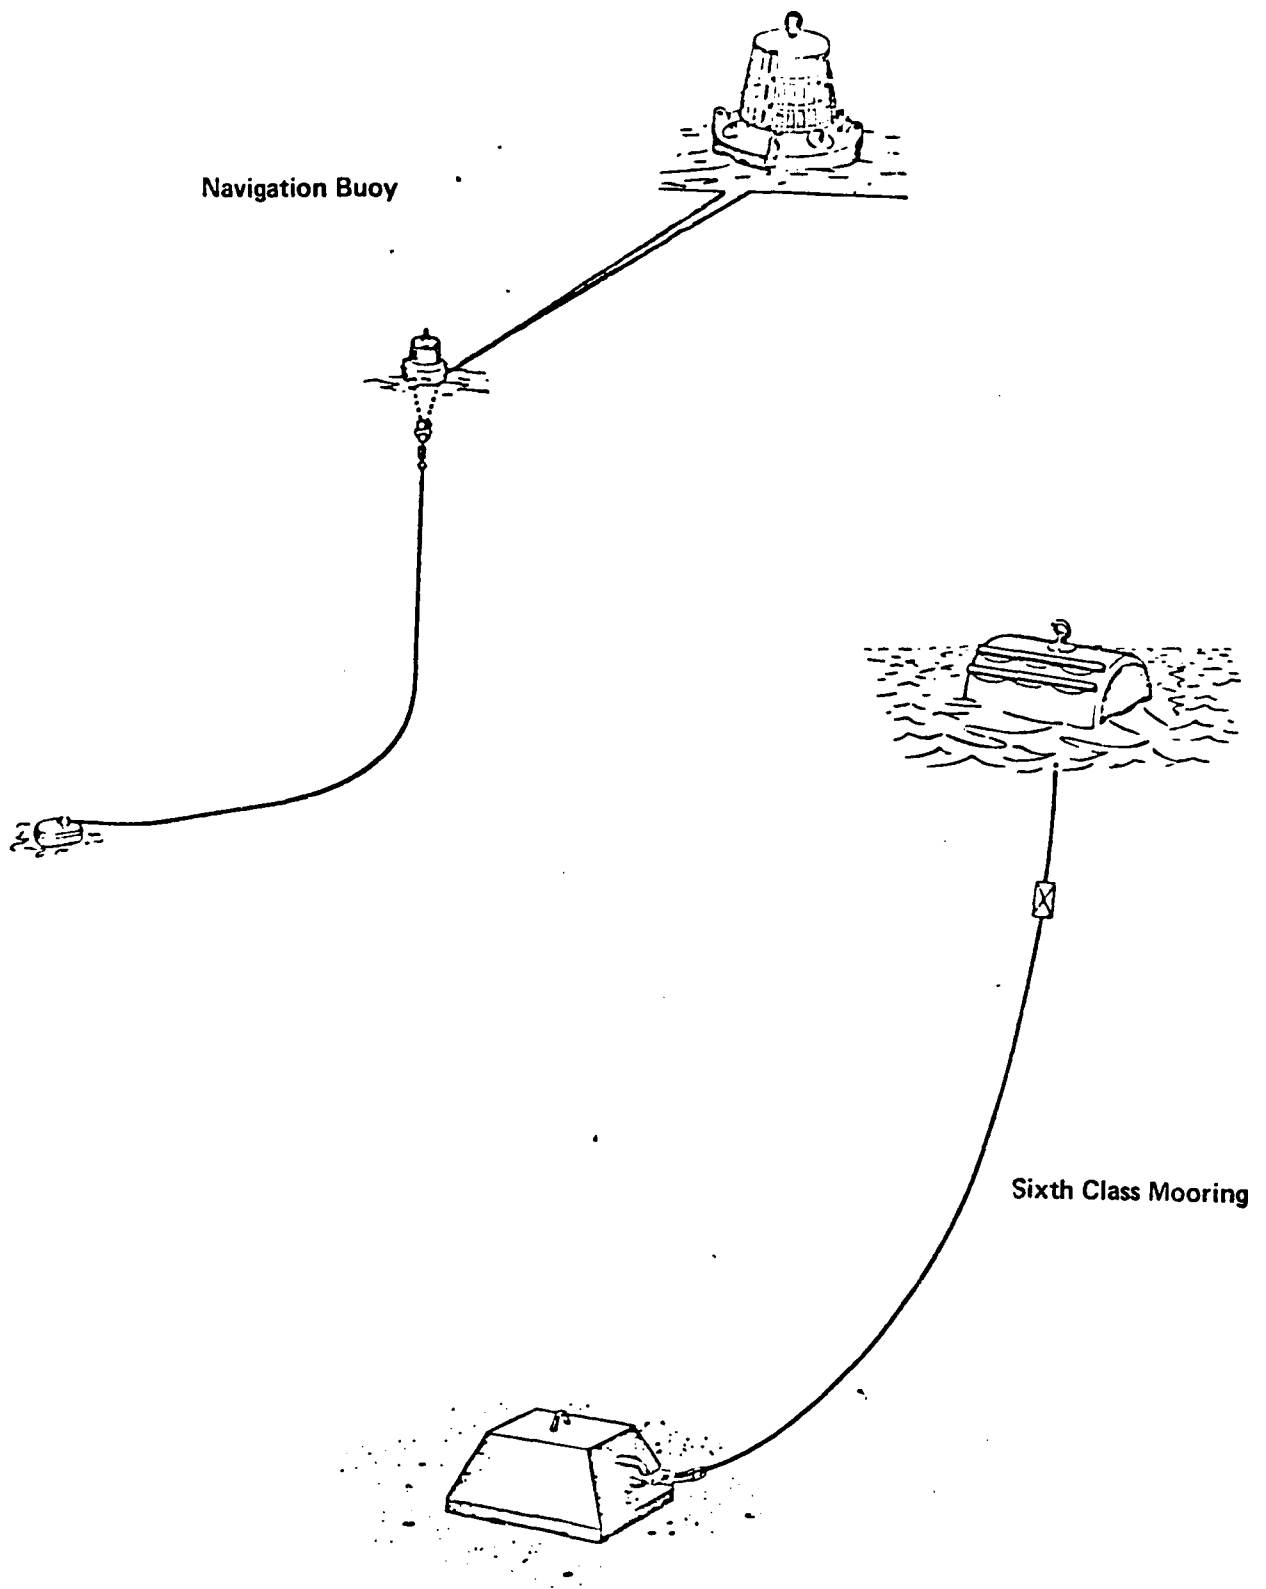
Figure 3. Schematics of Navigation Buoy and Sixth Class Mooring

**3.2.1 Findings.** The two moorings inspected are in generally good-to-excellent condition. Inspection of the buoys revealed no holes, dents, or pitting, and only medium marine growth was observed. The riser chain was in good condition, with all measurements +90%. Neither of the two anchors was observed. The riser of mooring #2 contained two swivels, while there was no swivel observed in the riser of mooring #3.

**3.3.1 Findings.** The condition of these buoys is generally good-to-excellent. The topside portion of each of the buoys is in good condition; minimal pitting was observed below the waterline. The bridles and risers are in good condition; all double link measurements were +90%. The anchors of both buoys were located and there was no evidence of dragging. The only notable observations were the existence of a box swivel in place of a standard swivel in one of the risers, and a 4 - 5' length of riser chain wrapped around the clump anchor, both in the Starboard buoy.

**4.3 Navigation Buoys.** These buoys should remain in excellent condition under the current program of inspection and maintenance administered by the British Navy.

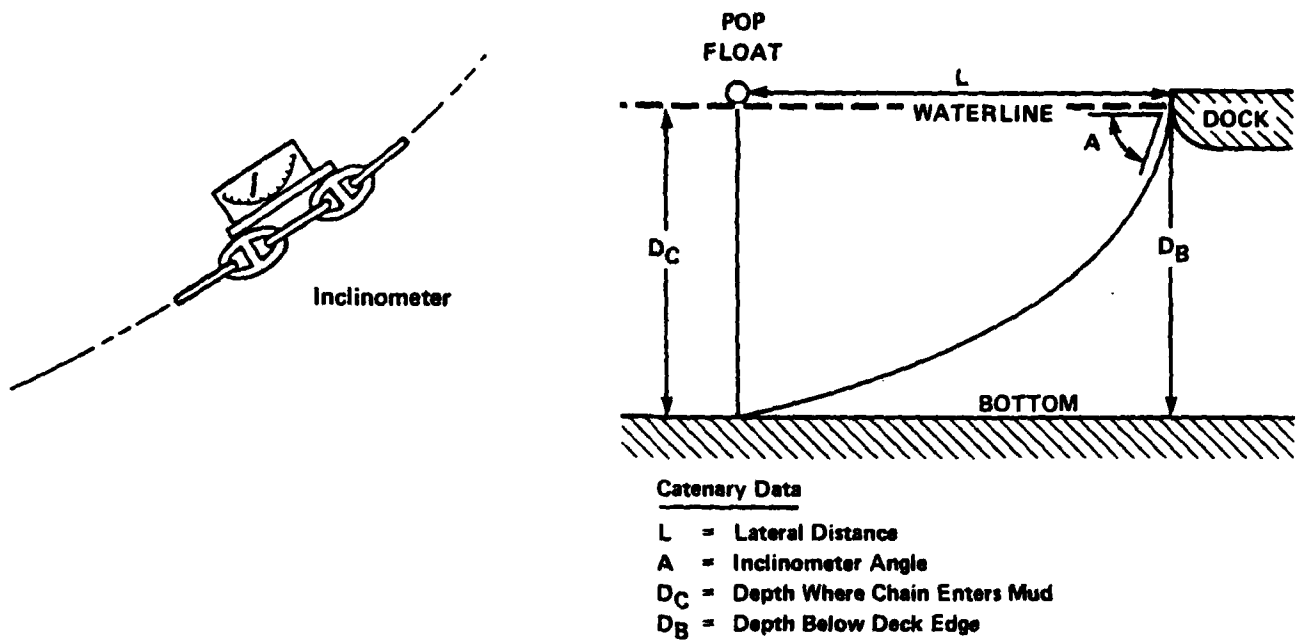
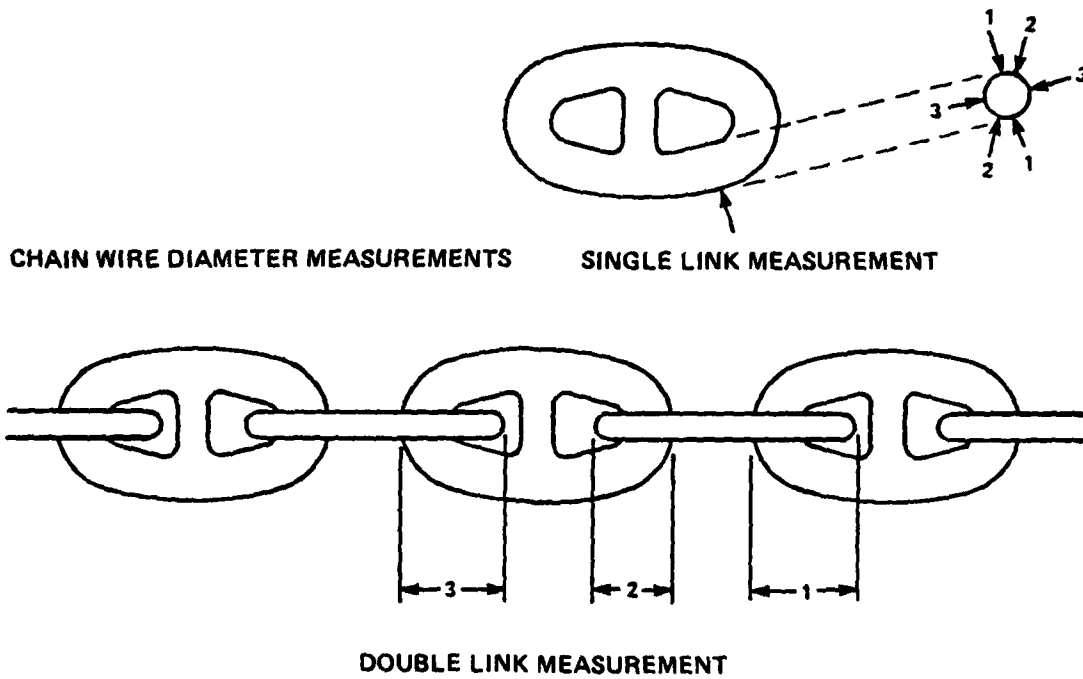
Figure 4. Chain Wire Diameter Measurements and Ground Leg Catenary Observations

2.1.3 Catenary Profile. Several observations were made in order to determine the catenary of each leg. The parameters involved are illustrated in Figure 4. The inclinometer readings were taken where the chain enters the water; depth readings were taken directly below the deck edge and where the chain enters the

mud; the lateral distance is the horizontal distance from the deck edge to the pop float installed above the position where the chain enters the mud. Two inclinometer readings were taken on several legs: the first under relatively calm conditions (winds less than 10 KTS), and a second during strong winds (to 40 KTS) in order to compare the effect on the catenary.

- No broken links or hardware were found; 27% (6 of 22) legs were +90% of original 3" chain wire diameter over the entire inspected length (to mudline); 68% (15 of 22) were +80% at some point along their length; one leg (#22) was -80% in Section II. All but one of the +80% or lower measurements occurred in Section II, the splash zone (see Figure 5). Leg #18 had no on-deck stopper (pelican hook).

- No anchors or sinkers were located; all legs were buried in bottom mud a relatively short distance from the floating dock.
- Three legs were noted to have slack chain resting on the bottom; 36% (8 of 22) of the legs had surface chain angles of greater than 85° from the horizontal; 41% (9 of 22) had angles of 75° - 85°; 32% (7 of 22) of the lateral distances were less than 18'; average lateral distance was 45' (see Figure 6).

- The chain in Section II of Leg #22 which measured less than 80% of original wire diameter must be replaced as soon as possible.
- An engineering analysis of AFDB-7 mooring design should be conducted in order to define the optimum catenary of each leg; pending results of such an analysis, a number of legs should be repositioned to tighten the catenary prior to the 82 - 83 winter season.

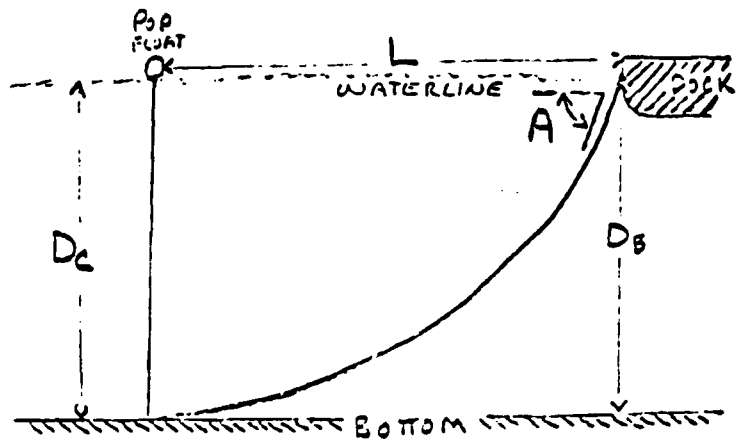
A = 77° A' = 55°  
 L = 60 ft (USS HANLEY  
 DIVERS APR 82)  
 D<sub>B</sub> = 89.3 ft  
 D<sub>C</sub> = 89.3 ft

NOTES: Depths @ Mean Low Water Springs  
 "A" recorded in winds 10 KTS  
 or less  
 A' RECORDED IN WINDS 30-40 KTS

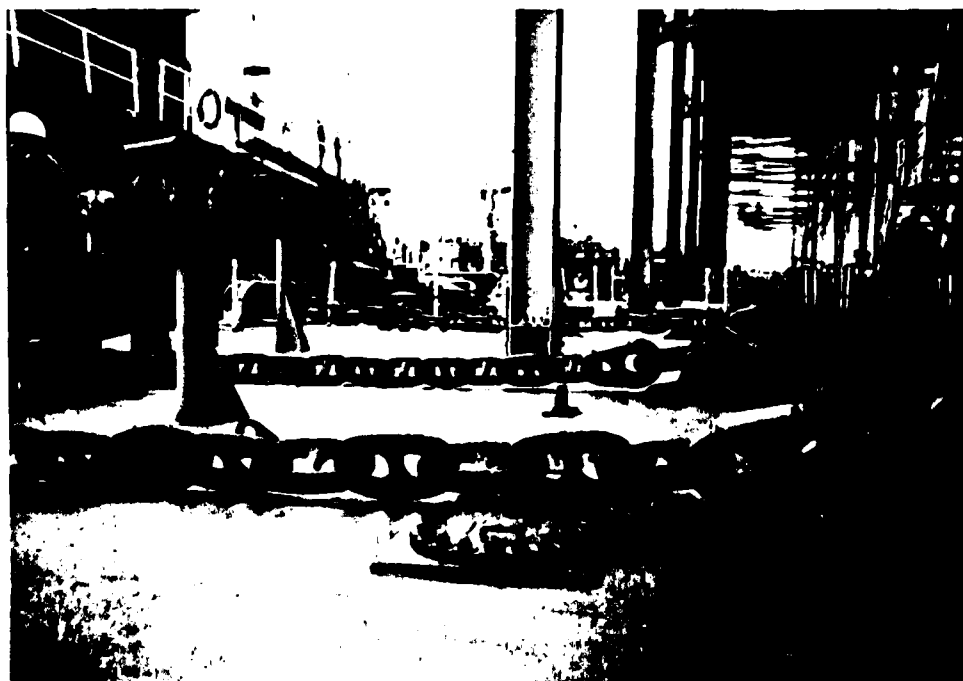
**On-deck arrangement of anchor leg, showing pad-eye, anchor joining link (red), and stud-link chain.**
