# **SAN DIEGO FLEET MOORINGS INSPECTION REPORT**

**30 NOVEMBER**

**OCEAN ENGINEERING AND CONSTRUCTION PROJECT OFFICE  
CHESAPEAKE DIVISION  
NAVAL FACILITIES ENGINEERING COMMAND  
WASHINGTON, DC 20374**

**FPO-1-82 (29)**

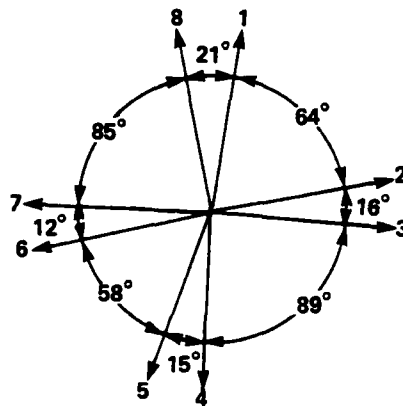
GROUND LEG ORIENTATION

MOORING NO.: FM-20 CLASS: BB LOCATION: HARBOR ISLAND LAT: \_\_\_\_\_ LONG: \_\_\_\_\_  
 WATER DEPTH: 42' 39 1/2' TYPE MOORING: ☐ RISER ☐ TELEPHONE ANCHOR SIZE/TYPER: M/S BUOY TYPE: DRUM  
 DATE: 8/18/82 ENGINEER-IN-CHARGE: M. WALTER DIVER: J. TORRENS, J. S. HARRING 16' d 49" F.B.

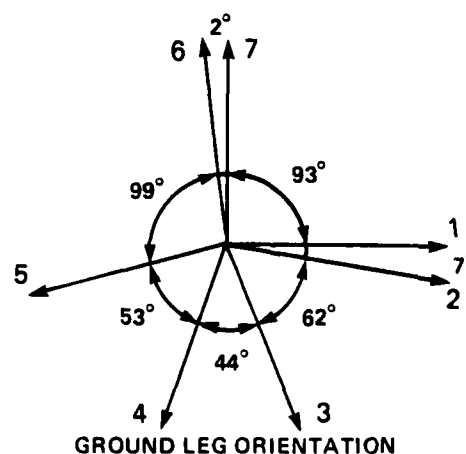
MOORING NO.: EM 21 CLASS: BB LOCATION: HARBOR ISLAND LAT: \_\_\_\_\_ LONG: \_\_\_\_\_

WATER DEPTH: 40' / 38 1/2' TYPE MOORING: ☒ RISER ☐ TELEPHONE ANCHOR SIZE/TYPER: N1 BUOY TYPE: REG. TOP  
11" Ø 42" F.D.

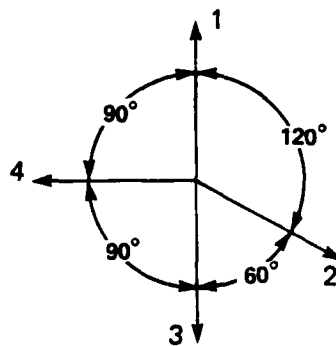
GROUND LEG ORIENTATION

MOORING NO.: FM-50 CLASS: B LOCATION: NAVSTA LAT:            LONG:

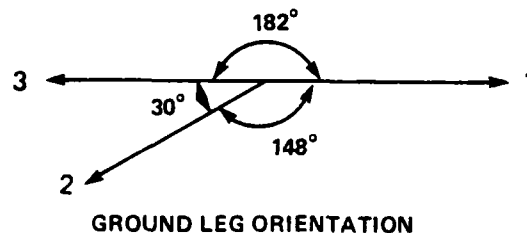
MOORING NO.: EM 51 CLASS: B LOCATION: NAVSTA LAT:            LONG:             
 WATER DEPTH: 42' 39" TYPE MOORING: ☒ RISER ☐ TELEPHONE ANCHOR SIZE/TYPER: AL BUOY TYPE: DRUM  
 DATE: 8/17/82 ENGINEER-IN-CHARGE: M. WALTER DIVER: J. TORRENS, S. HARDY  
 TIME: 0800
