CENTERVILLE BEACH SPLIT  
PIPE REPAIR

4. PERFORMING ORGANIZATION REPORT NUMBER  
FPO 7703.5

14. DATE OF REP. (YYMMDD)  
77-06-09

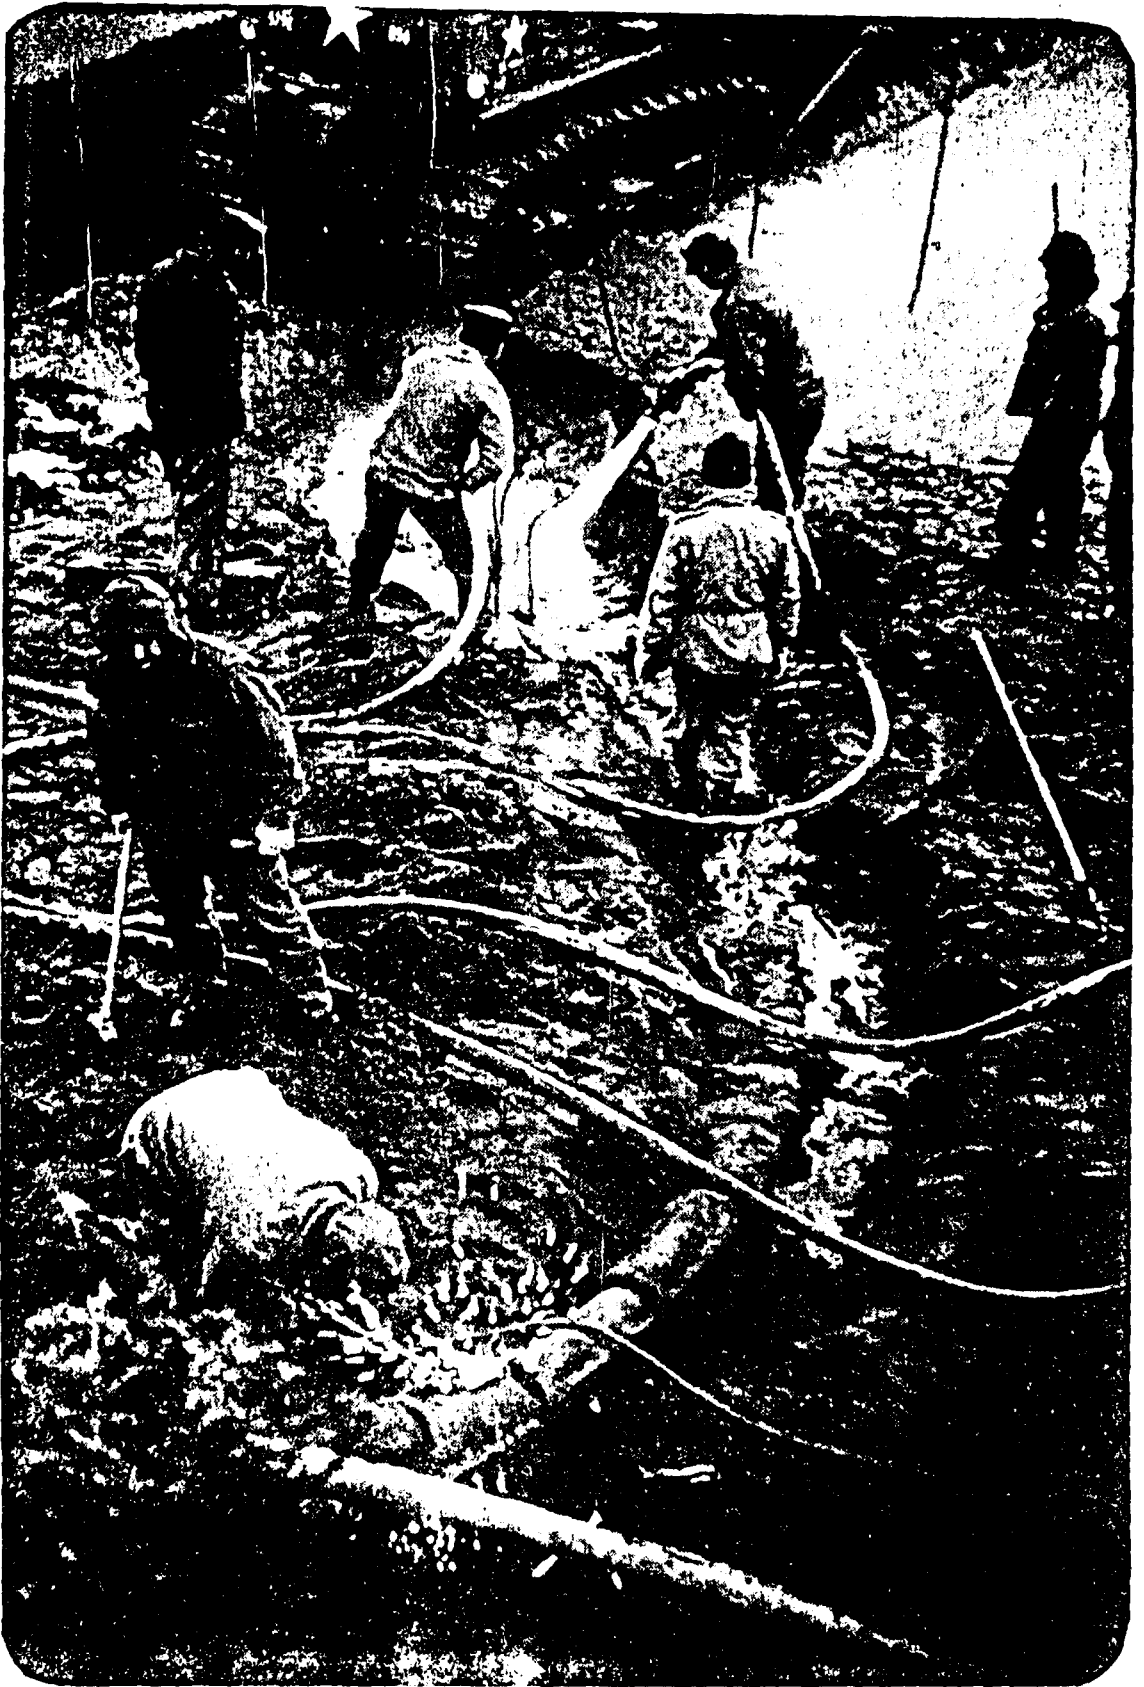
Men working on the cable.

(U) 2. Next, sections of the cable were lifted either by hand or with the backhoe while the wire mesh cage with the standoffs attached were fitted around the cable. The standoffs (rectangular plastic boxes) were stapled on the inside and outside circumference of the prefabricated steel cage in order to center the cable inside the cage and center the cage inside the nylon bag (Appendix B). Figure 9 shows the cable being lifted and the wire cage with standoffs being applied (note the taped section of cable). This phase of the operation took about 30 minutes per cable.
