# Technical Memorandum

UNITED STATES NAVY - CANADIAN FORCES  
SOLID STATE FLIGHT DATA RECORDER/CRASH POSITION LOCATOR  
EXPERIMENT ON THE B-720 CONTROLLED IMPACT DEMONSTRATION

11 November 1985

TM 85-76 SY  
11 November 1985

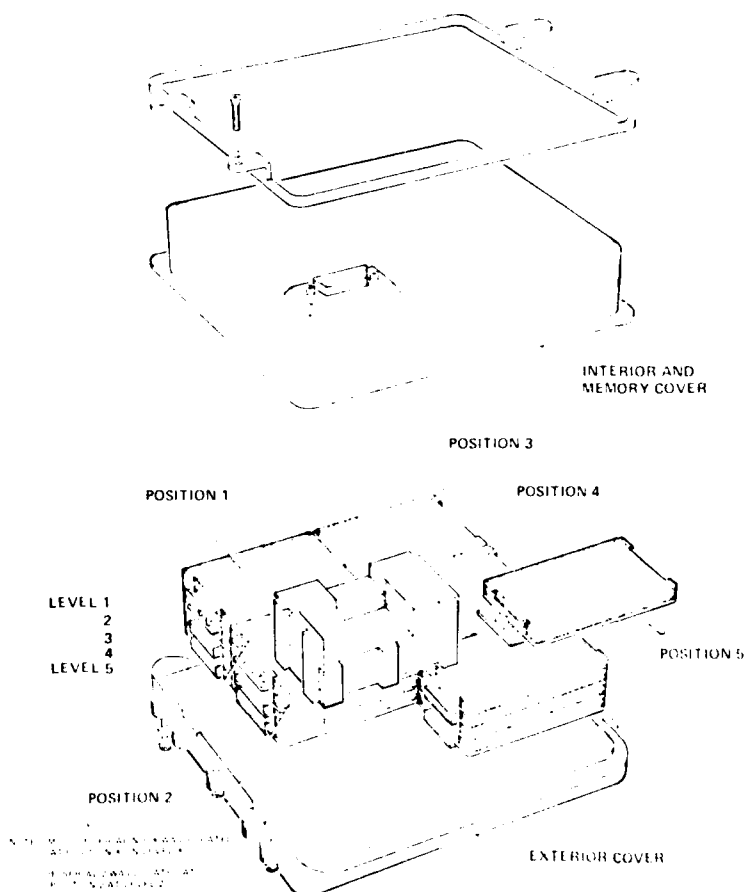
**Figure 4**  
**SSFDR MEMORY MODULE ARRANGEMENT**

3. The B-720 SSFDR contained 5 memory modules and 20 dummy modules. Each of the five memory modules contained two 32 Kbit memory chips (64 Kbits total). The five memory modules were spaced to measure thermal gradients within the SSFDR. The memory modules/chips (320 Kbits total) were preprogrammed with alternating ones and zeros (checkerboard pattern) prior to CPL/B-720 installation. Also, temperature stick-on indicators were attached to each memory module and interior and exterior SSFDR covers prior to CPL/B-720 installation.

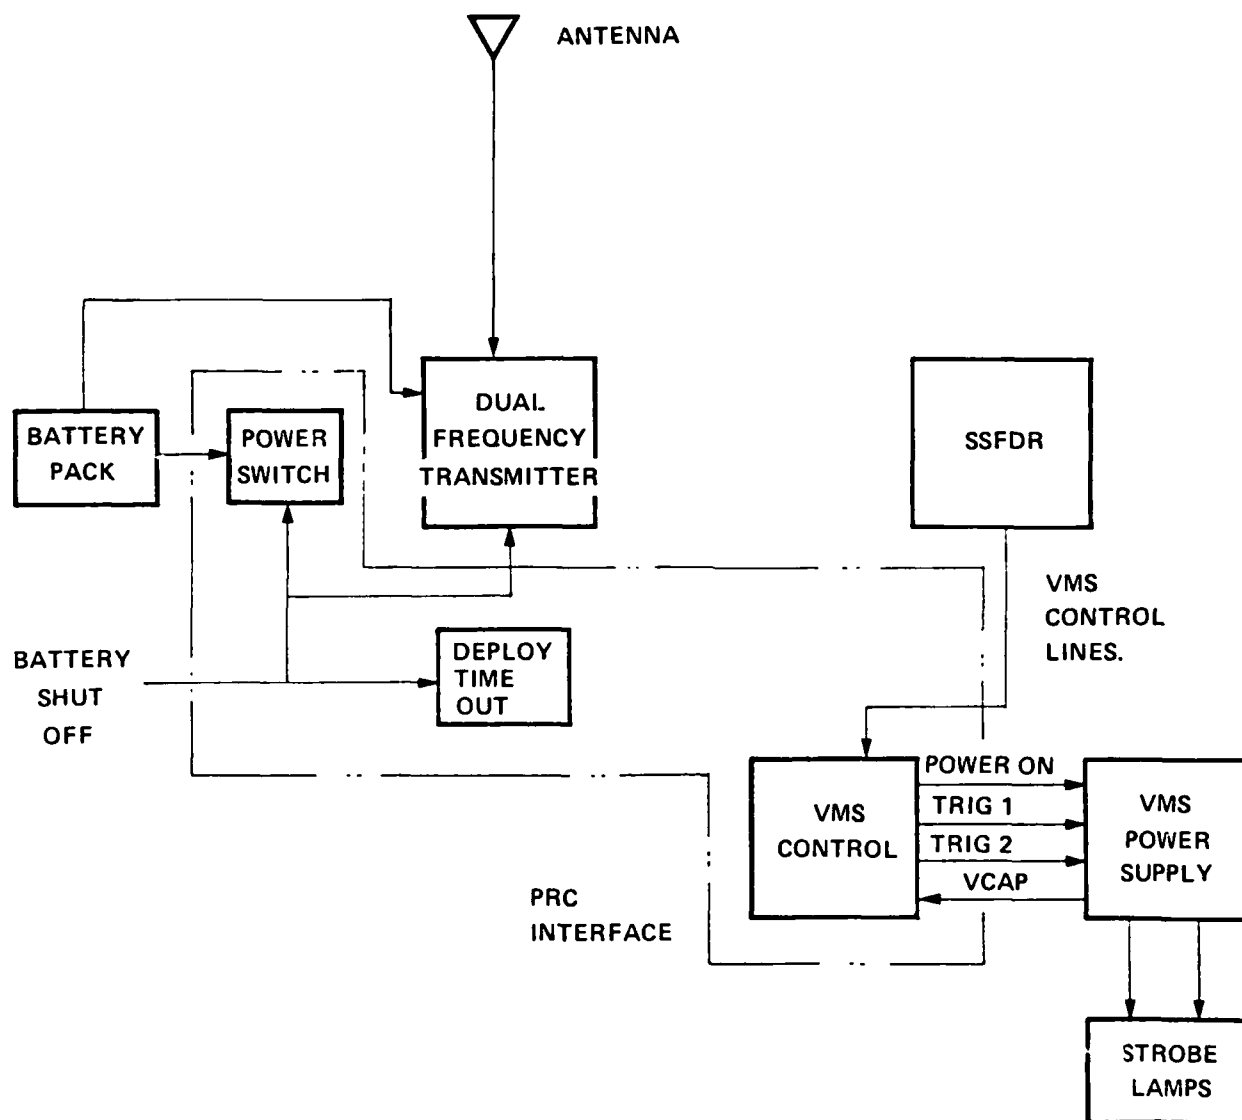
Figure 5  
 B-720/RBA-46 PAYLOAD BLOCK DIAGRAM

6. The B-720 RBA-46 CPL design configuration was established as shown in figure 5 with electronic circuitry and space provisions to implement the design configuration, figure 6, after the B-270 CID. The B-720 RBA-46 CPL overall specifications are as follows:
