DOT/FAA/CT-85/33

Galley and Overhead Compartment Experiment Results - Full-Scale Transport Controlled Impact Demonstration

Roger M. Lloyd
RMS Technologies, Incorporated
Trevose, Pennsylvania

December 1985

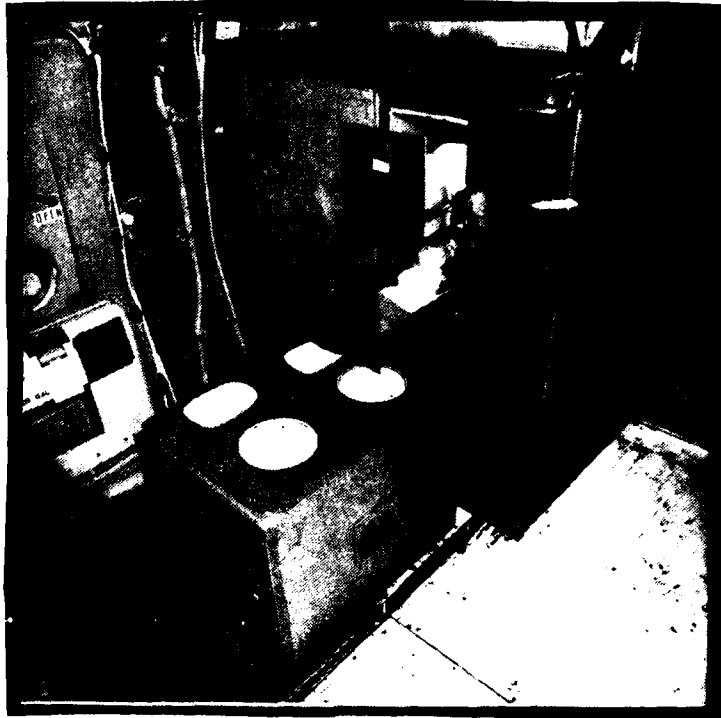
FIGURE 11. GALLEY LOADED WITH PLATES, TRAYS, ETC.

The forward and aft galleys were loaded to simulate in-service conditions. In the aft galley (forward facing) the above counter section was left empty while the lower individual food service modules were filled with actual trays, dishes, and silverware (no food) as identified under Table 3 (Figure 11). These contents weighed approximately 96.6 pounds. In the forward galley (aft facing), a coffee pot was placed in the above counter heating unit. However, the lower food service module area was not loaded with the normal food service equipment. Instead, the contents included a series of special "hazardous material" packages manufactured by the Lawrence Packing, Eli Lilly, and Dow Chemical companies (Figure 12). These packages are identified under Table 4. The total weight of these packages was approximately 147 pounds. (NOTE: The "hazardous material packages" contained non-hazardous jelled material and represented an experiment to determine the adequacy of such packages in resisting high impact conditions).

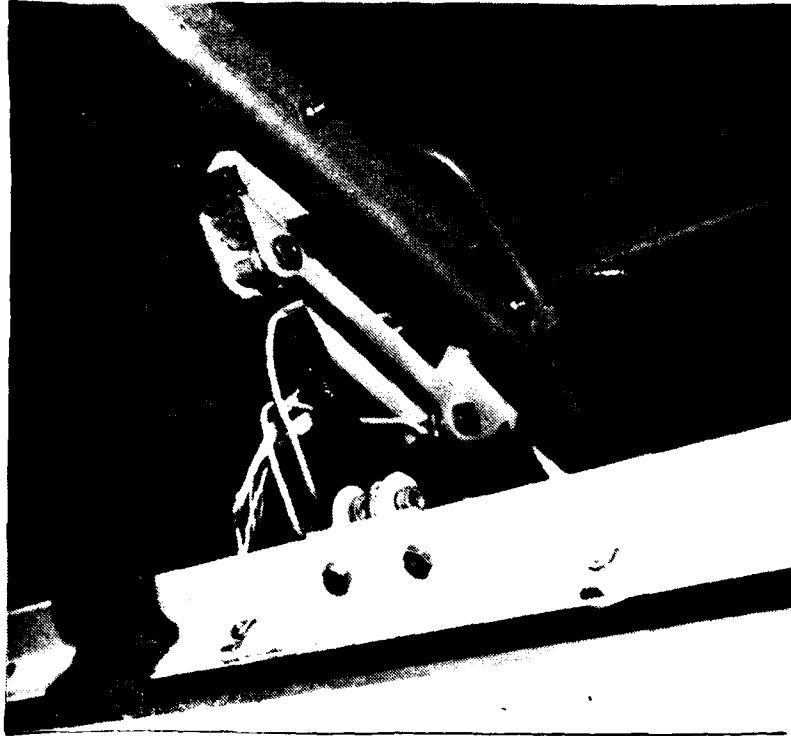
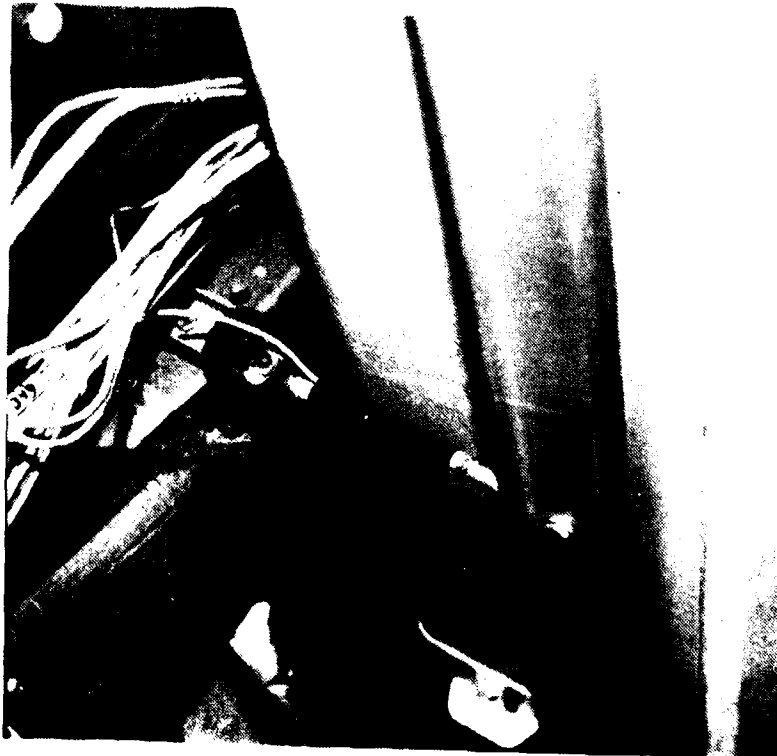
Similar to the galley modules, two enclosed type overhead stowage compartments were acquired from the same Boeing 720 located at Davis-Monthan AFB. The compartments and their structural hardware were installed in the test aircraft at locations corresponding to those of the original installation. This greatly facilitated the installation and allowed a realistic mounting scheme. The compartments were mounted on the right side of the aircraft just aft of the galleys (see figure 13). As shown in figures 14 through 16, the compartments were attached to the airframe by four sets of three support links and two drag links. One set of the support links was strain gaged to measure the forces in the supports during the crash. The strain gaged links are shown in figures 17 and 18.

FIGURE 17. STRAIN GAGES UPPER SUPPORT LINKS

FIGURE 18. STRAIN GAGE LOWER SUPPORT LINK

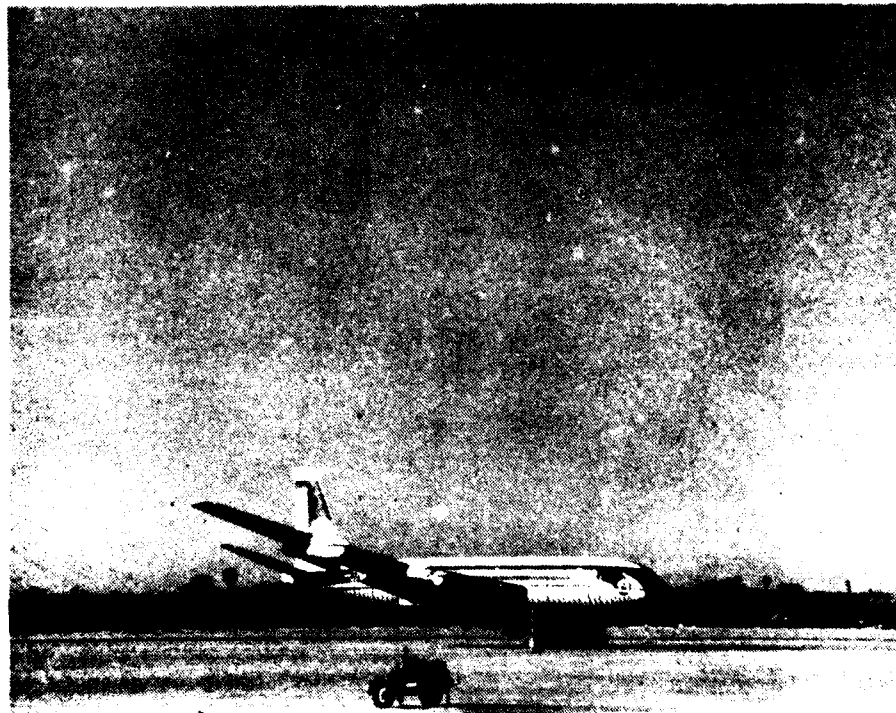
FIGURE 20. LEFT WING IMPACT

On final approach to the impact site, the aircraft had a speed of 152 knots, a sink rate of 17 ft/sec, and a 0 degree pitch attitude. Prior to impact, the aircraft experienced alignment problems which when corrected caused the left outboard engine to touch the ground first, 410 ft. short of the target as shown in figure 20. This initiated a left yawing motion of the aircraft. The forward portion of the fuselage (approximately B.S. 540) then touched down (figure 21) and the aircraft continued to yaw as it slid through the wing openers (figure 22). A fire erupted when a wing opener impacted the right inboard engine. The right wing, having been failed by the obstacles, separated, lifted upward as the aircraft continued to slide (figure 23), then plummeted to

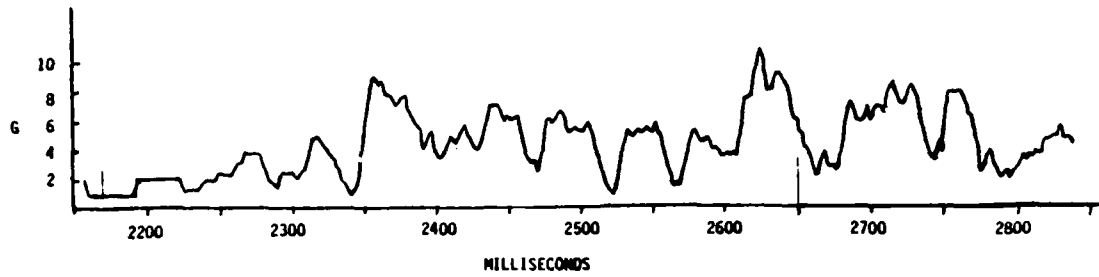
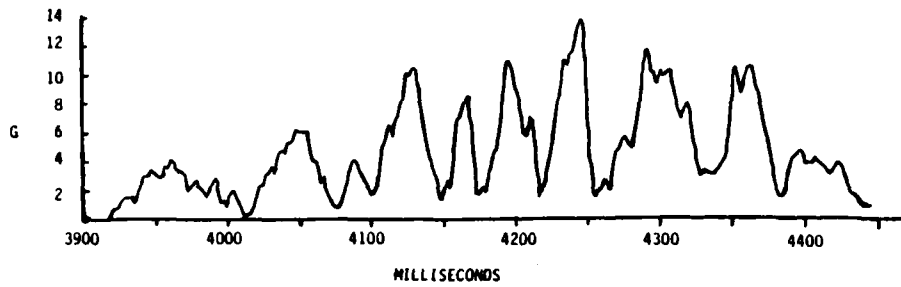
the 50 milliseconds range. Figures 45 and 46 identify the resultant compartment mass accelerations which were analytically derived from the individual accelerometer data. The maximum resultant G measured in the compartment was approximately 11.0 G during the ground impact stage, 10.5 at the implanted obstacle impact and 13.7 G during the slide out over the railroad bed rock.

FIGURE 45. RESULTANT ACCELERATIONS ON OVERHEAD COMPARTMENT

FIGURE 46. RESULTANT ACCELERATIONS ON OVERHEAD COMPARTMENT
