**NAVAL WEAPONS
STATION
CHARLESTON
FLEET MOORINGS
UNDERWATER
INSPECTION
REPORT**

JUNE 1985

**OCEAN ENGINEERING
AND CONSTRUCTION PROJECT OFFICE
CHESAPEAKE DIVISION
NAVAL FACILITIES ENGINEERING
COMMAND
WASHINGTON, D.C. 20374**

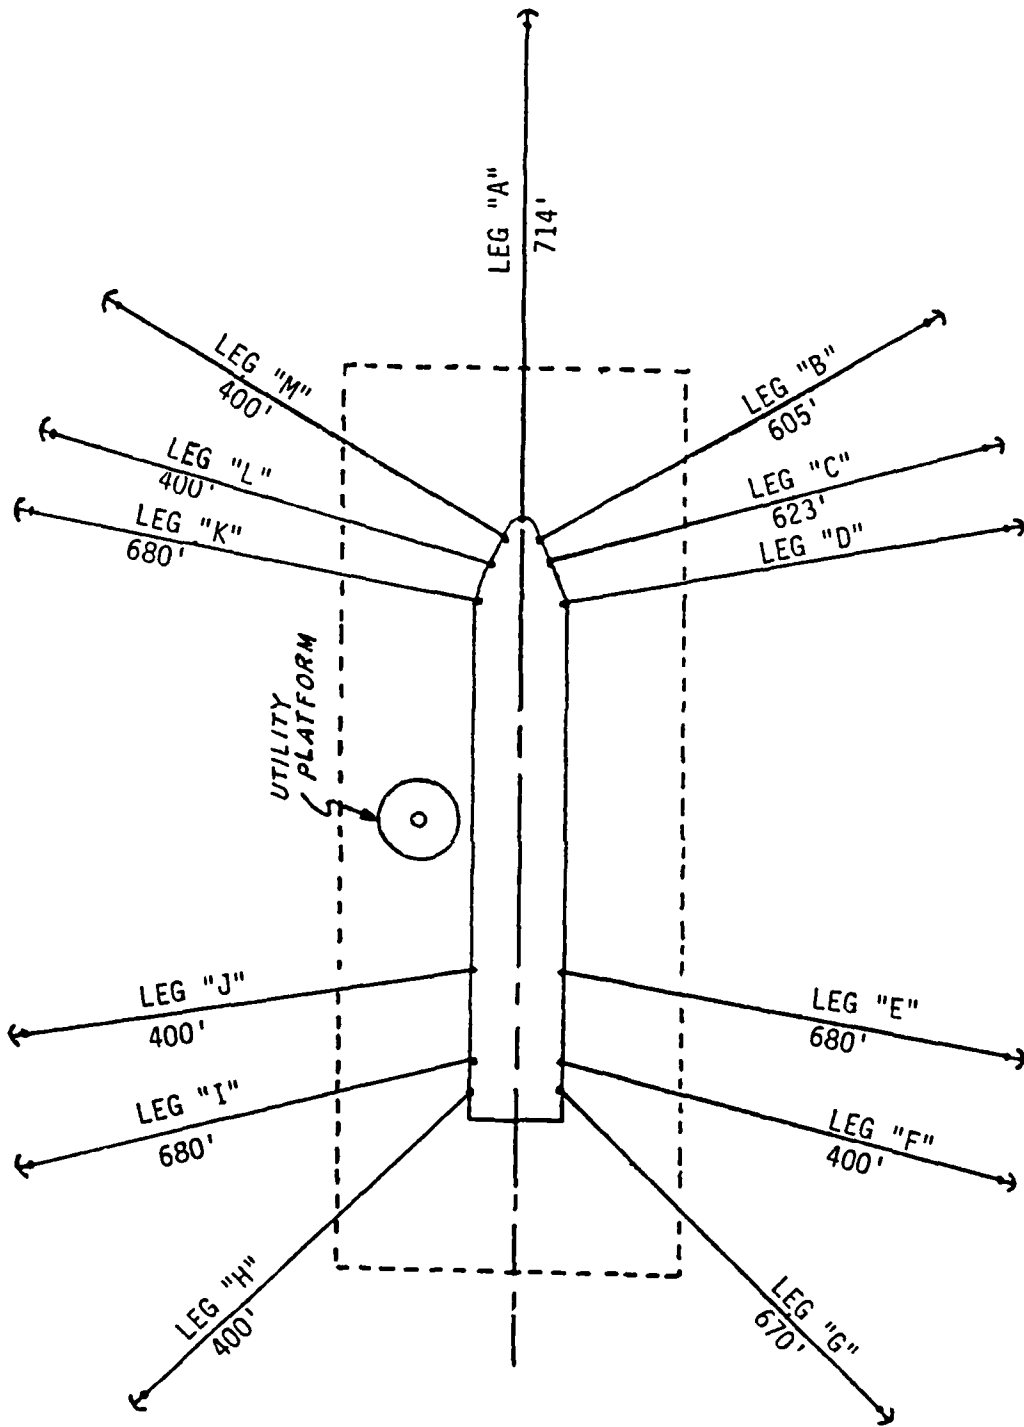
FIGURE 3. SCHEMATIC OF DESIGNED ARDM-2 MOORING
(Not To Scale)

- o Only 8 legs out of 13 were inspected due to repairs taking place on the ARDM.
- o Seven of the ARDM legs measure greater than 90 percent of original wire diameter. Leg C, however, was measured to be barely greater than 80 percent where it is attached to the hull of the ARDM. The remainder of the leg was measured to be greater than 90 percent of its original wire diameter.

- o The mooring is in satisfactory condition for continued fleet use.
- o The top two links in ground leg C should be removed during the next maintenance period.
- o In repositioning the ARDM after dredging, the chain catenaries should be checked to insure proper ARDM mooring position.
- o During this inspection, Leg C was found to have measurements near 80 percent. During the last inspection, Legs J and K (which were not inspected this time) were found to have measurements between 80 and 90 percent. Therefore, it is recommended that all three of these legs be changed out during the next scheduled maintenance period.

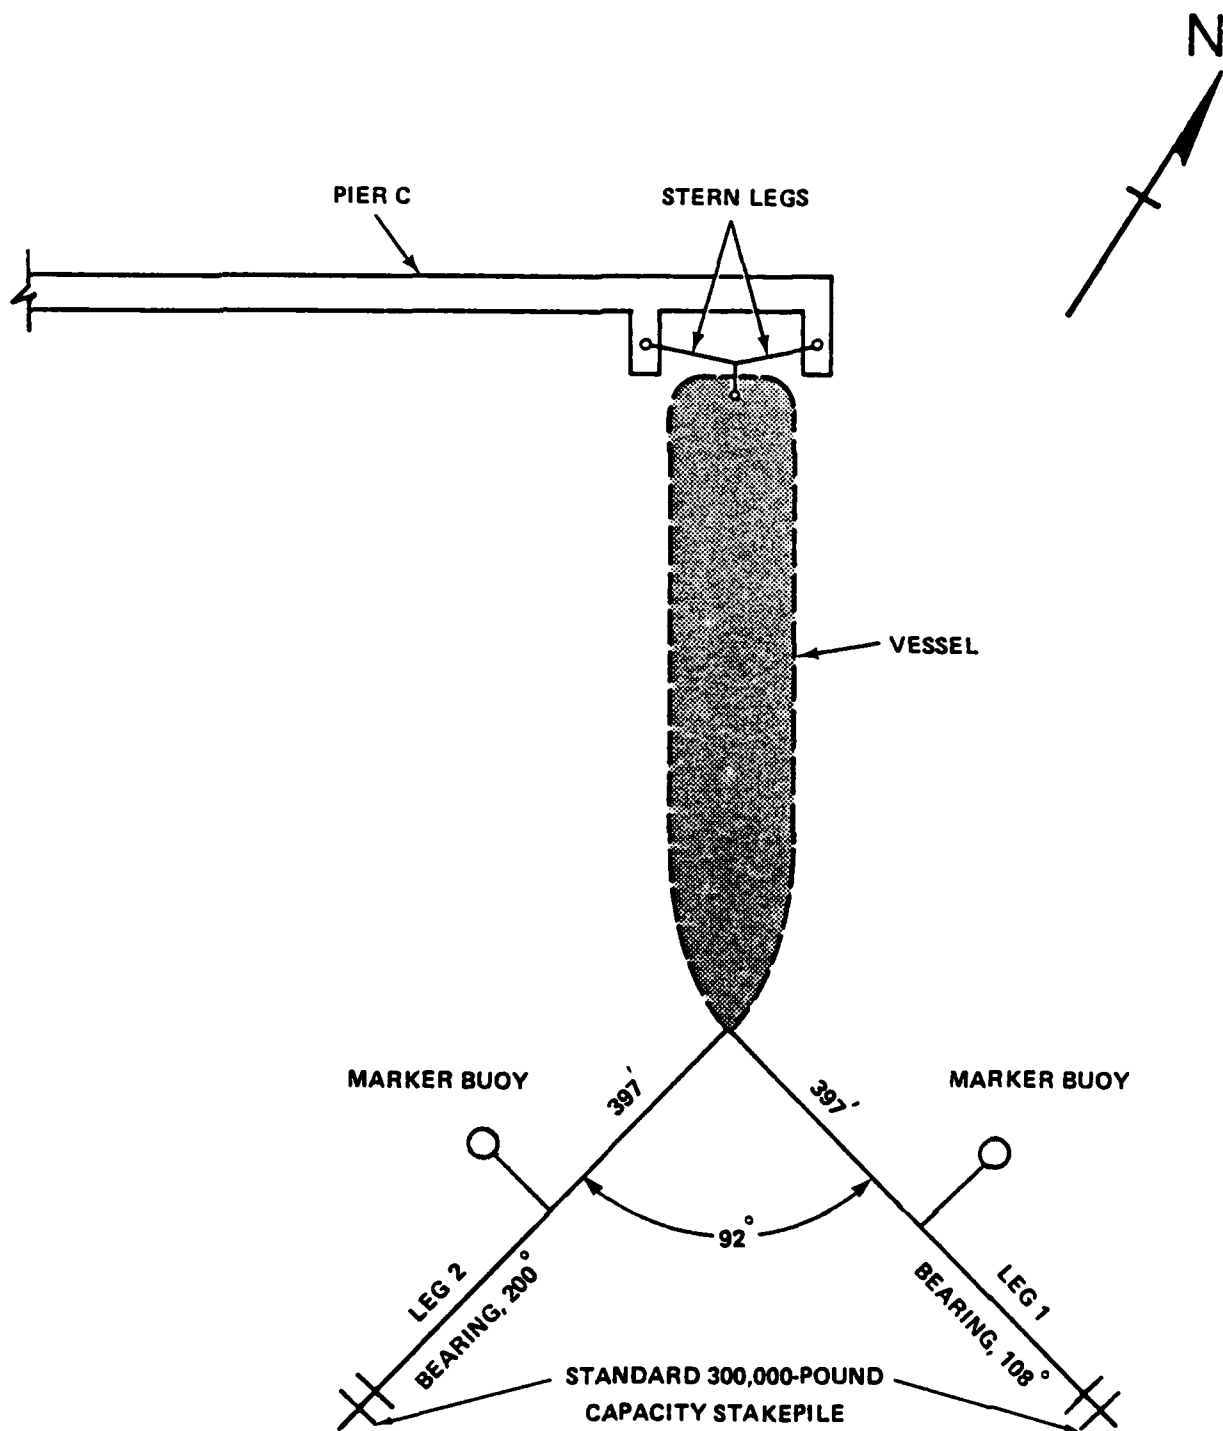
Figure A-1. Design Schematic of WPNSTA Charleston's Mediterranean Mooring.

- o Visible sections of the bow and stern legs are in good condition
- o The two bow legs are heavily pitted and rusted near the waterline, and each is covered with a relatively thick marine growth.

The divers reached the cast iron sinkers of the port leg and found the chain on the bottom not under tension. The stakepiles of each leg were buried. Inclinator readings were recorded on each leg as shown below:

- o The bow legs, stern legs, and marker buoys are in satisfactory condition for continued use.
- o The stern legs should be placed on the pier when not in use.

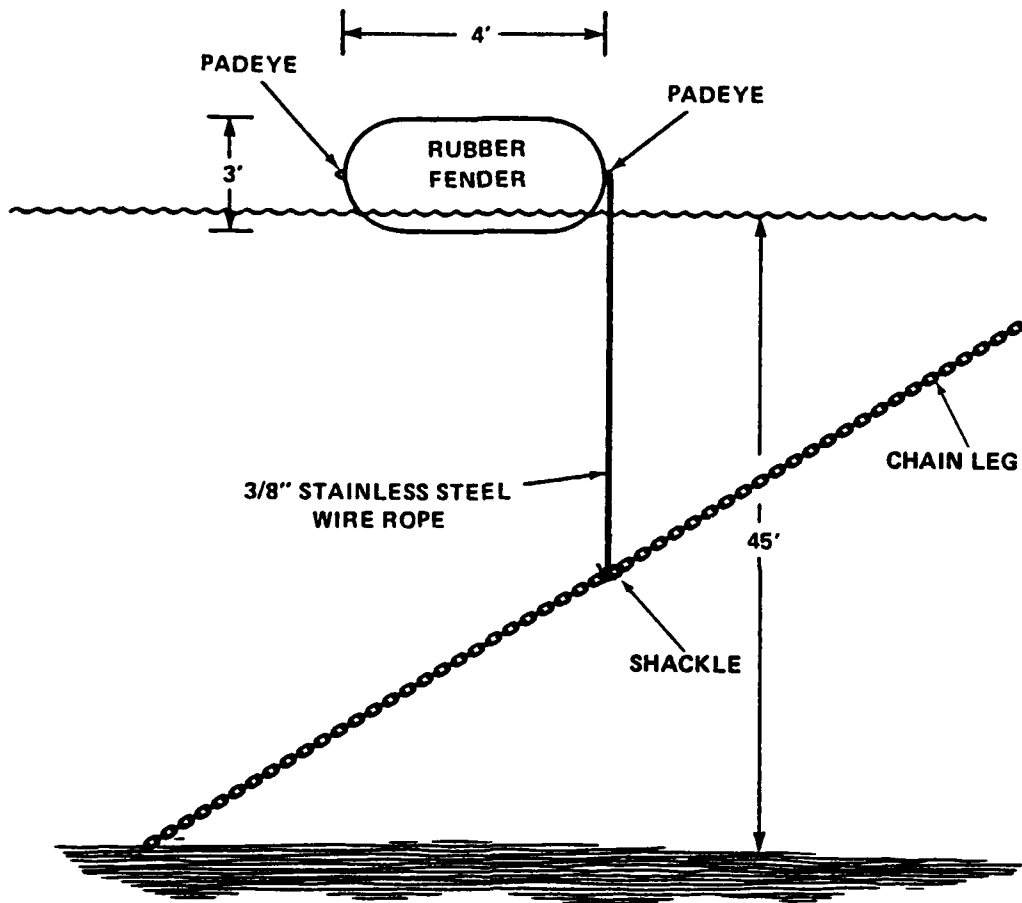
Figure A-3 Mediterranean Mooring Bow Leg Marker Buoy

Currently, large rubber fenders (normally used for protection of yard craft) are being used in place of buoys. One is located about halfway between each stakepile and the tender. (See Figure 2.) They are used as retriever buoys and navigation aids during tender mooring operations. Each marker buoy is attached by 3/8-inch steel wire rope to a shackle which is connected to the mooring chain (see Figure A-3). The fenders are in place and in good condition with moderate to light marine growth.

- o The visible portions of the bow legs and the stern legs are in good condition.
- o The retriever buoys are in good condition.
- o When the tender is away from the mooring, the stern legs are dropped in the water. To reduce corrosion, it is recommended that the stern legs be placed on the pier when not in use.

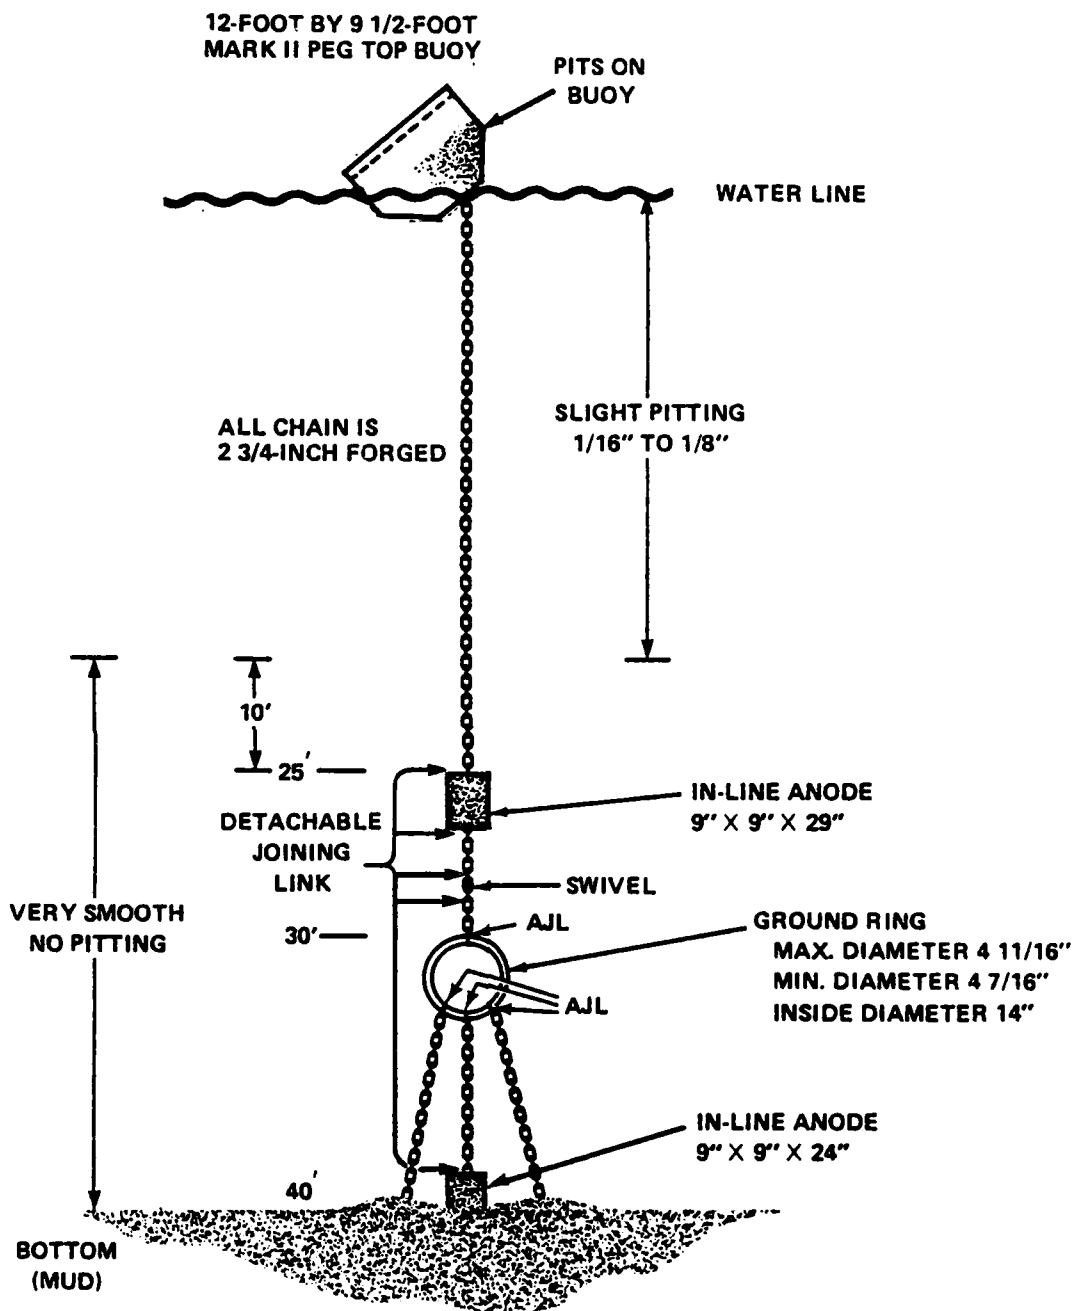
Figure A-4 Auxiliary Mooring

- o This mooring's buoy is in poor condition.
- o The buoy has a 54° list that could be caused by loss of water tight integrity. It is badly pitted and rusted.
- o The riser chain and ground legs are in good condition.
- o Voltmeter readings showed that the cathodic protection system is working properly.

This Mark II Peg Top Buoy with hawse pipe measures 12 feet in diameter by 9 1/2 feet high. The buoy has a 54° list which could be caused by failure of its watertight integrity. It has two wooden fenders which are covered with thin steel strips and a 1/4-inch thick steel plate covering the topside. The wooden fenders are splintering and the upper and lower steel plates are badly rusted, loose, and layers of rust are flaking off at the waterline. In addition, the buoy has 1/8-inch deep pitting in its bottom, and the top has a heavy coating of guano. In general, this buoy is in very poor condition and should be removed from the water before it sinks.

- o The buoy should be removed from the water before it sinks. The cause of its list should be determined and the buoy overhauled or replaced. The remainder of the mooring is in good condition.

- o The buoy should be removed and the cause of its list determined and repaired.
- o All voltmeter readings are within accepted values.
