# UNDERWATER FACILITIES INSPECTIONS & ASSESSMENTS

NAVAL AIR STATION,  
NORTH ISLAND  
SAN DIEGO, CALIFORNIA

FPO-1-84(19)

OCTOBER 1984

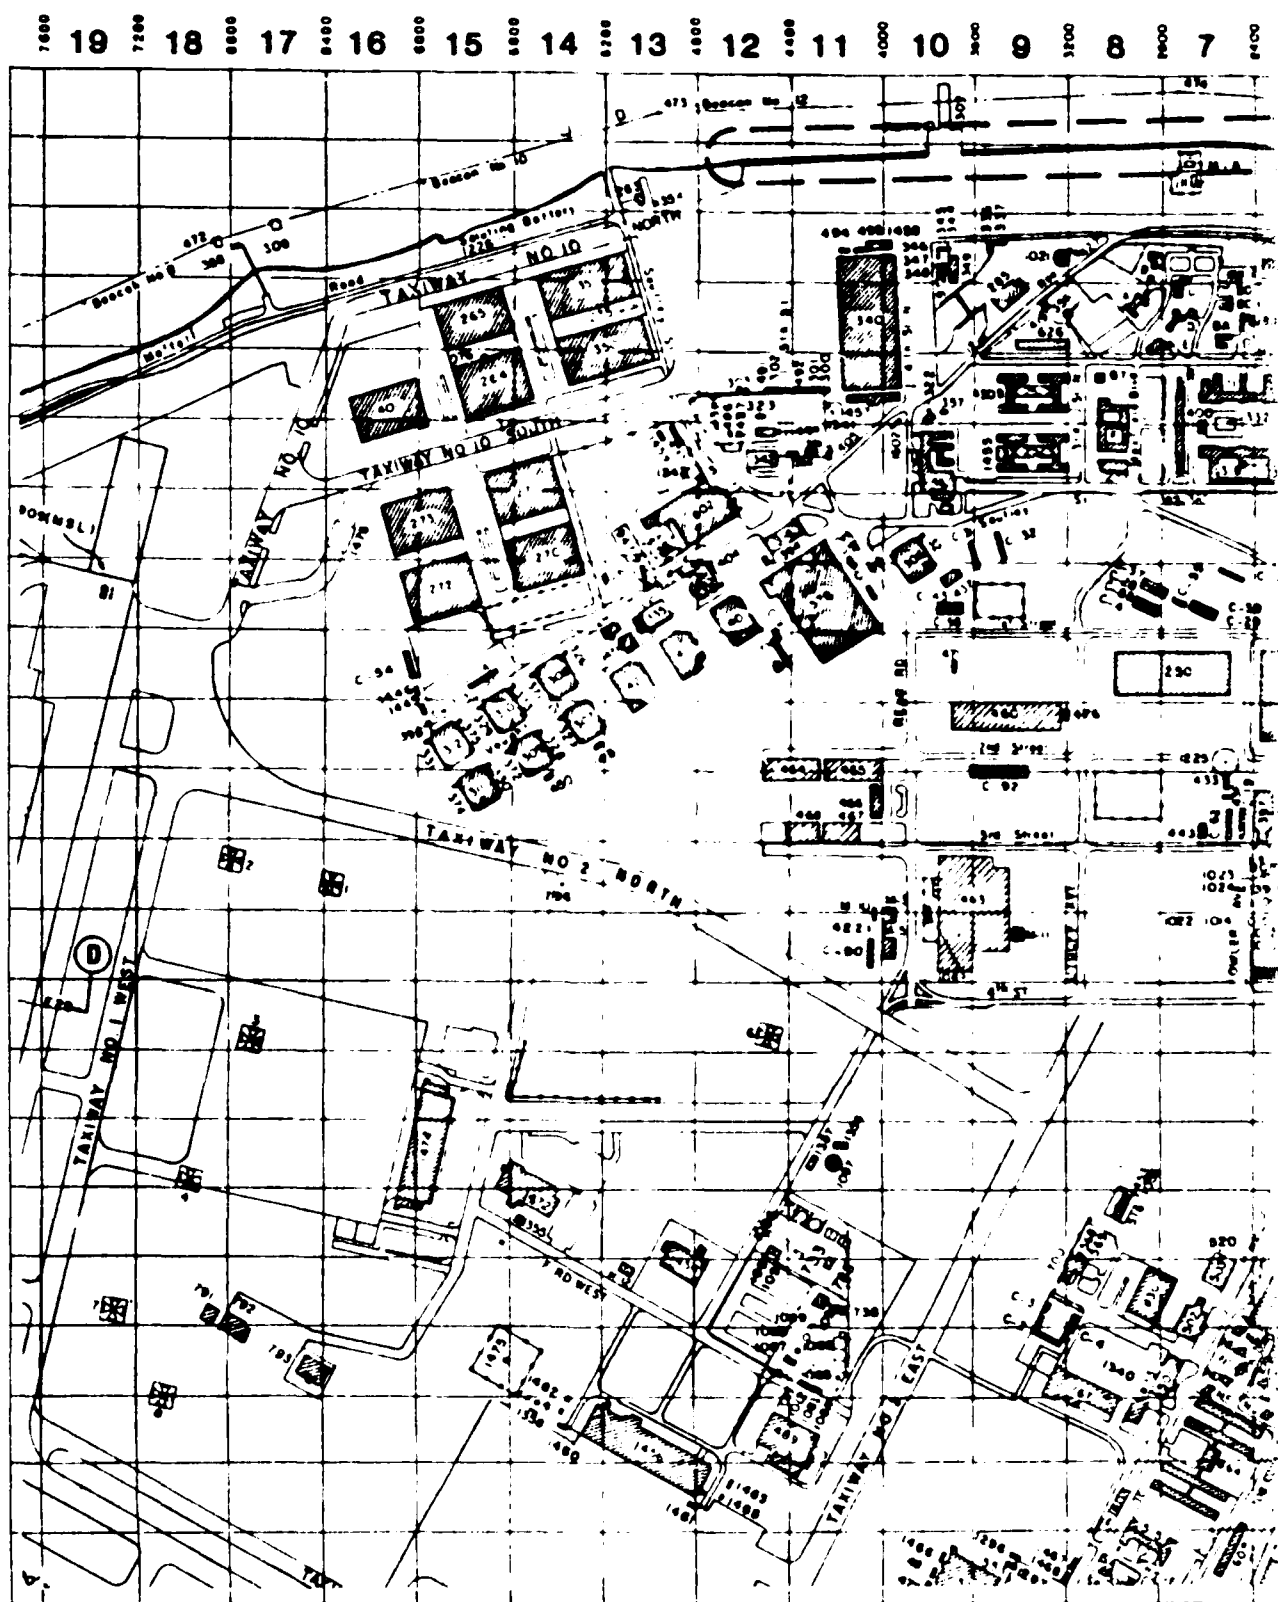
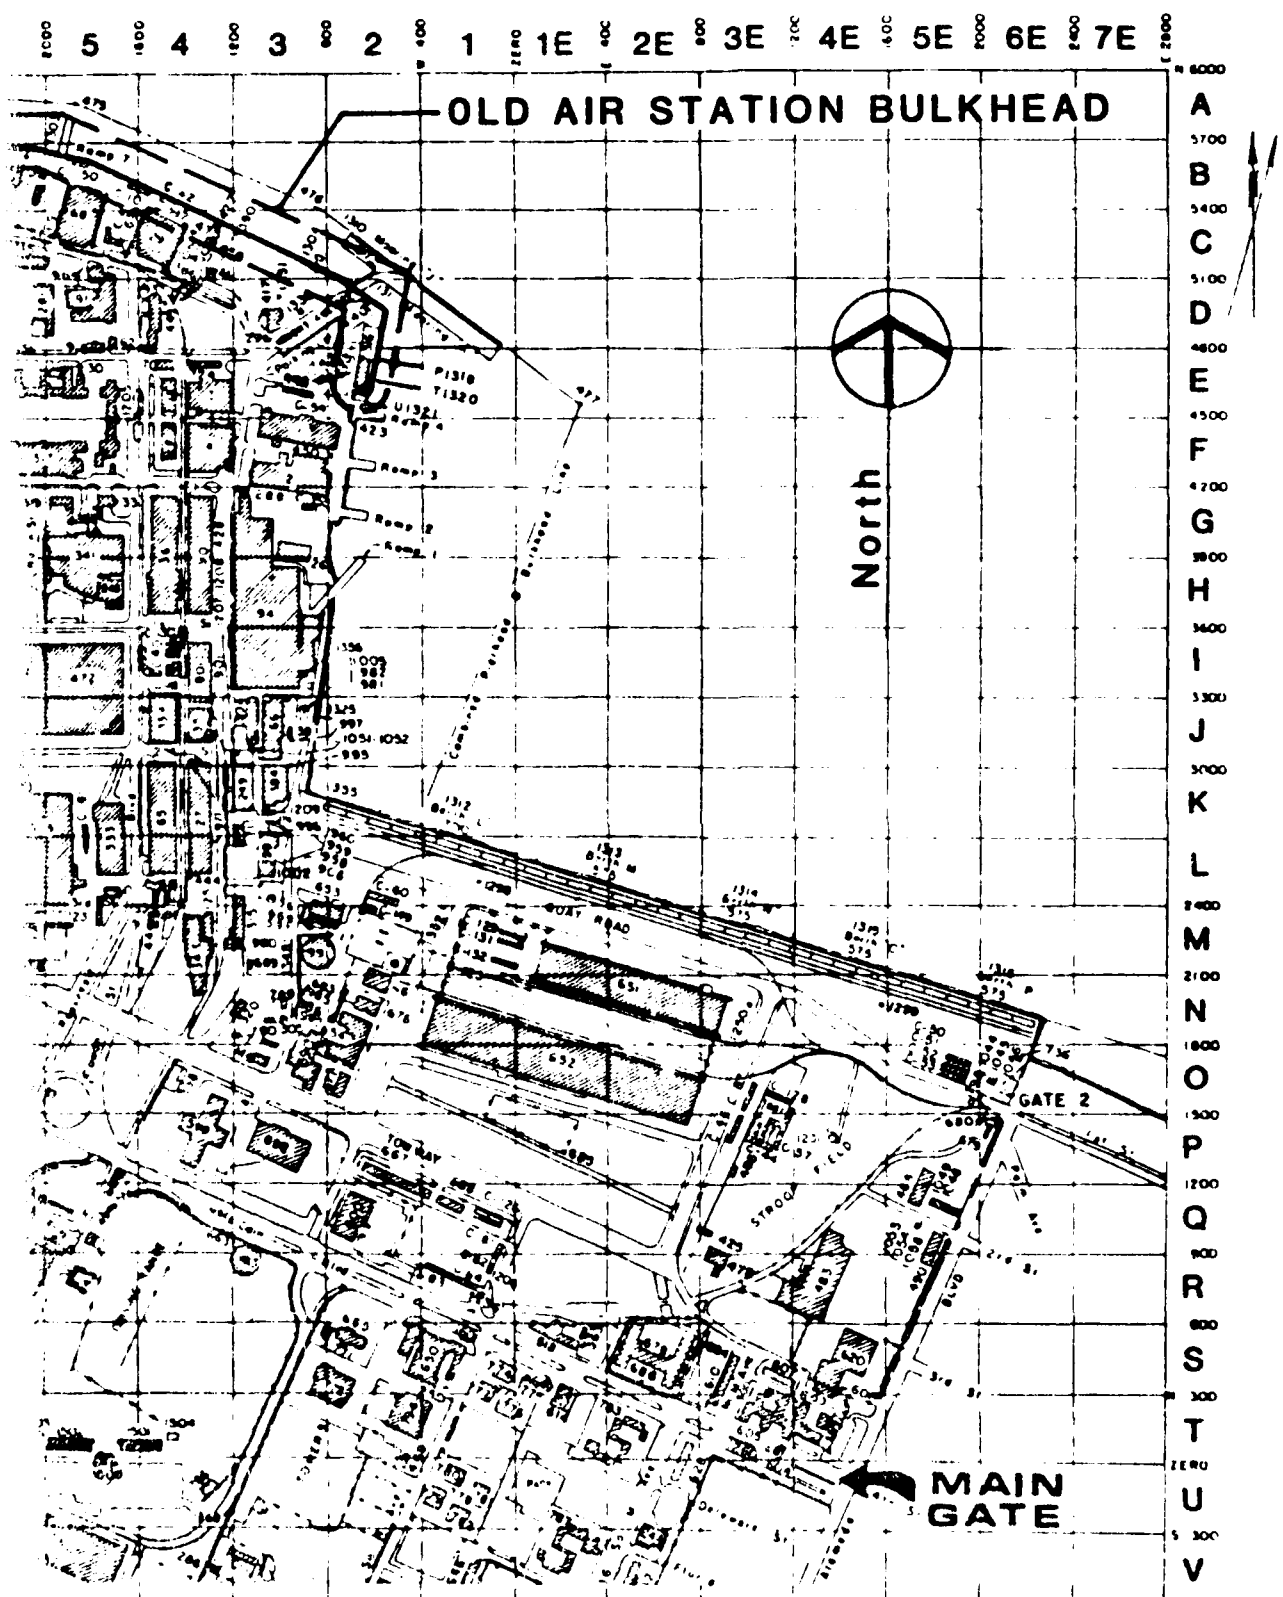
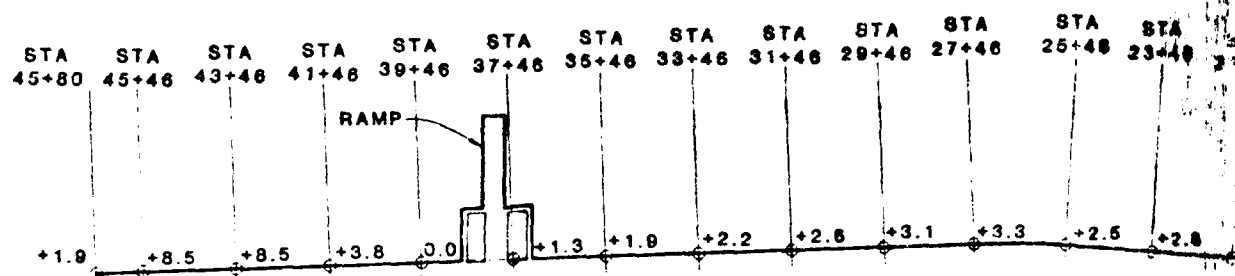
FIG. 3

It is recommended that the wall be strengthened or replaced if surcharges in excess of 200 pounds per square foot are planned in areas adjacent to the wall.

At various locations the tied wall has sustained leakage of backfill into the bay. The surface evidence of this leakage are surface cavities which have occurred immediately to the rear of the wall. These cavities represent a hazard to traffic both by foot and vehicle. It is recommended that their filling be a regular maintenance function, and the wall inspected again in five years.

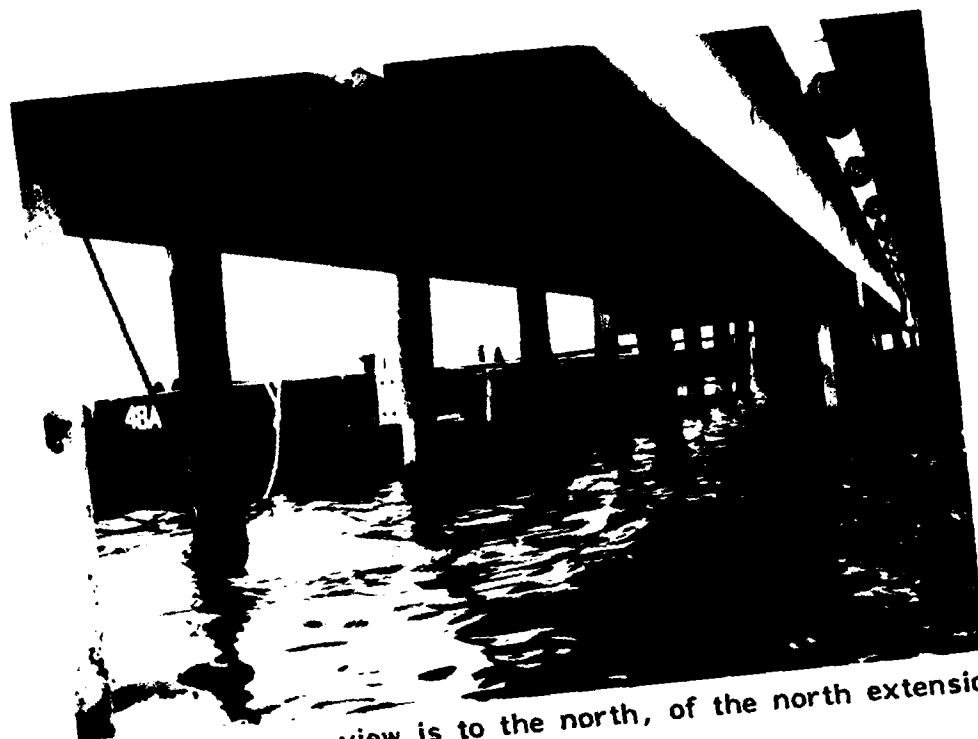
33 Pier Bravo, view is to the north, of the north extension of the pier.

Pier Bravo is in excellent condition. The only recommendation is that the piles be inspected again in six years.
