UNDERWATER FACILITIES INSPECTIONS AND ASSESSMENTS AT

PHILADELPHIA NAVAL SHIPYARD

VOLUME I FILE COPY

FPO-1-83-(48) OCTOBER 1983

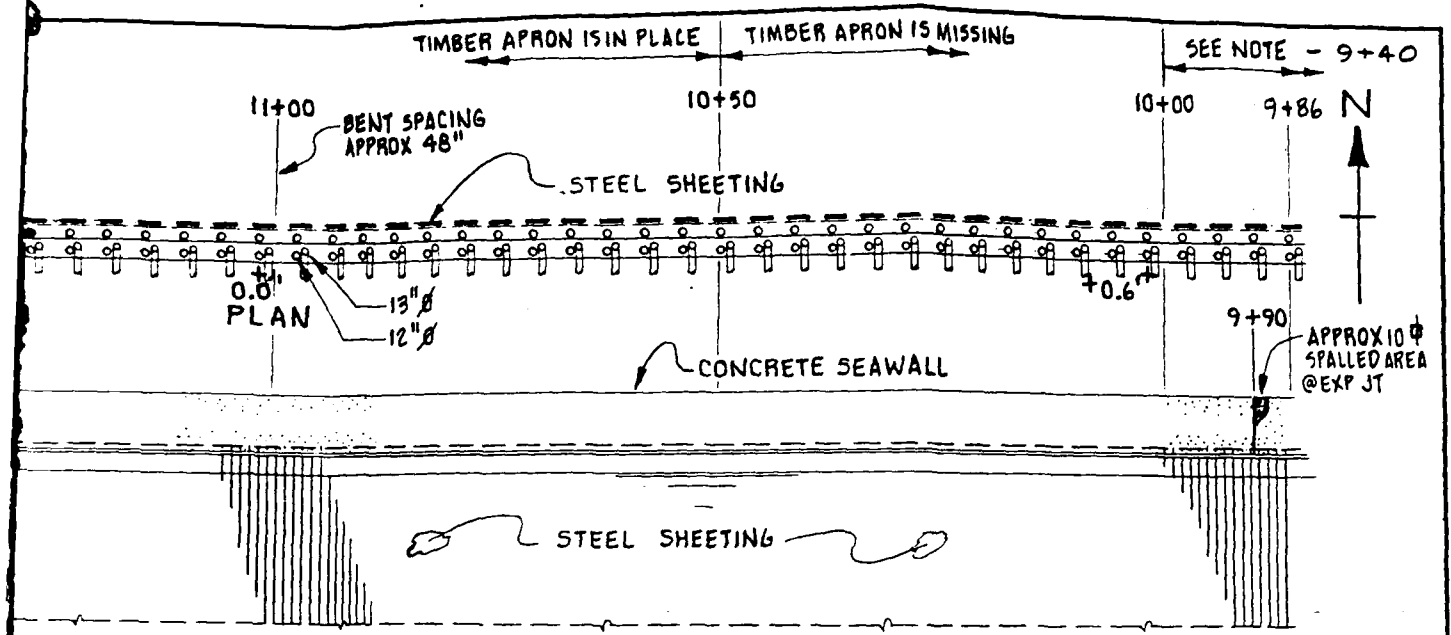
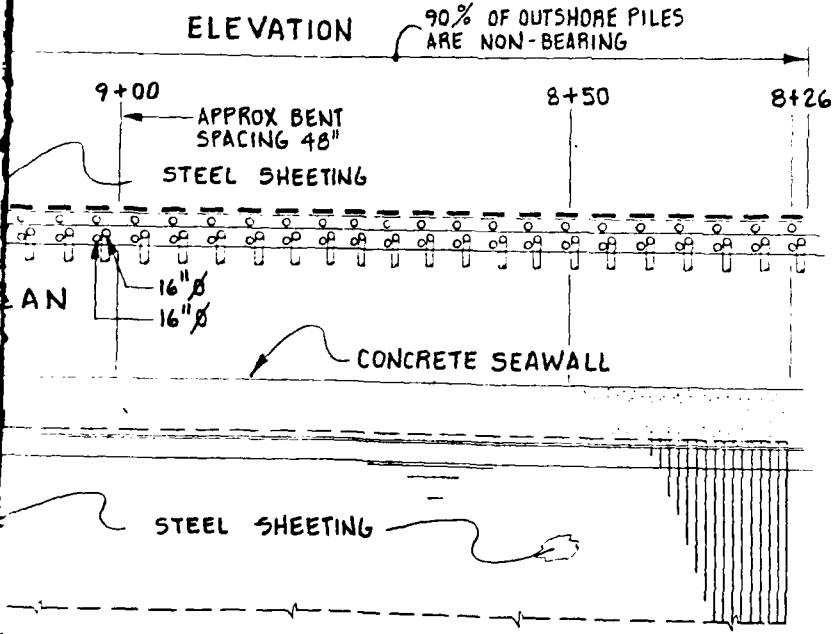
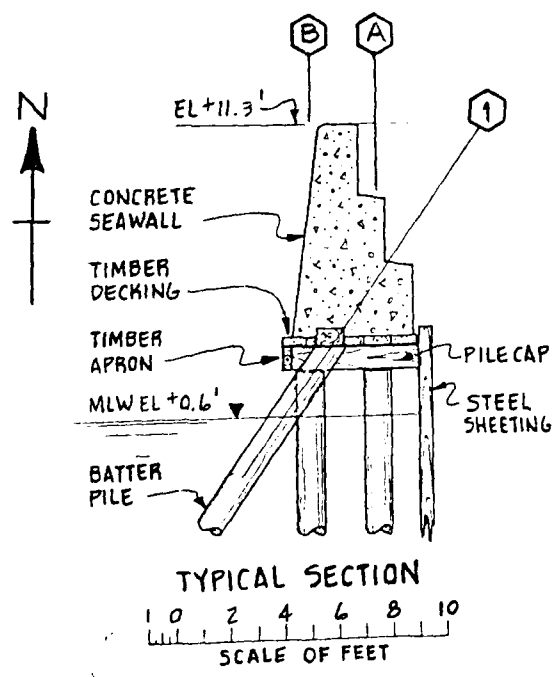
GRAPHIC SCALE	CHILDS ENGINEERING CORPORATION 828 322 MEDFIELD, MA	CHESAPEAKE DIVISION NAVAL FACILITIES ENGINEERING COMMAND WASHINGTON, D.C.	
		PHILADELPHIA NAVAL SHIPYARD PHILADELPHIA, PA	FIG. NO. 11
AS SHOWN		EASTERN SEAWALL

From Station 8+00 through Station 48+00 there are a considerable number of non-bearing perimeter piles (see Photo #15). Percentages range from 50% of all the piles being non-bearing to 10% of

the piles being non-bearing (see Figures 11 through 15 for locations).

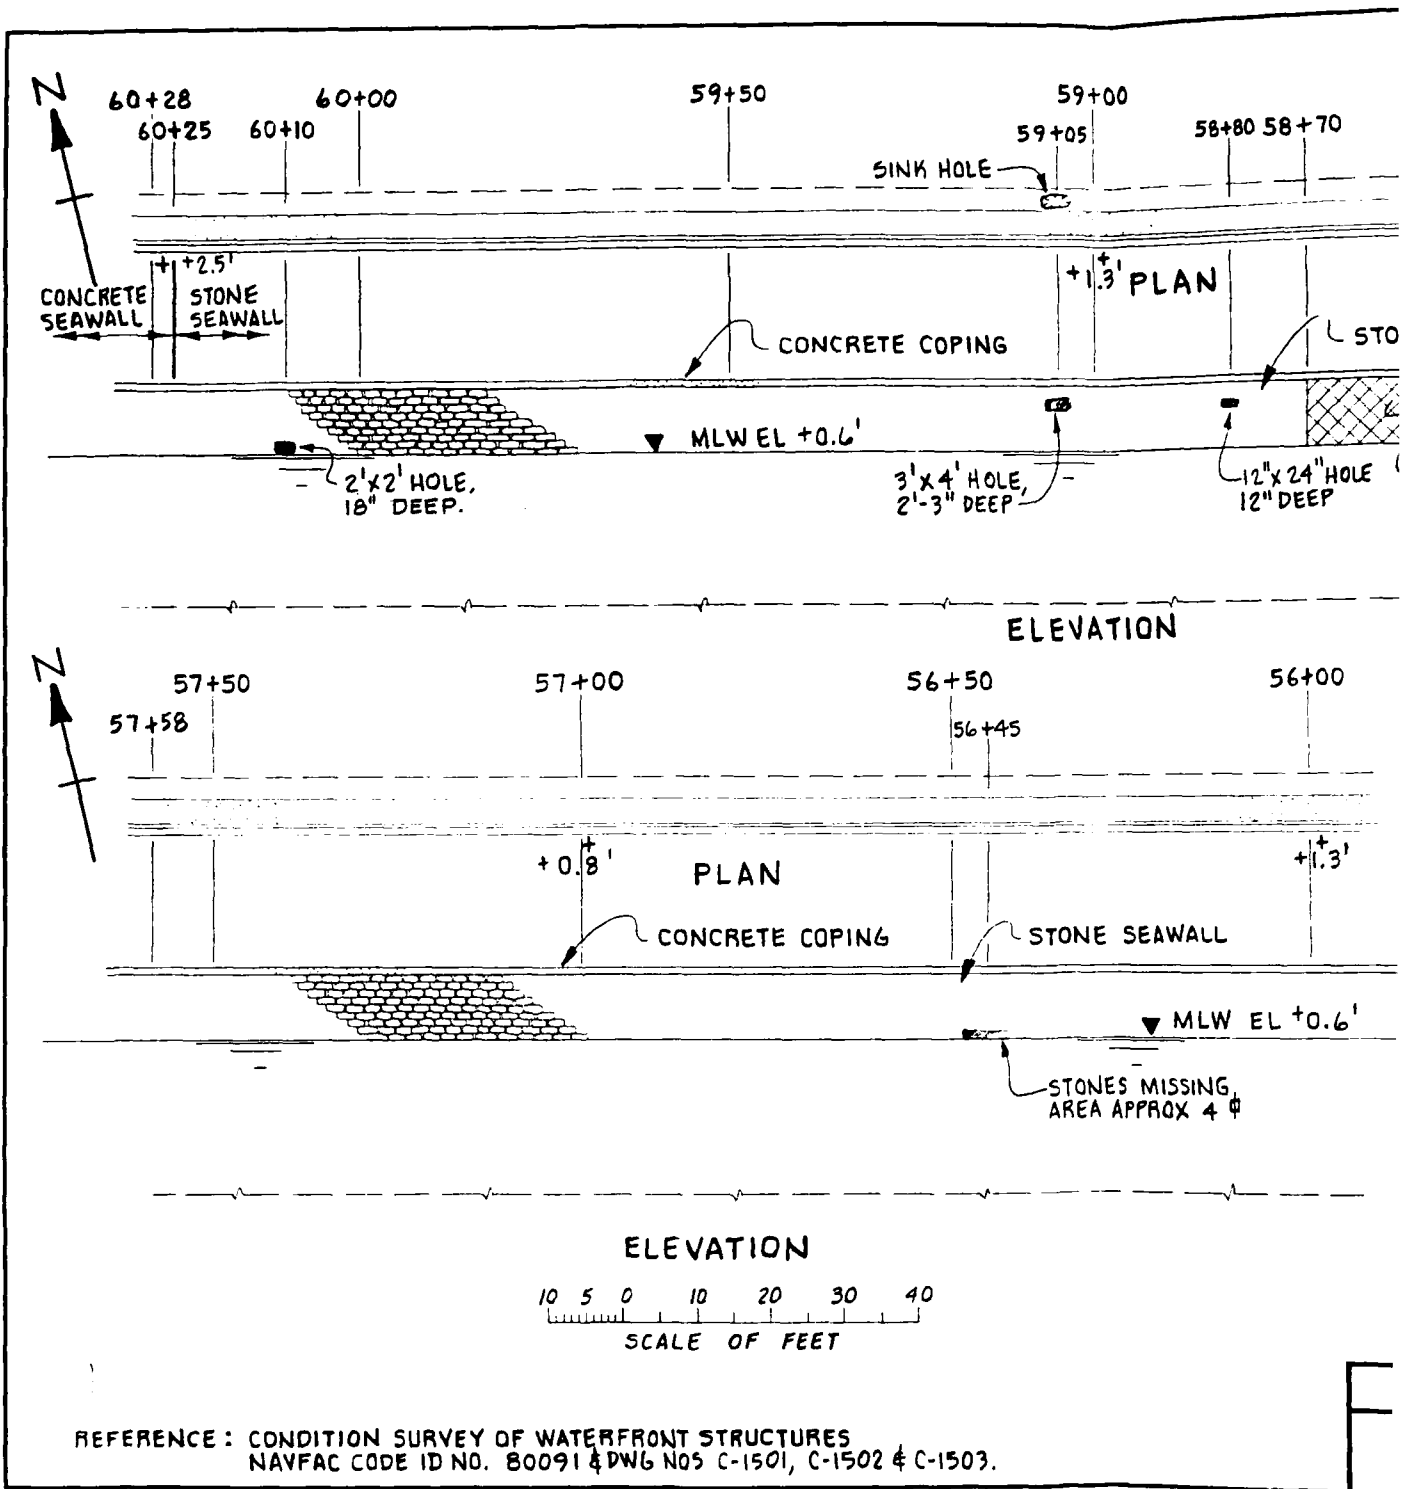
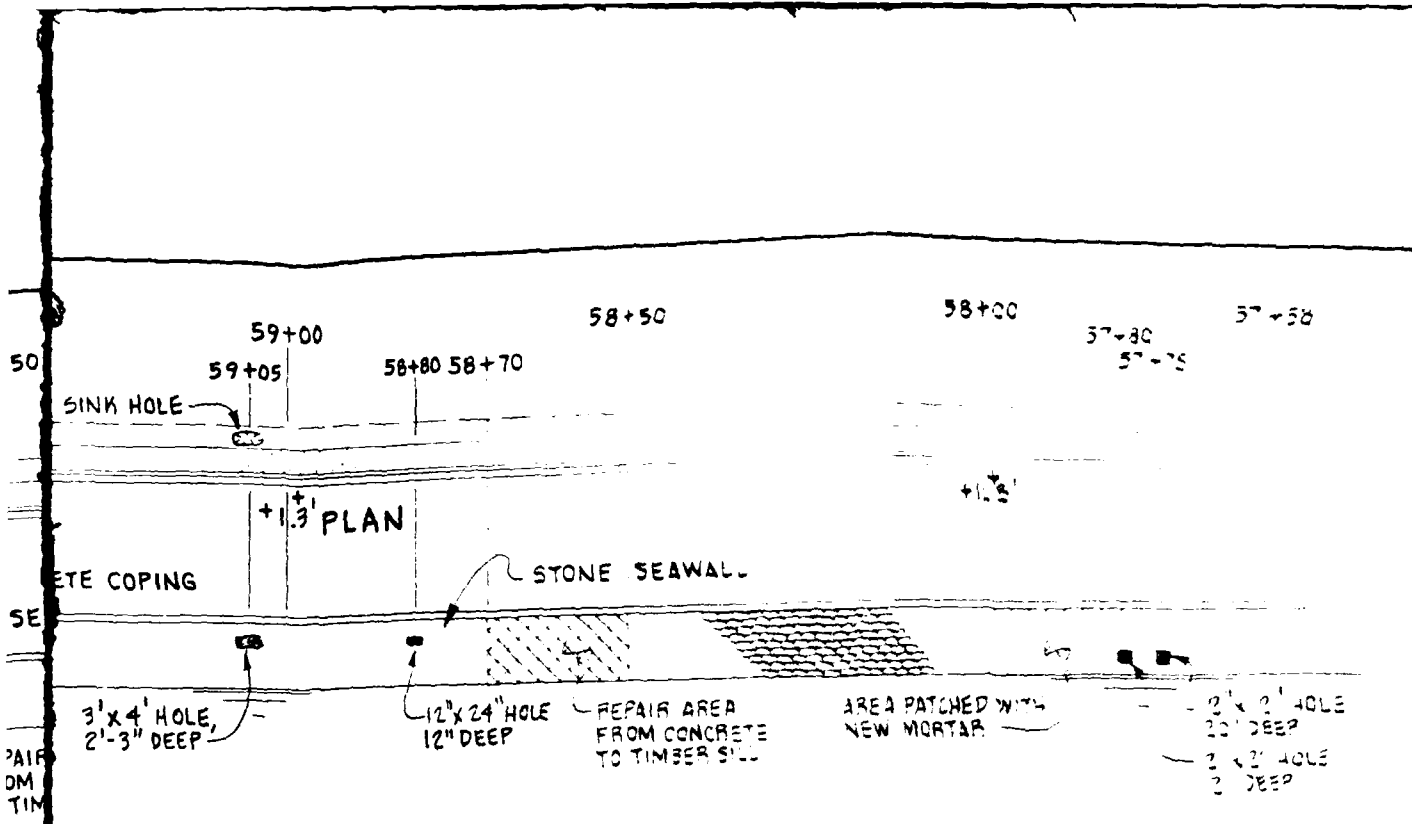
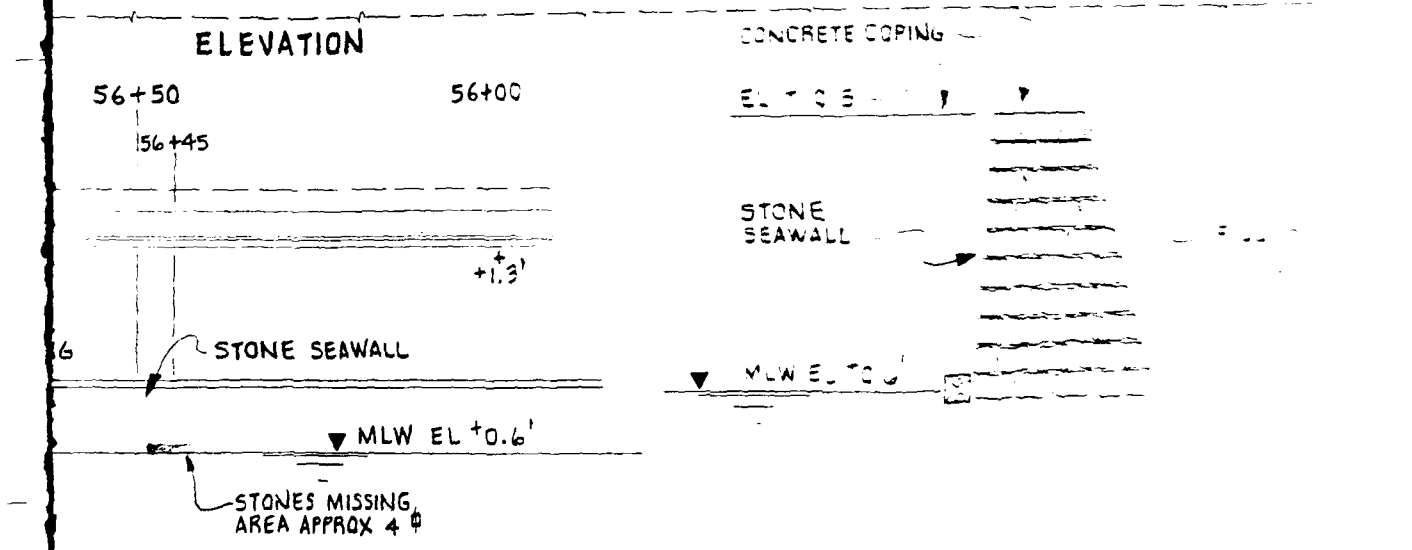
GRAPHIC SCALE	CHILD ENGINEERING CORPORATION 304 333 WPROF. B. MA	CHESAPEAKE DIVISION NAVAL FACILITIES ENGINEERING COMMAND WASHINGTON, D.C.	
		PHILADELPHIA NAVAL SHIPYARD PHILADELPHIA, PA	22
AS SHOWN		EASTERN SEAWALL

Along the stone seawall between Station 52+35 to Station 60+25, there is no mortar remaining between the stones. Also there are areas along the wall (see Figure 22) where stones are missing leaving voids or holes ranging from 6" in depth to 3' in depth. Previously patched areas along the wall are beginning to deteriorate at the lower elevations.

The previously described condition of the stone seawall (Stations 52+35 to 60+25) is caused by the frequent wetting/drying and freeze/thaw along with the wave and chemical action (sulfate attack) that occurs in the tidal zone.

The stone seawall between Station 52+35 and Station 60+25 should be pointed and the loose and missing stones should be replaced. The estimated cost per linear foot of seawall is \$40.00. The total estimated cost is approximately \$32,000.

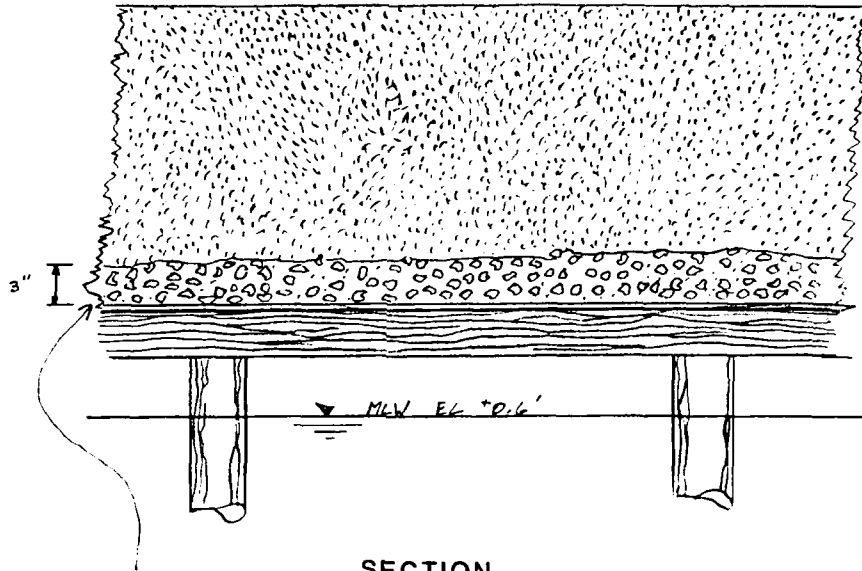
There is no functional fender system along the full length of the seawall. The concrete seawall showed only minor spalling generally limited to the MLW elevation. This spalling is exemplified by the loss of the fine aggregates and cement while leaving the larger aggregates in place (see Figure 25 and Photo #13). There is some vertical cracking in the seawall at various locations.

CONCRETE FINES ERODED AWAY
AGGREGATE EXPOSED

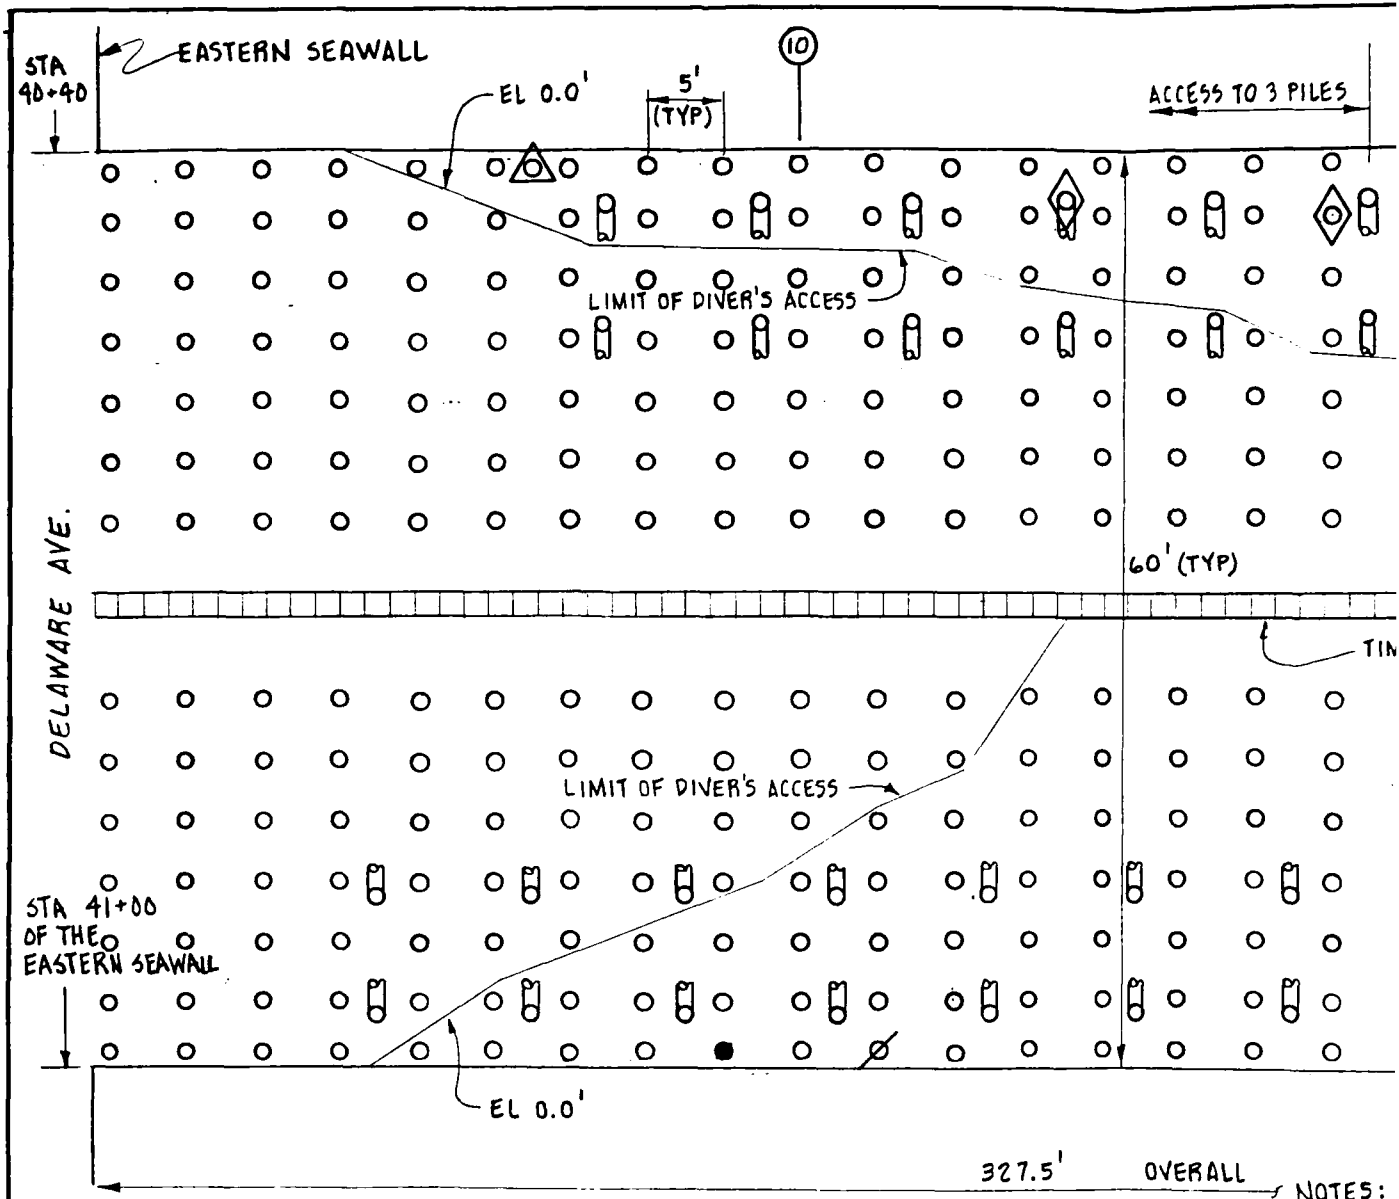
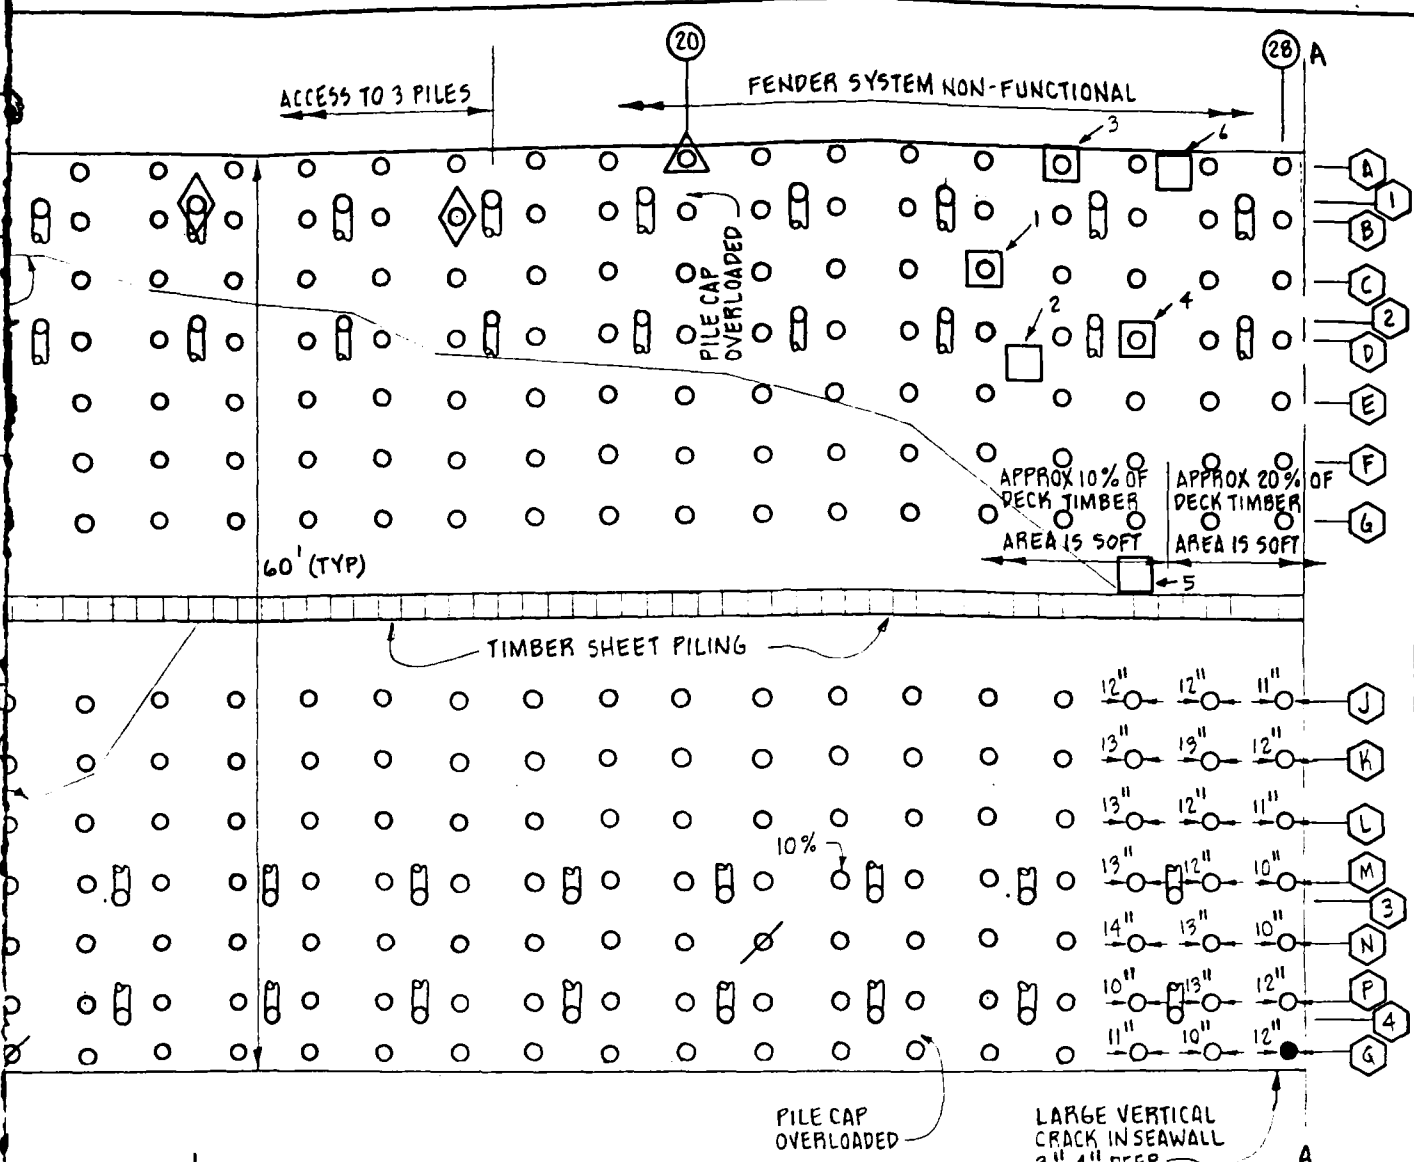
CHESAPEAKE DIVISION NAVAL FACILITIES ENGINEERING COMMAND WASHINGTON D C	
PHILADELPHIA NAVAL SHIPYARD PHILADELPHIA, PA	FIG. NO.
PIER 7	26

These anomalies as well as other conditions can be found on Figures 26 thru 28, (see Photos #17 and 18). The structural piles have suffered no apparent loss of cross-sectional area, although softness was generally found to be approximately 1" in depth. Minimum pile diameters range from 10" to 14".

The pile caps and deck timber were found to have soft spots where divers could probe with a knife into the wood approximately 2"-6", generally the depth of this softness is 2". There are three specific areas at the south end of Pier 7 (see Figure 28) where deck timbers have failed and earth fill has leached out of the structure. This, in turn, causes the concrete upper deck to be unsupported and therefore very weak. At Bent 44 over Pile N the pile cap has failed (see Photo #19) due to overloading.

Pier 7 is in need of major repairs. At the present time we recommend no live-loading be imposed. Depending upon the intended use of the structure, there are many options. Option A would be to return the structure to full live-loading capacity, (600 psf). We would recommend replacement of the pile-supported relieving platform with a steel sheet pile, solid fill bulkhead. The following is a list of the estimated costs associated with various options:

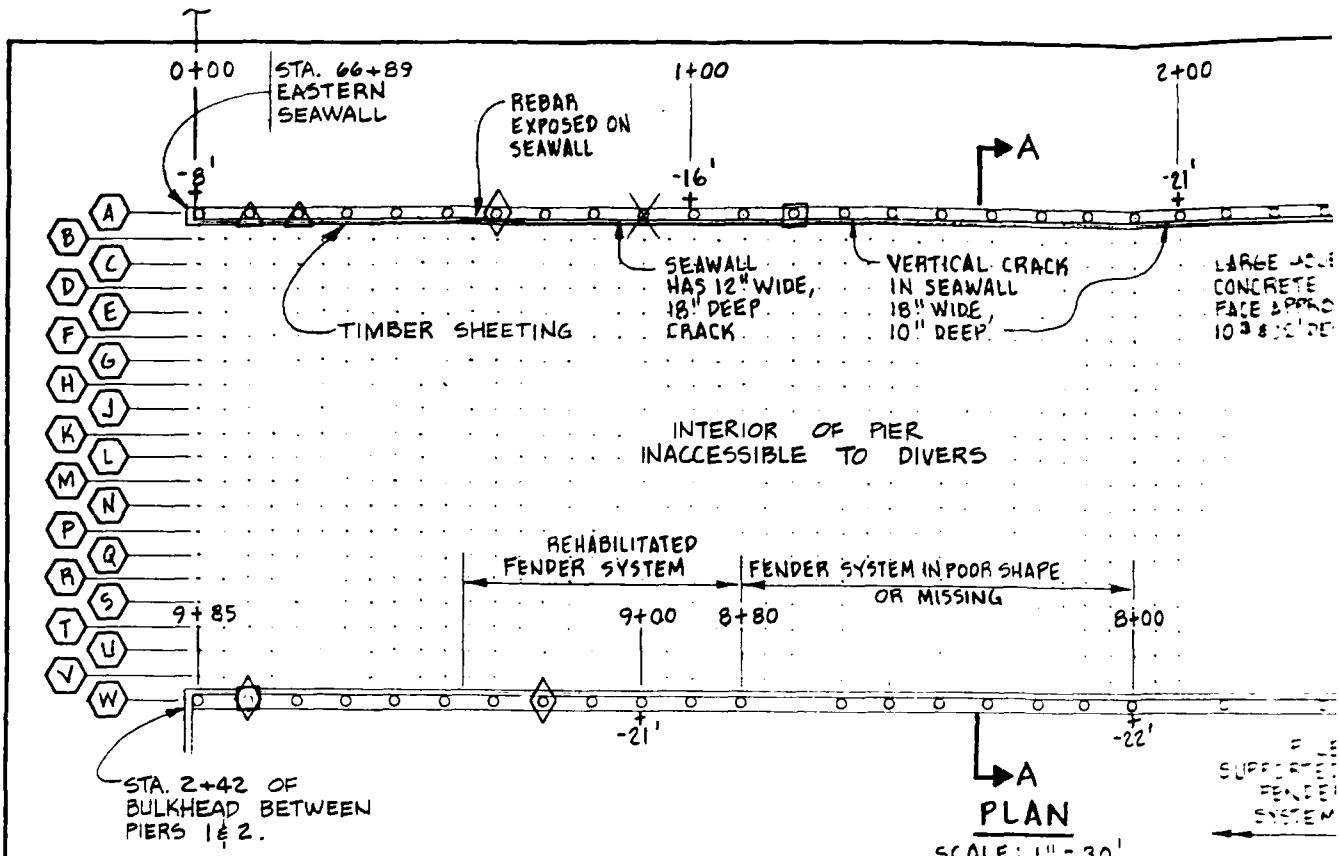
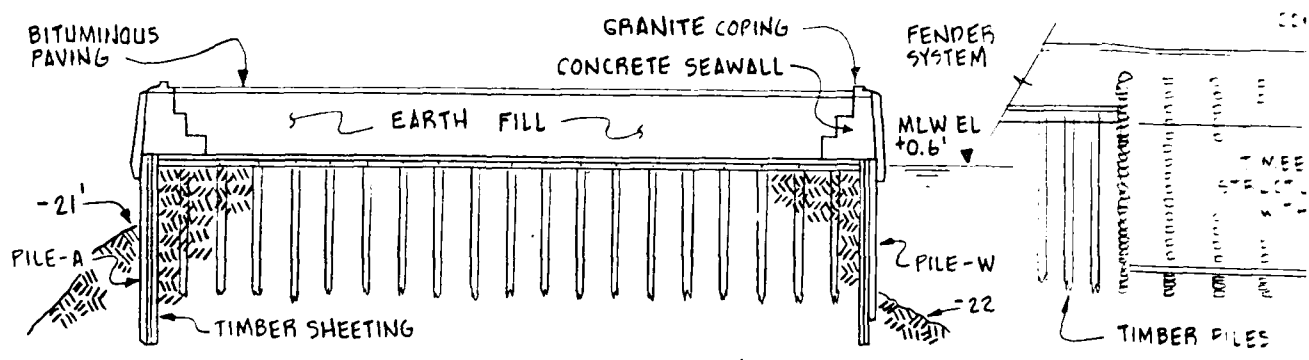
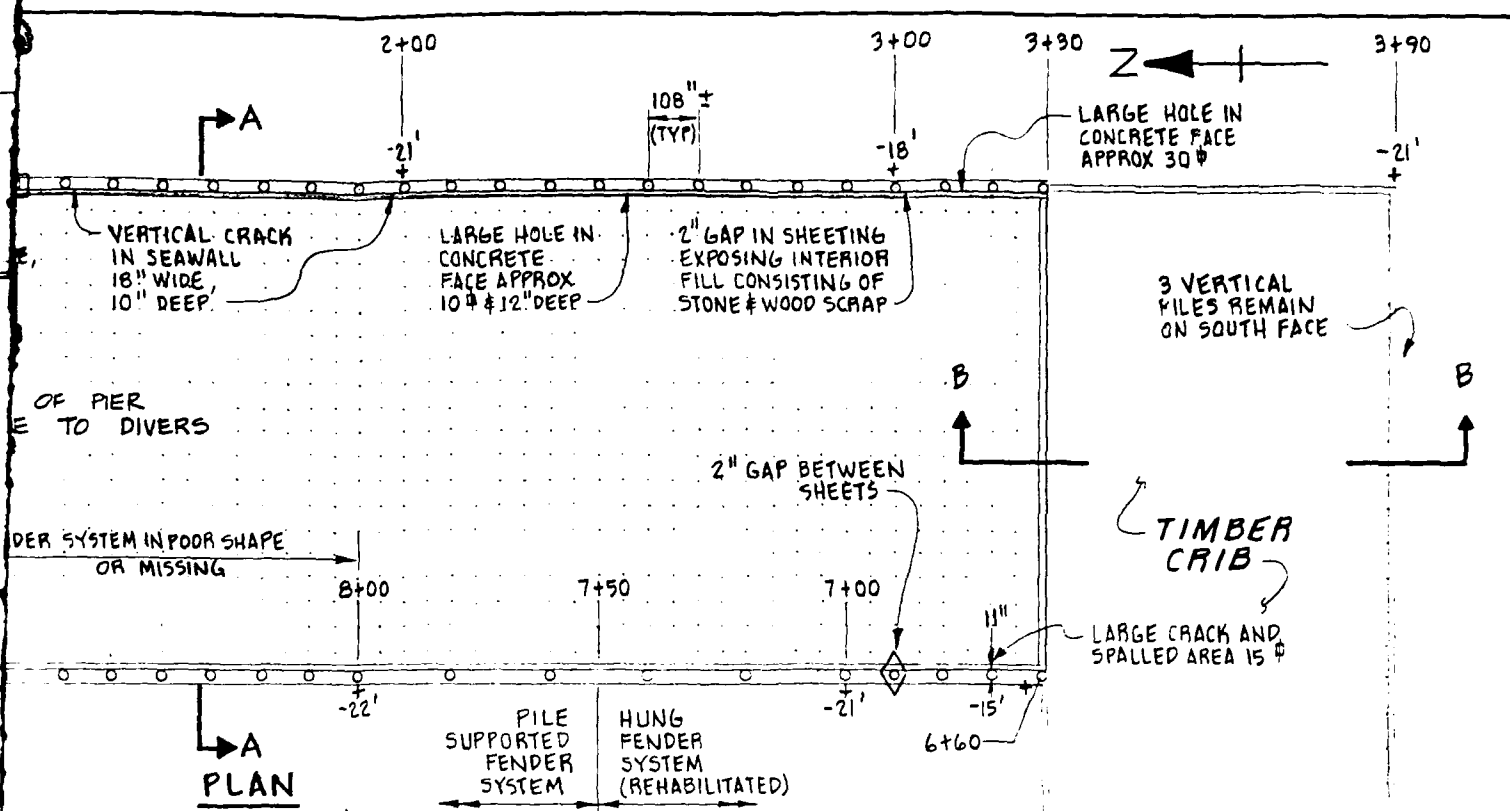
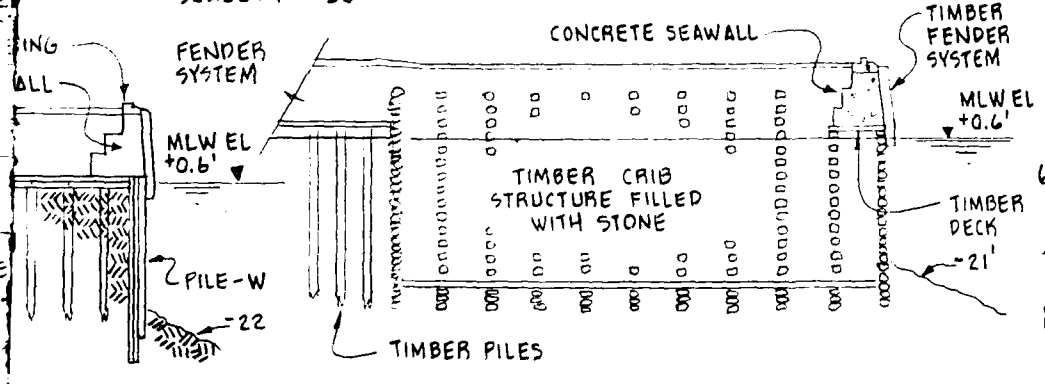
CHESAPEAKE DIVISION NAVAL FACILITIES ENGINEERING COMMAND WASHINGTON, D.C.	
PHILADELPHIA NAVAL SHIPYARD PHILADELPHIA, PA	FIG. NO.
PIER 1	29

The fender system is in poor condition over 80% of the structure. On the west side of the pier there is a rehabilitated section as shown on Figure 29. The general condition of the timber on Pier 1 and the bulkhead between Pier 1 and Pier 2 is excellent.

Locations of these anomalies can be found on Figures 29 and 30. The exact bent and pile spacing could not be verified due to non-accessibility caused by timber sheeting.

We recommend that all mechanically damaged piles be repaired. The estimated cost would be: 7 piles refastened to the pile clamps at \$400.00 per pile, total cost of \$2,800.00.

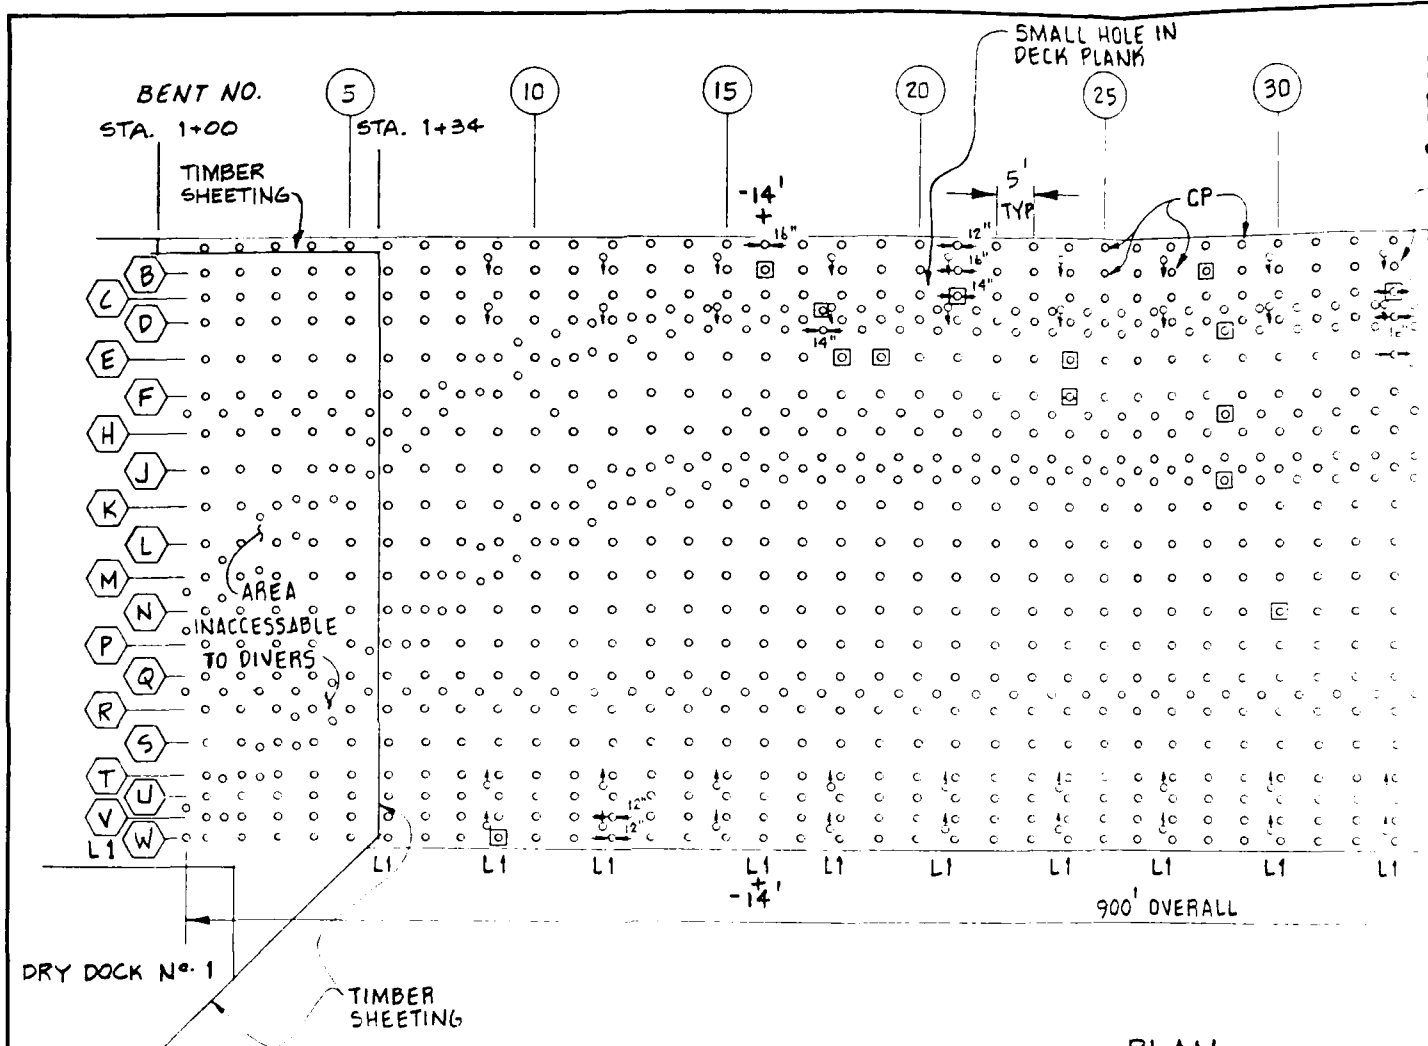
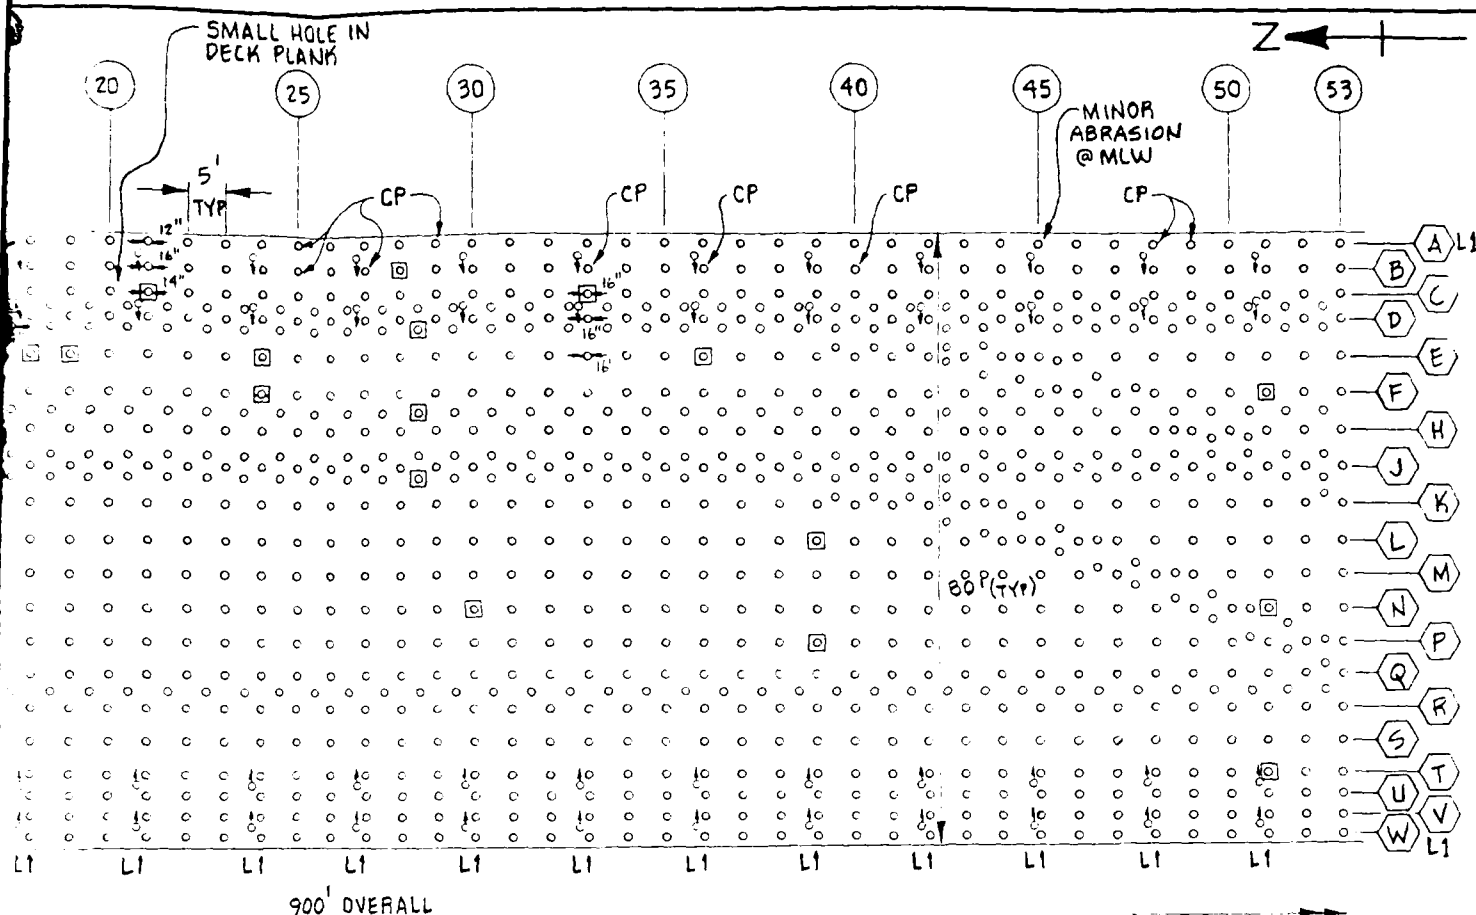
GRAPHIC SCALE	CHILDS ENGINEERING CORPORATION BOX 333 MEDFIELD, MA	CHESAPEAKE DIVISION NAVAL FACILITIES ENGINEERING COMMAND WASHINGTON, D.C.	
AS SHOWN		PHILADELPHIA NAVAL SHIPYARD PHILADELPHIA, PA	FIG NO PIER 2 31

Locations of these anomalies along with other abnormalities have been noted on Figures 31 through 33. Also there are approximately 83 piles which have been previously refastened to the pile cap with a clamp arrangement (see Photo #21). At the southern end of Pier 2 there is a high concentration of non-bearing batter piles as shown on Figure 33.

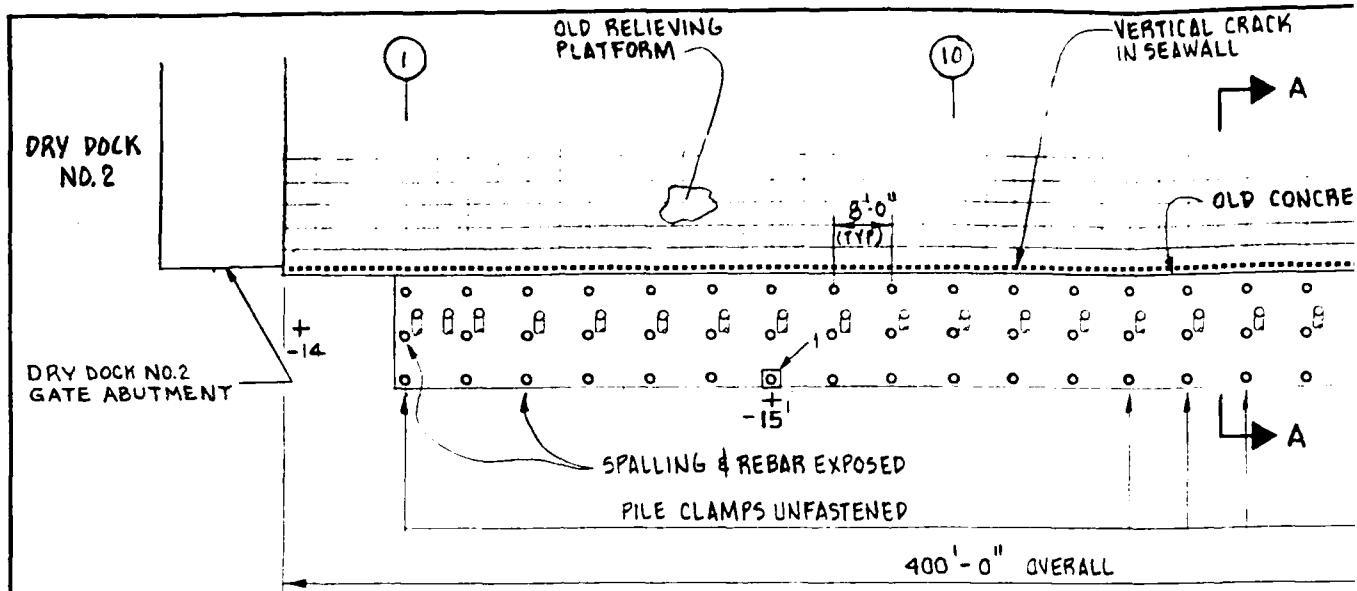
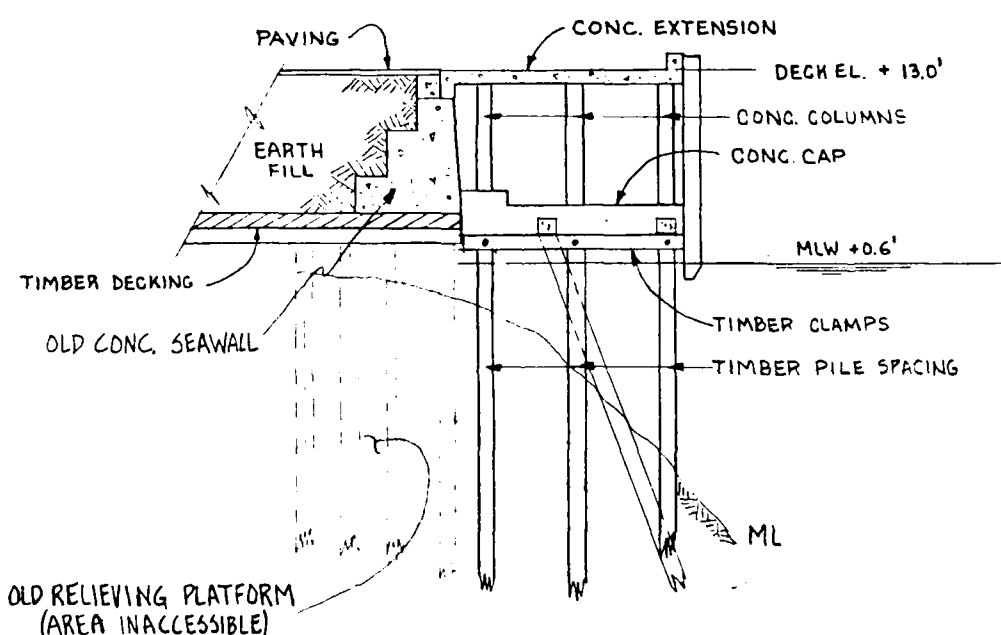
CHESAPEAKE DIVISION NAVAL FACILITIES ENGINEERING COMMAND WASHINGTON, D.C.	
PHILADELPHIA NAVAL SHIPYARD PHILADELPHIA, PA	FIG. NO.
WHARF 4A	35

The timber clamps (non-structural) used to align the pile bents are becoming unfastened and falling away from the piles (see Figures 35 and 36 and Photo #24). Otherwise the fasteners connecting the batter piles to the longitudinal beam are in excellent condition (see Photo #25).

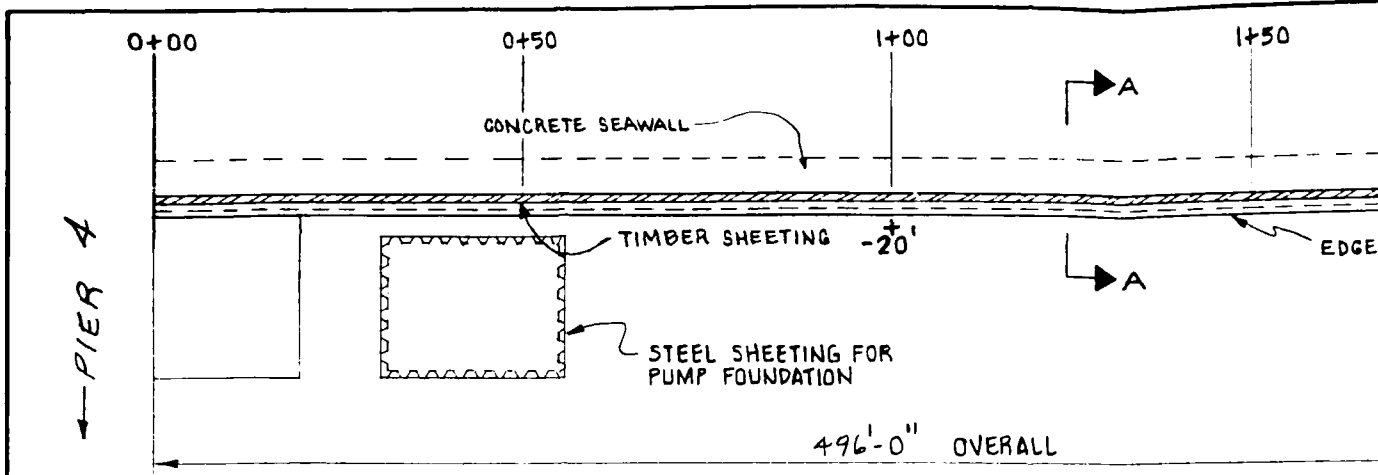
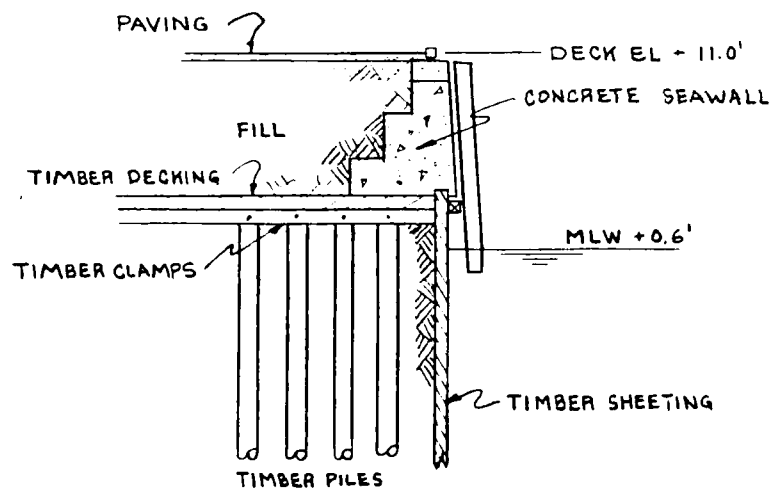
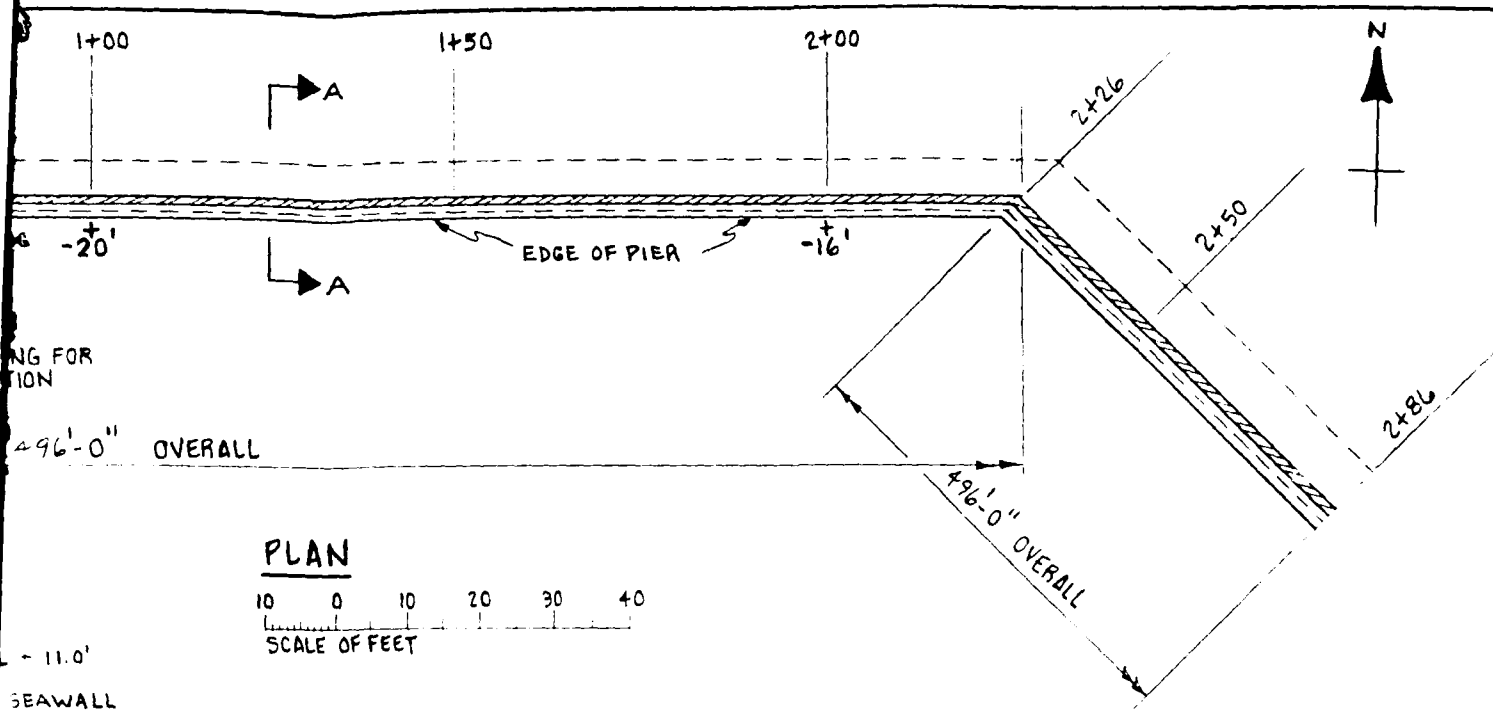
GRAPHIC SCALE	CHILD'S ENGINEERING CORPORATION BOX 333 MEDFIELD, MA	CHESAPEAKE DIVISION NAVAL FACILITIES ENGINEERING COMMAND WASHINGTON, D.C.	
AS SHOWN		PHILADELPHIA NAVAL SHIPYARD PHILADELPHIA, PA	FIG NO 37

NOTE:
SEAWALL FACE HAS BEEN REPAIRED WITH GUNITE
