UNDERWATER FACILITIES INSPECTIONS AND ASSESSMENTS AT

PHILADELPHIA NAVAL SHIPYARD

VOLUME I FILE COPY

FPO-1-83-(48) OCTOBER 1983

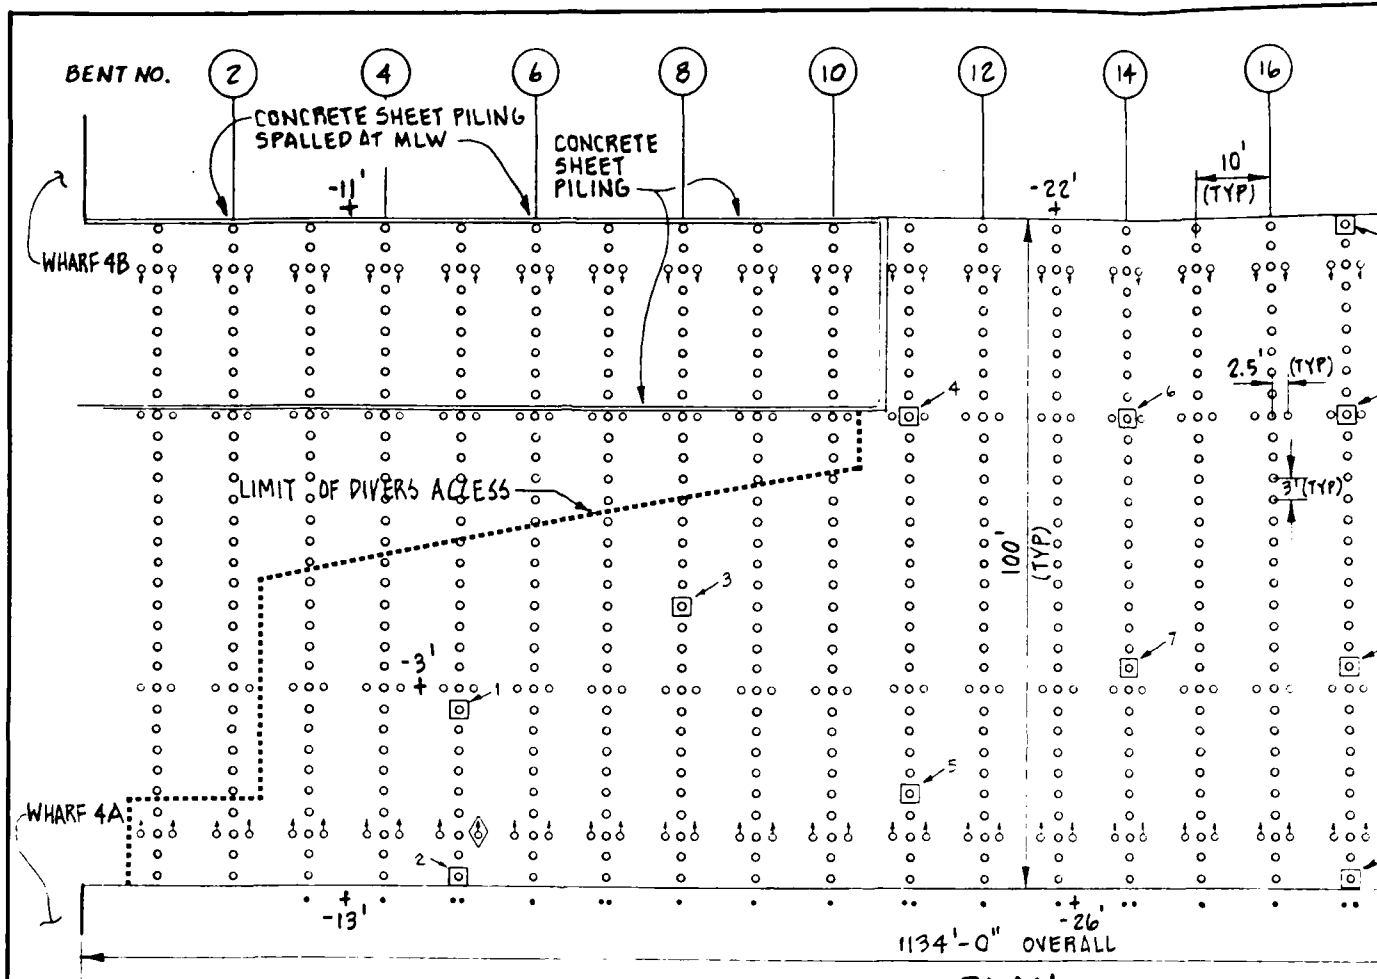
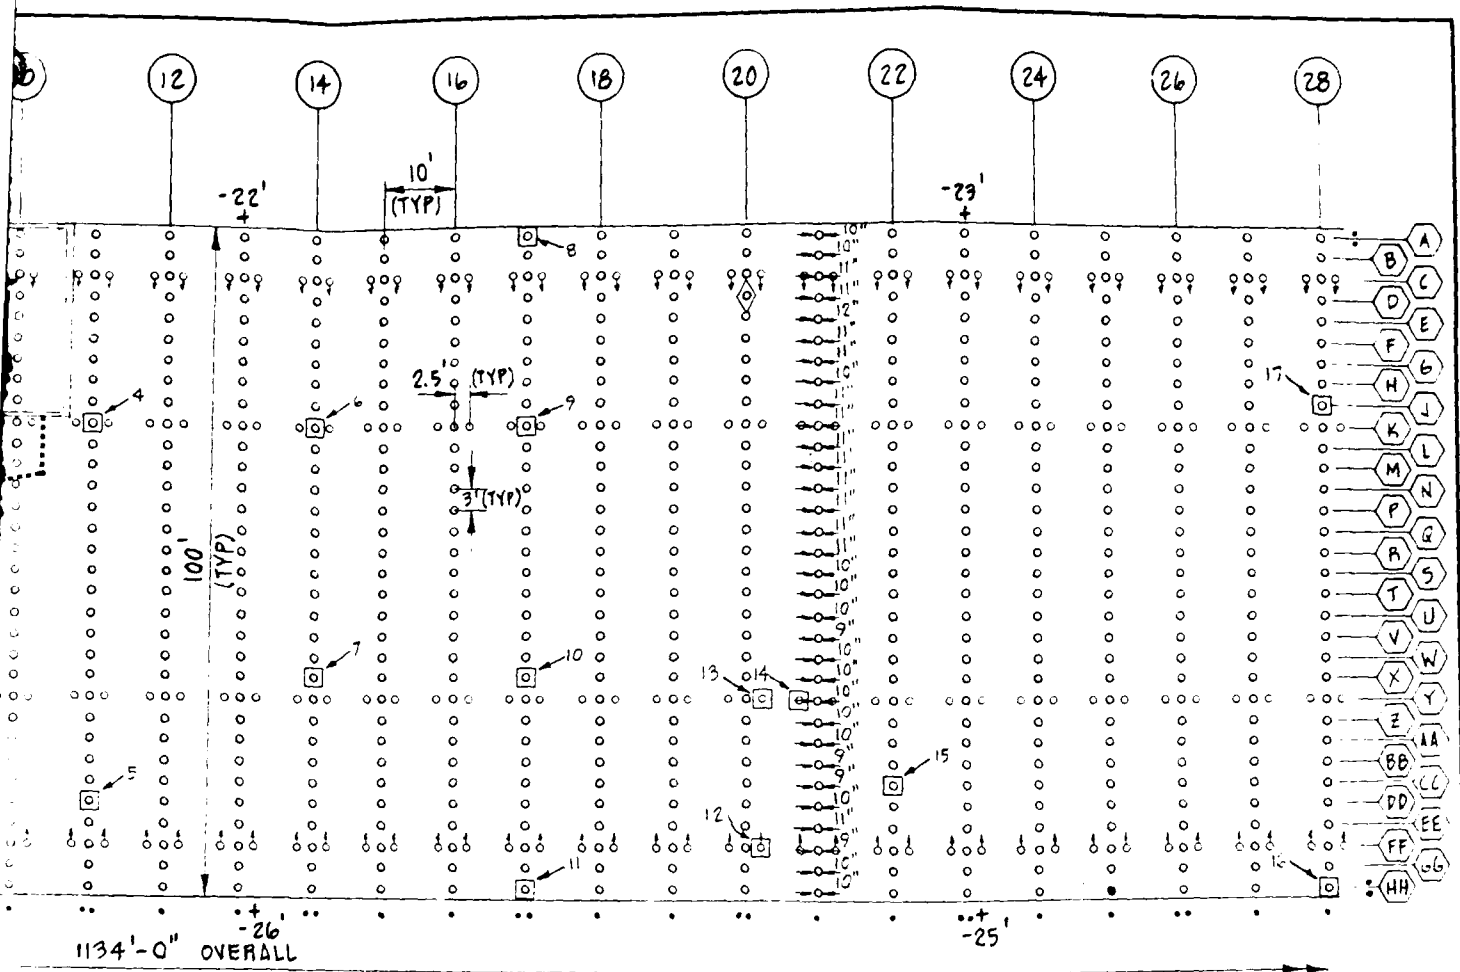
CHESAPEAKE DIVISION
 NAVAL FACILITIES ENGINEERING COMMAND
 WASHINGTON D.C.
 PHILADELPHIA NAVAL SHIPYARD PHILADELPHIA PA
PIER 4
 FIG NO. **39**

There are two locations on the pier (see Figures 39 and 41) that have a concrete sheet pile enclosure. The concrete sheet piling is deteriorating at El. -0.0. There is spalling of the corners of the piles and reinforcing steel is exposed. Generally, for the length of the concrete sheet piling the concrete is approximately 1/4" soft. In four locations below the stationary crane (see Figure 41), there are large gaps in the sheet pile wall. An attempt was made at one time to plug these gaps. The method of repair used concrete bags placed in the gap. These repairs are ineffective and fill is still leaching out from behind the wall, leaving large void spaces behind the wall.

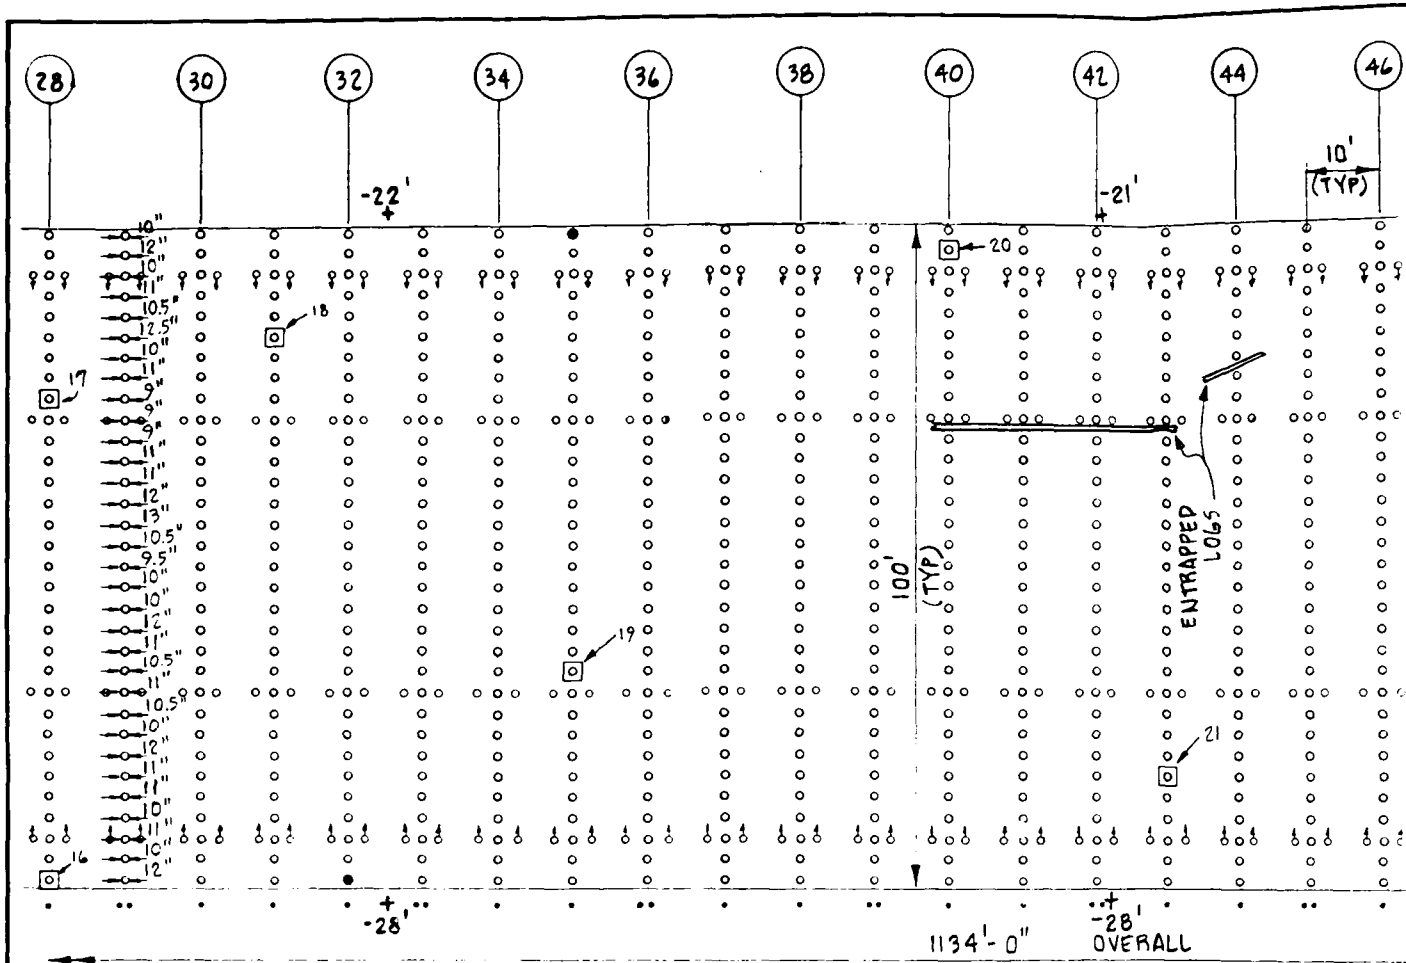
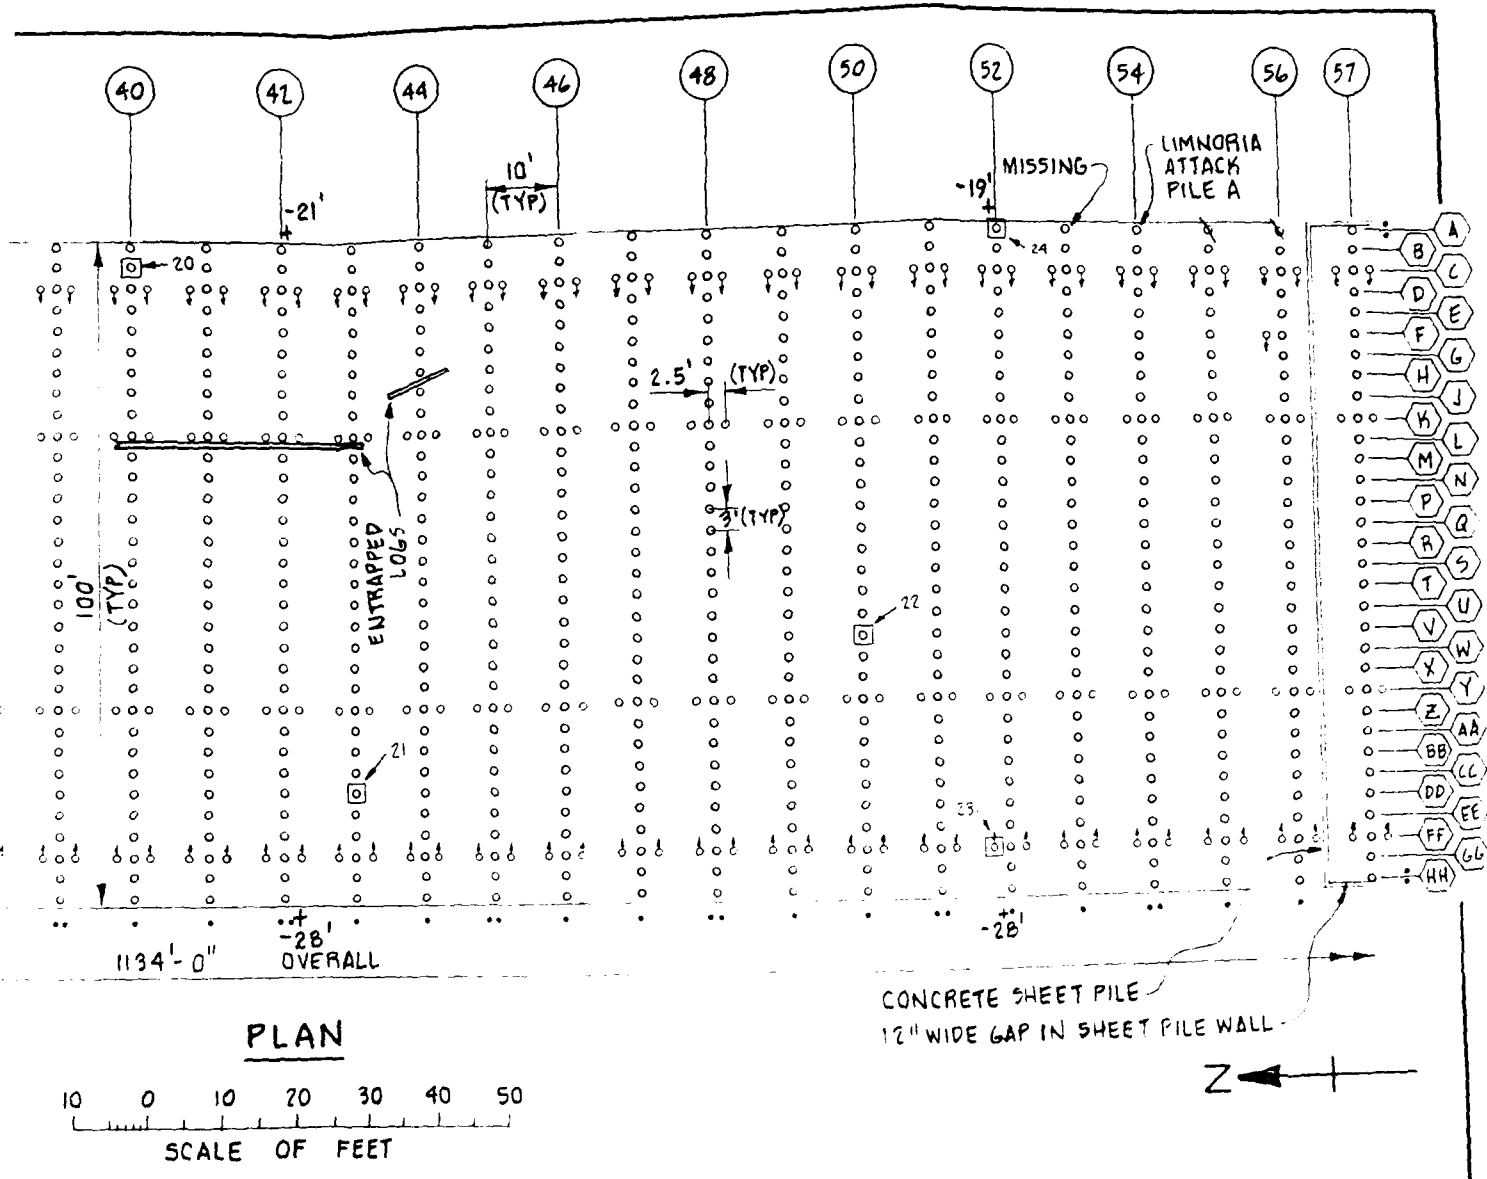
CHE SAPEAKE DIVISION NAVAL FACILITIES ENGINEERING COMMAND WASHINGTON, D.C. PHILADELPHIA NAVAL SHIPYARD PHILADELPHIA PA	
PIER 4	40

From Bent 40 to Bent 43 between Piles K and L there is a large floating log entrapped inside the pier. Due to tidal action and wave action the log is abrading the adjacent structural piles resulting in a 30% loss of their original diameter. There is a similar condition at Bent 43 between Piles G and H and between Bents 80 and 81 between Piles K and L.

At the three locations where there is abrasion being caused (see Figures 40 and 41), the source of this abrasion should be removed. This involves removing the free floating logs. The total estimated cost is \$3,000.
