UNDERWATER FACILITIES
INSPECTIONS
AND
ASSESSMENTS
AT

NAVAL AIR
STATION
NEW ORLEANS, LA.

FPO-1-85-(18)

JUNE 1985

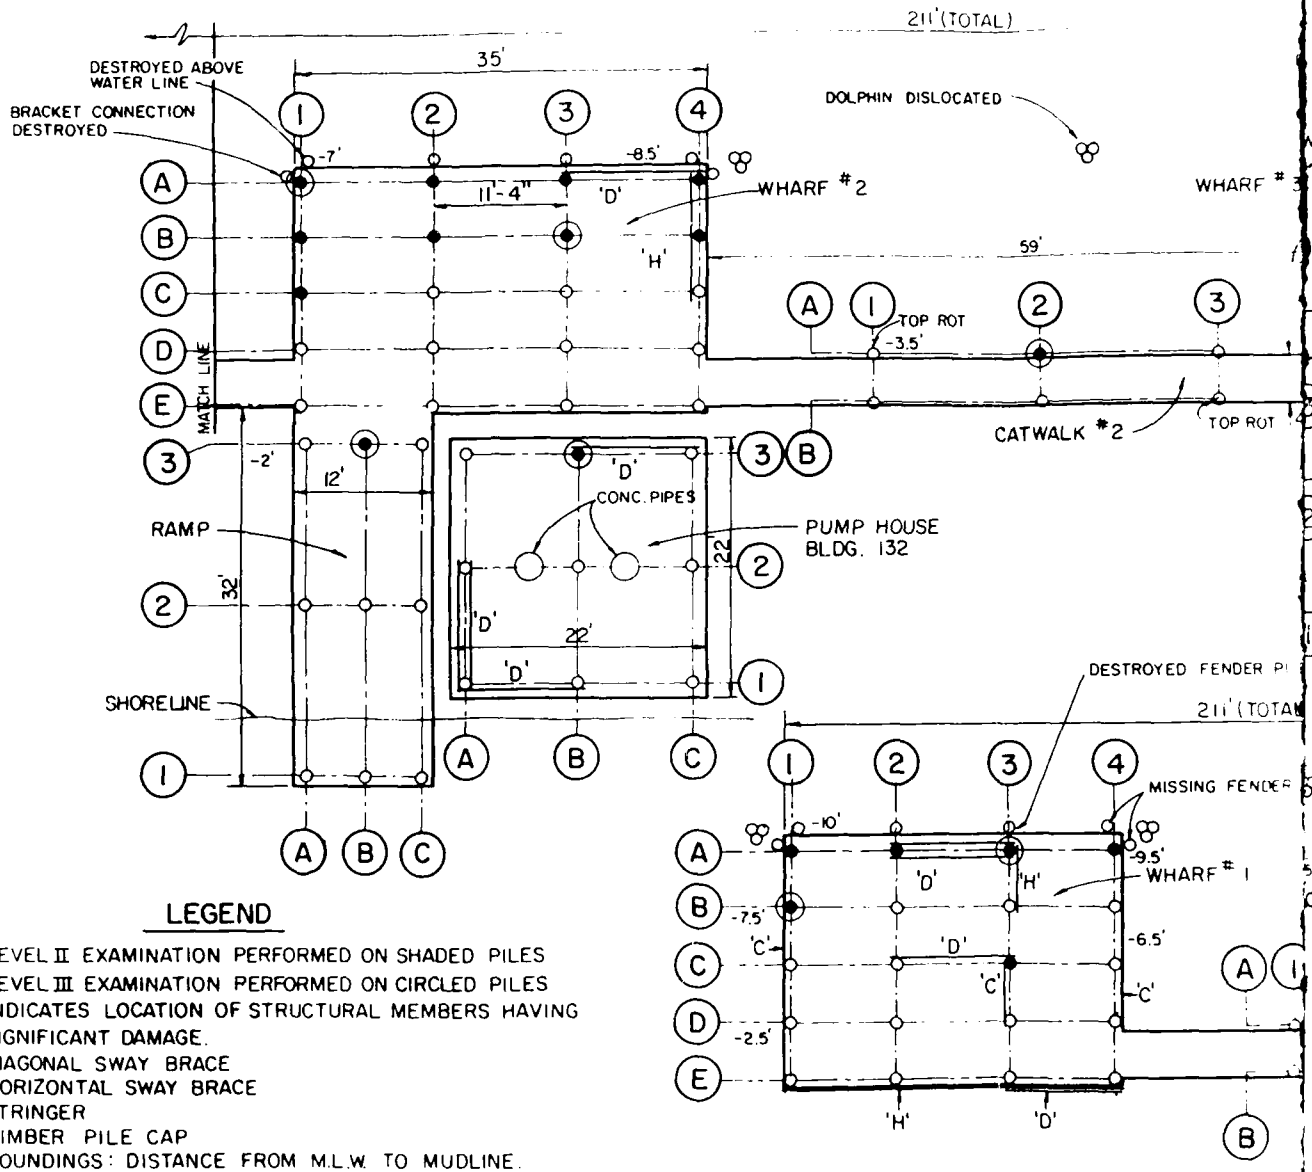
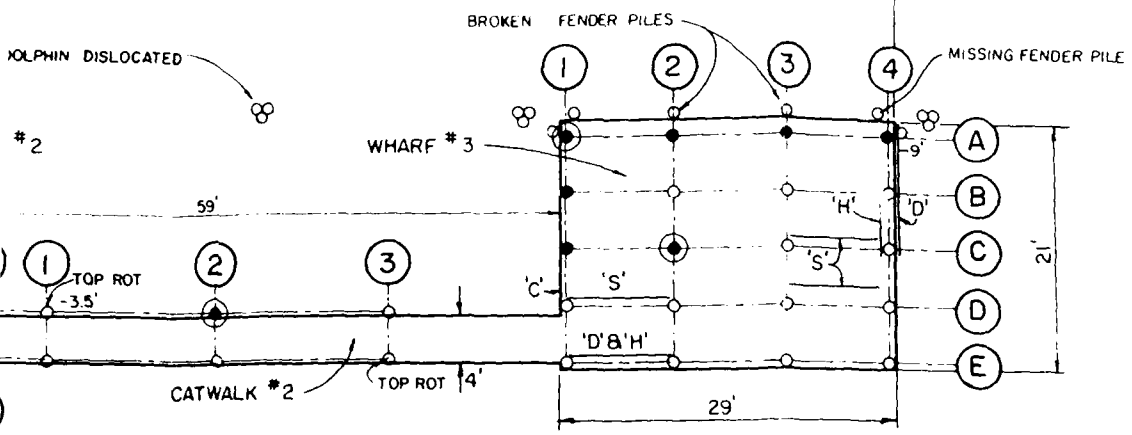
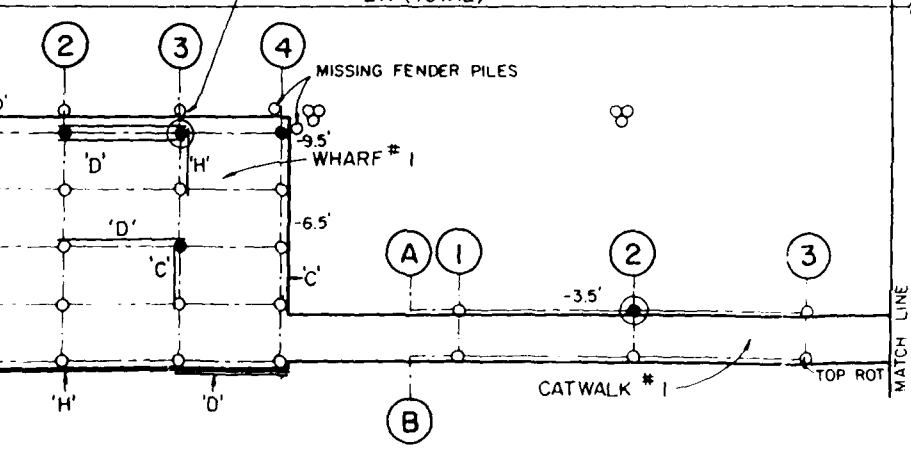
<p>GRAPHIC SCALE</p> <p>SCALE IN FEET</p>	<p>GOLETTREE ENGINEERING INC CORPUS CHRISTI, TEXAS</p>	<p>CHESAPEAKE DIVISION NAVAL FACILITIES ENGINEERING COMMAND WASHINGTON, D.C.</p>	<p>FIG NO 3</p>
		<p>NAVAL AIR STATION NEW ORLEANS LOUISIANA FUEL WHARF 128</p>

Above the waterline, the timber piles were generally structurally sound. Top rot was observed in the exposed tops of three catwalk
