UNDERWATER FACILITIES
INSPECTION AND ASSESSMENT

**DEPERMING PIER
TRIDENT REFIT FACILITY
BANGOR, WASHINGTON**

FPO-L-85 (6)

January, 1985

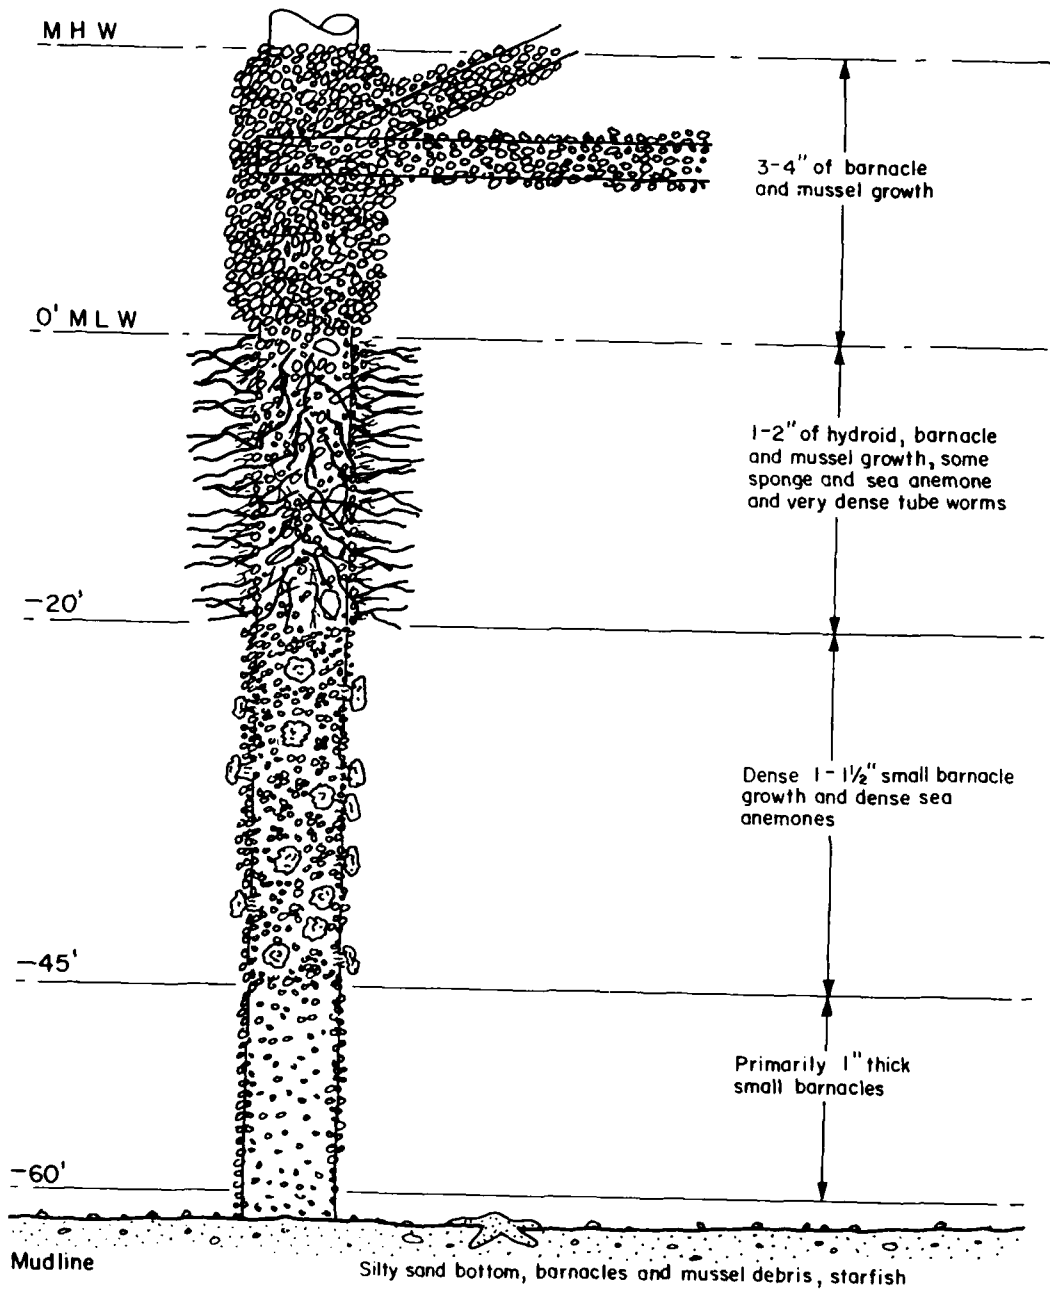
J. Agi & Associates Co. Ltd. Suite 600, 1414 Alaskan Way, Seattle, WA		CHESNAVFACENGCOM	
Not to scale		MAGNETIC SILENCING FACILITY BANGOR, WA.	
January, 1985.		Fig. 1

The following Figure 1 and all photographs illustrate the typical condition found.

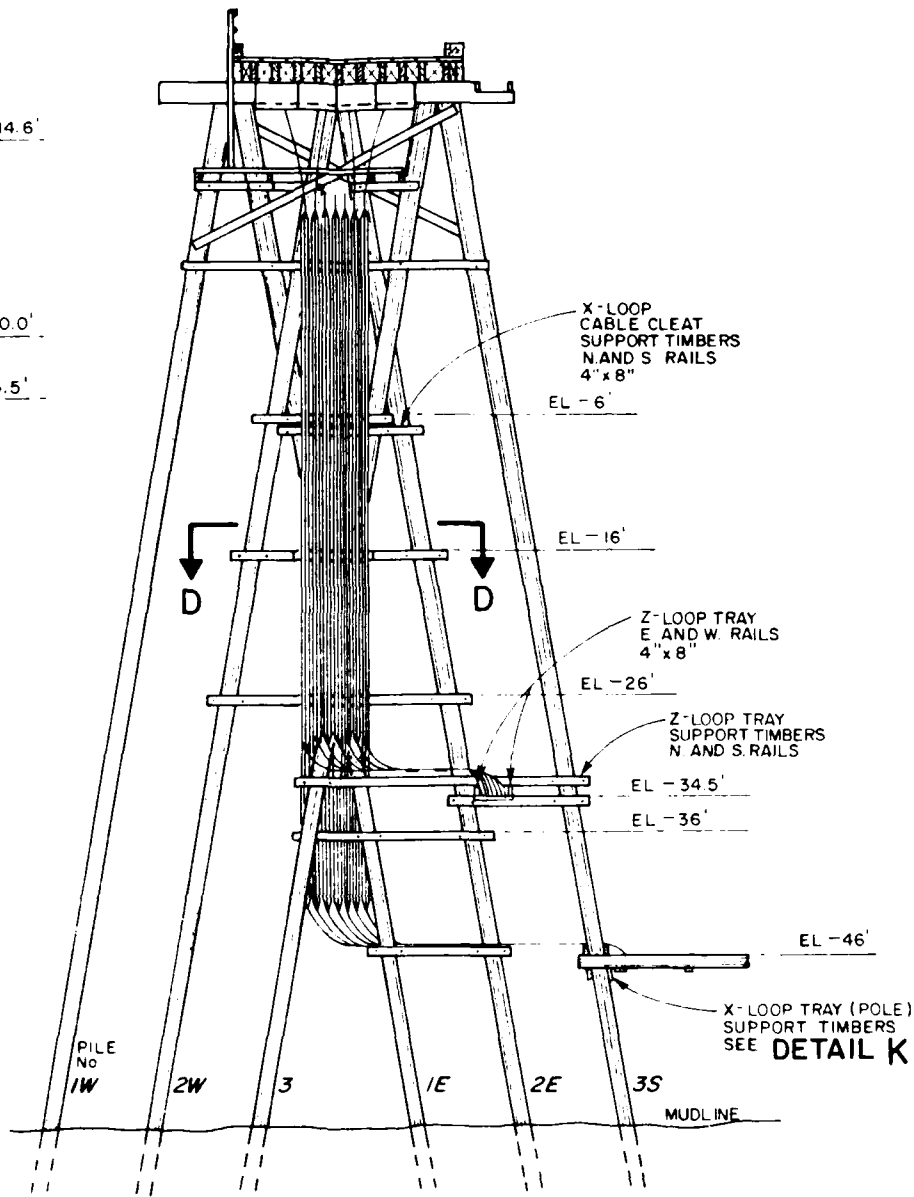
**SECTION C-C
WEST PIER - BENT 77**

The miscellaneous timbers covered by this inspection include the Z-loop clamp timbers located at Bent 40 and 77 of the East Pier and Bent 39 and 77 of the West Pier. As illustrated on Drawing 2, Section D-D and Detail E, these timbers serve to support the massive bundles of Z-loop cables that run into/out of the water at these locations. In addition to the above Z-loop clamping timbers, the miscellaneous component of the inspection also included the above noted Z-loop troughs (poles) plus trough supports which span Bents 76W-76F and 77W to 77E and the trough bottom timbers along the Z-loop troughs. For further details on these members, see Table 6 and Drawing 2, Section C-C.
