FPO-1-85 (14)

NAVAL SUBMARINE
BASE
KINGS BAY
FLEET MOORINGS
UNDERWATER
INSPECTION
REPORT

MAY 1985

OCEAN ENGINEERING
AND CONSTRUCTION PROJECT OFFICE
CHESAPEAKE DIVISION
NAVAL FACILITIES ENGINEERING
COMMAND
WASHINGTON, D.C. 20374

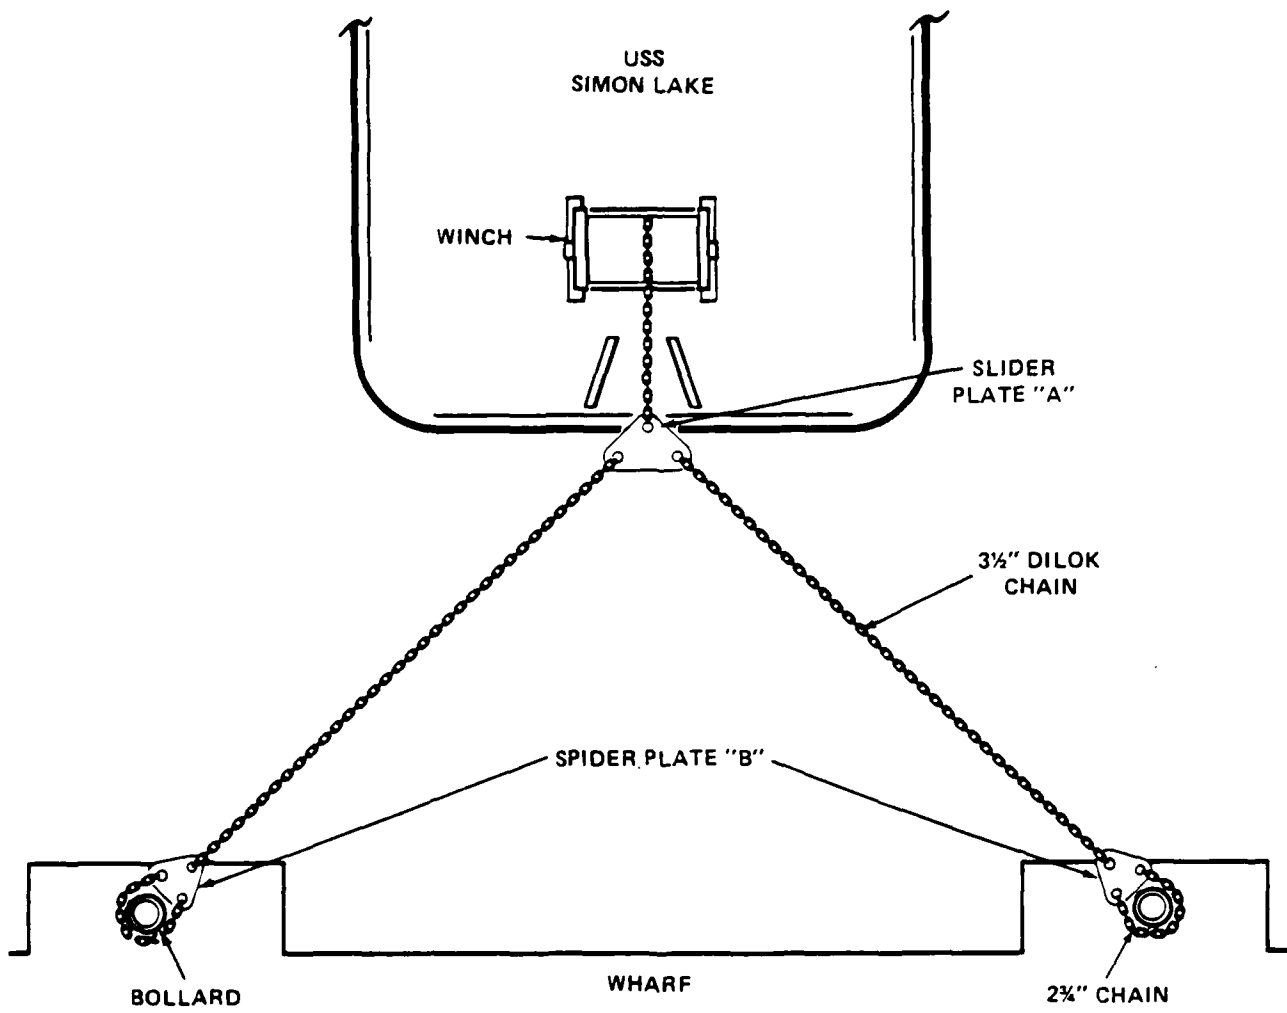
Figure A-2. USS SIMON LAKE (AS 33) Stern Legs

Stern Legs. Two 3 1/2-inch Dilok chain legs secure the stern of the Tender to the eastern end of the wharf at SUBASE Kings Bay. Both legs are rusting and the paint on them is blistering. Double- and single-link measurements were all above 90 percent of the original wire diameter. A schematic diagram of the Mediterranean mooring's stern legs is contained in Figure A-2.

- o Overall, the Mediterranean mooring is in good condition and satisfactory for continued fleet use.
- o Due to measurements between 80 and 90 percent near the mudline, the retriever buoy chain should be refurbished during the next scheduled mooring overhaul.
- o In its current configuration, the northern stern leg contains 12 consecutive detachable links. During the next scheduled overhaul, this unusual and nonstandard configuration should be replaced with a comparable length of 3 1/2-inch common "A" links.
