REPORT  
MRL-R-984

INVESTIGATION OF COATING PERFORMANCE AND  
CORROSION OF COMPRESSOR COMPONENTS IN THE TF30-P-3  
ENGINE OF F111C AIRCRAFT

L.V. Wake & P.S. Smith

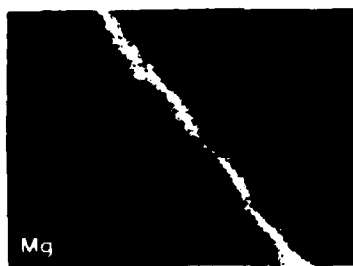
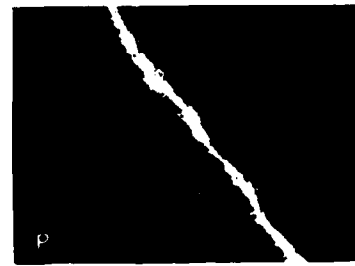
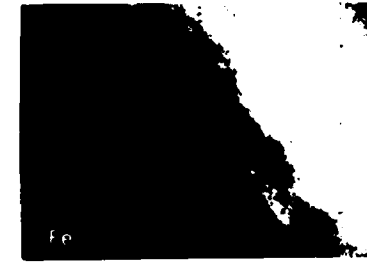
EPMA of cross sections through corroded areas of the coating showed that an oxidised deposit containing an aluminium product was present in a layer over components of the original ceramic top coat. Also present in this layer were oxygen, chlorine, and sulphur. This oxidised layer resulted in a cross sectional coating thickness much greater than that of the original protective system (Fig. 19). EPMA maps around the mouth of a pit in the coating showed the presence of oxide and sulphur materials (Fig. 20).

Figure 19. EPMA area scans of a degraded section of the surface coating. The corroded material lying over the original surface is composed of products rich in Al, O, Cl and S.
