## FAILURE ANALYSIS OF COMPOSITE STRUCTURE MATERIALS

Brian Smith  
Ray Grove  
Thomas Munns  
Boeing Military Aircraft Company  
P.O. Box 3707 M/S 73-43  
Seattle, WA 98124

May 1986  
Interim Report for 18 July 1984 to 1 October 1985

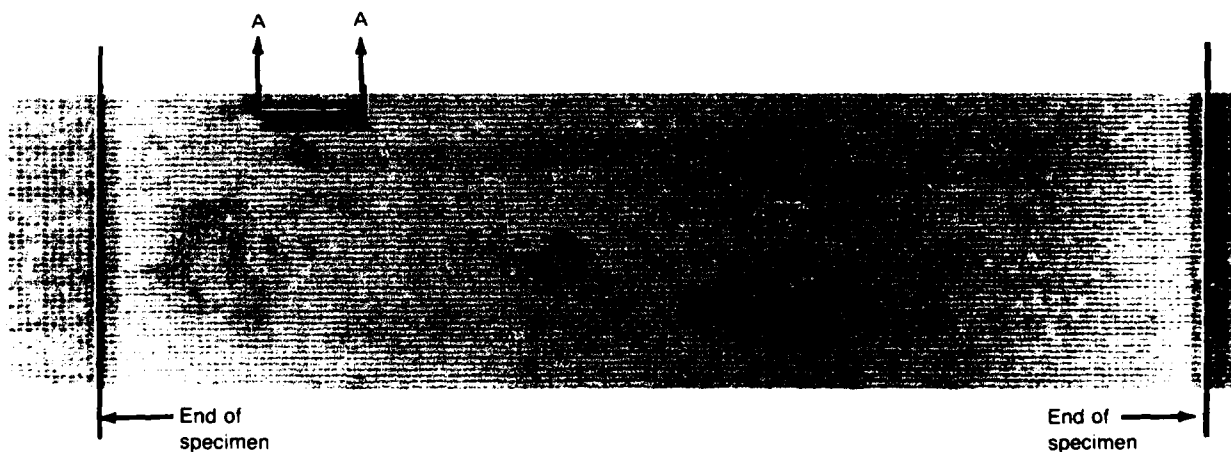
**Figure 6-7.** *Typical TTU Plan View of Specimen No. 7-2*

Through-transmission ultrasonic (TTU) techniques were used to inspect each specimen for defects resulting from panel fabrication or subsequent machining. Those specimens with areas greater than approximately 0.322 square cm (0.05 square inch) that exhibited ultrasonic indications 3 levels higher (18 dB) than the baseline were rejected and scrapped. Over 97% of the fabricated specimens were found to be acceptable. Figure 6-7 illustrates a typical TTU scan and reject-specimen condition.

This specimen was rejected and cross-sectioned at location A-A (Figure 3.2.1-4) for evaluation of defect condition. The specimen baseline output symbol is 1. For this program, specimens having areas greater than 322 cm<sup>2</sup> (0.05 inch<sup>2</sup>), and exhibiting ultrasonic attenuation indications three levels higher than specimen baseline were rejected. One numerical level change is equal to a six dB change in sound transmittance.

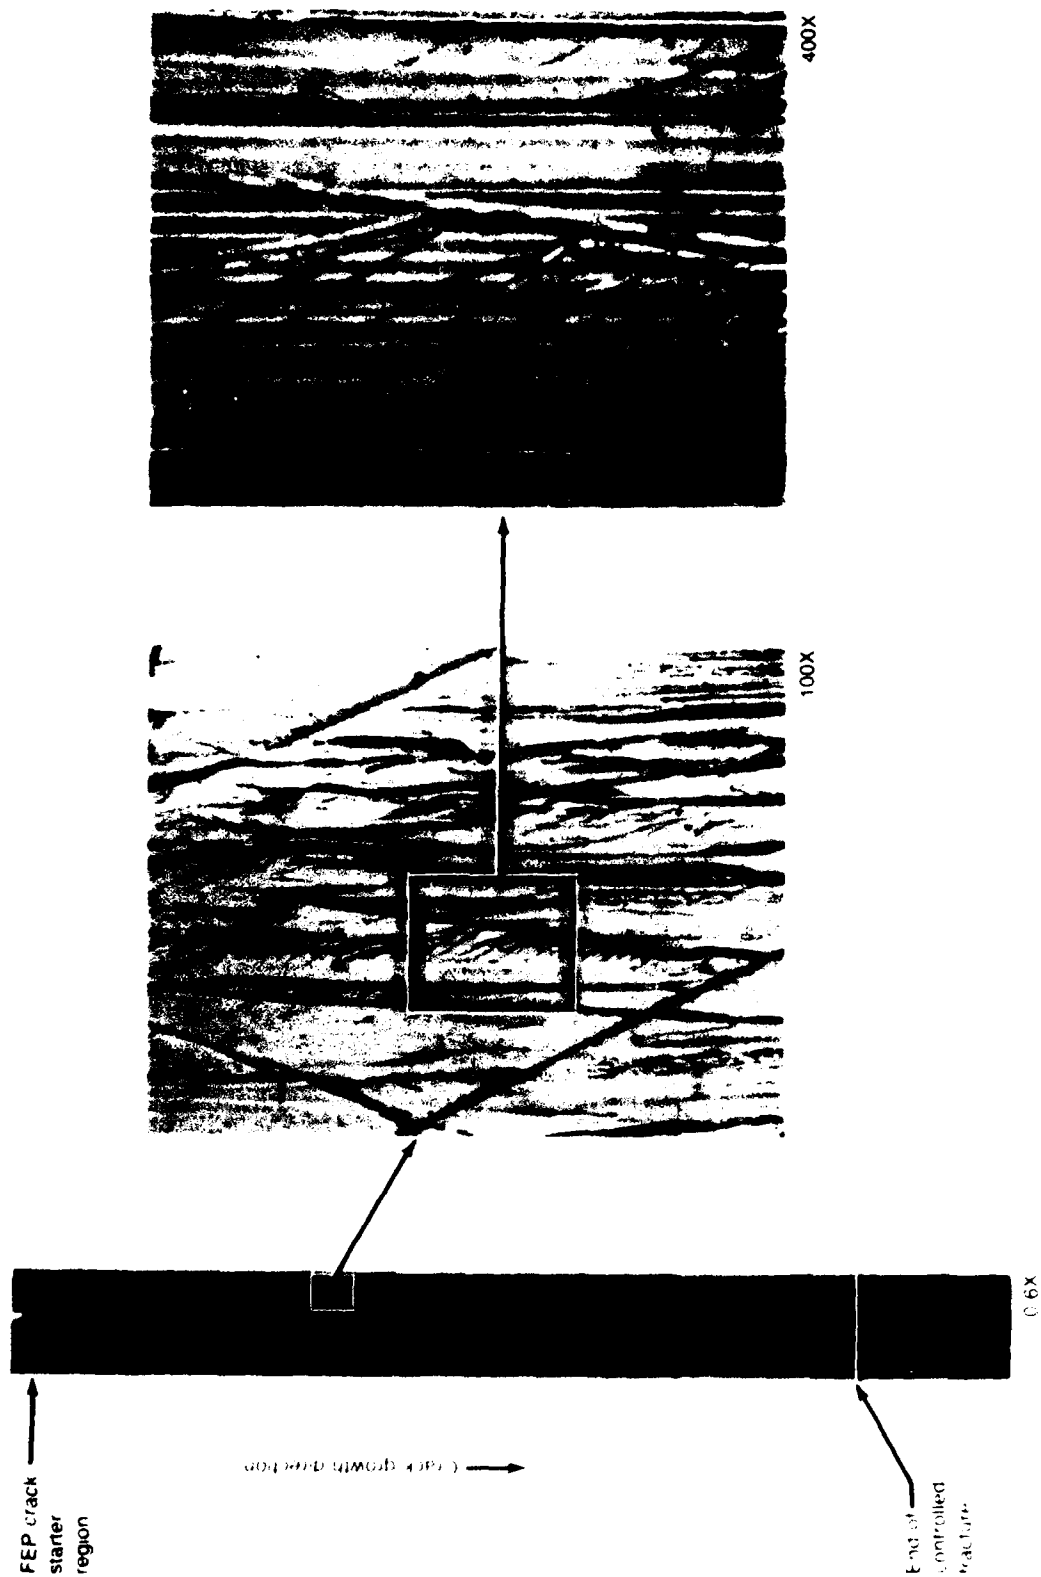
Figure 7-1. Optical Photomicrographs of Intended Fracture Plane Between 0/0-Degree Plies, DCB 210C (70°F) Specimen

The surface characteristics of interlaminar tension fractures generated between adjacent 0-degree plies is illustrated in Figure 7-1. Macroscopic examination of the surface reveals that interlaminar fracture occurred as intended between the 0-degree plies, with no out-of-plane crack wandering. Although not visible in the 0.6X macrograph, several arced bands were found running transverse to the specimen length. These bands are similar in appearance to beach markings found in metals and unreinforced polymer fractures. Such markings are indicative of the crack-front geometry and are formed in response to pronounced changes in crack velocity. Internal Boeing studies performed on similar beach markings revealed that they consist of a distinct morphological change in fracture surface roughness and microplane. This observation supports the concept of a

distinct change in crack-front propagation rate. Numerous investigators have demonstrated that in neat polymeric materials, low crack velocities resulted in mirror-smooth fracture surfaces, and high crack velocities result in roughened, less reflective fracture topographies. The overall shape and curvature of the beach marks indicate that crack propagation occurred away from the implanted FEP crack starter, and toward the opposite end of the specimen. The arced shape, however, suggests that some crack growth retardation occurs at, or adjacent to, the specimen edges. This retardation corresponds with a localized shift in the direction of crack propagation off the center axis, toward the specimen edge. It is significant to note that this behavior occurs in unreinforced polymers as well as metals. Its appearance is typically associated with the tendency of a propagating crack front to run toward a free surface. This observation led to further high-magnification examinations concentrating on those areas in which crack progression occurred directly along the specimen length.

High-magnification optical inspection of the fracture surface reveals a reflective appearance with flat areas of resin fracture. These areas of resin fracture are separated by intermittent lines corresponding to fiber-matrix separation. Inspection at 400X reveals a distinct branched structure (river markings) in these flat resin fracture areas, along with more subtle evidence of resin microflow; the direction of river mark coalescence corresponds with the direction of induced crack progression. At higher magnification, the direction of river mark coalescence is often biased at an angle to the induced direction of crack propagation. However, at lower magnification (200X) the direction of coalescence appears to correspond well with the direction of induced fracture. These observations suggest that the direction of coalescence does coincide with the overall crack direction as long as local variations are averaged either by supplemental examination at lower magnifications or by additional high-magnification examinations of adjacent areas.

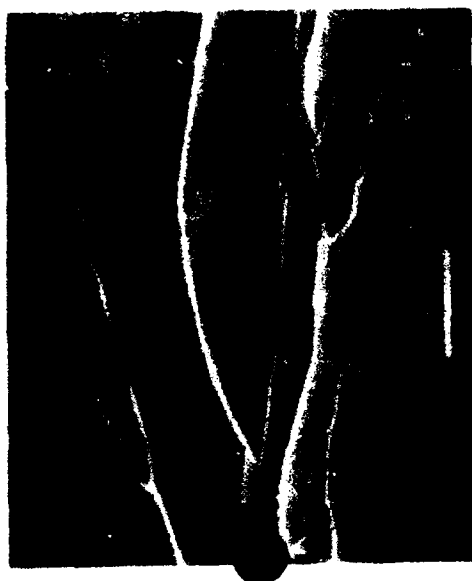
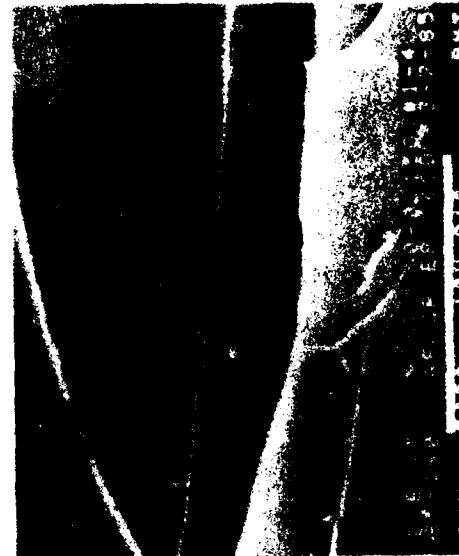
Figure 7-2. SEM Fractographs of Mode 1 Delamination Between 0/0-Degree Plies

Following optical microscopy, scanning electron microscope (SEM) examinations were performed. Typical fracture surface characteristics identified by SEM analysis are illustrated in Figures 7-2 and 7-3. One of the most distinctive features of the fracture in Figure 7-2 is its relatively smooth, planar topography. At 400X, the overall fracture surface is composed of microstructural areas of cohesive resin fracture, fiber/matrix separation, and partially buried fibers. Of these three, regions of cohesive resin fracture constitute the predominant features in terms of exposed area. The areas are divided into roughly longitudinal segments by regions of fiber/matrix separation and partially buried fibers. At higher magnification, partially buried fibers occur when the fracture plane

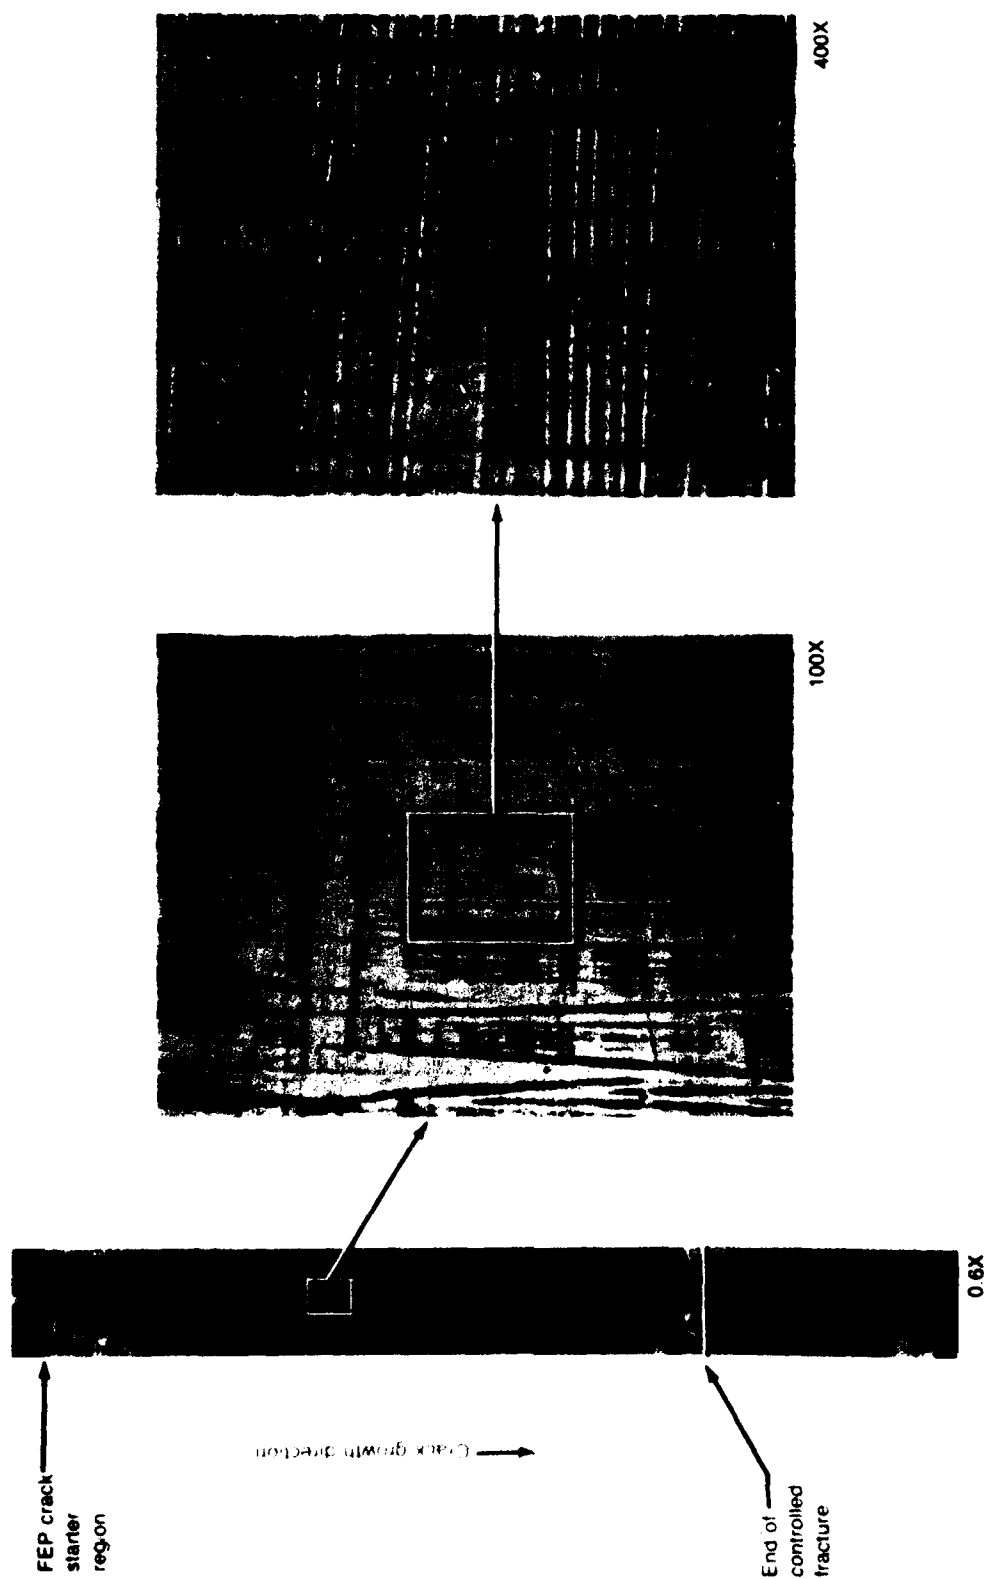
Figure 7-4. Optical Photomicrographs of Intended Fracture Plane Between 0/90-Degree Plies, DCB 210C (70°F) Specimen

Interlaminar tension fracture characteristics produced between 0-degree and 90-degree ply orientations are illustrated in Figure 7-4. The macrograph shows that crack propagation generally occurs along the desired 0- to 90-degree interface. However, occasional intraply fracture into the 90-degree ply is evident adjacent to the FEP crack starter insert. A detailed inspection of this macrograph reveals numerous beach marks in the 0/90-degree interface area. The orientation of the beach marks indicate that crack

progression occurred from the implanted FEP insert toward the opposite end of the specimen. The general contour of these marks is relatively straight, indicating less variation in the local crack direction over the full specimen width as compared to the 0/0-degree specimens.

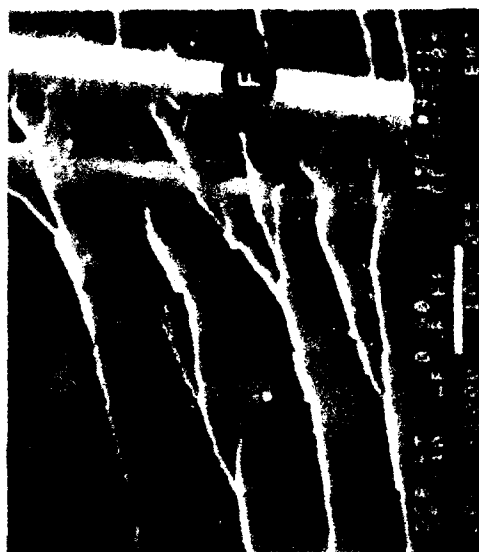
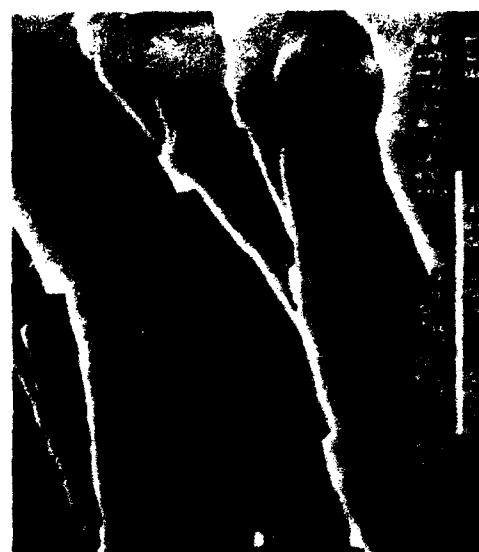
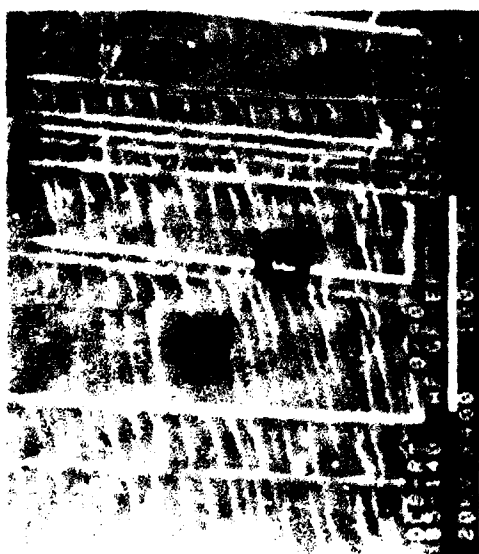
Figure 7-5. SEM Photomicrographs of Mode 1 Delamination Between 0/90-Degree Plies

Results of scanning electron microscope examinations are presented in Figure 7-5. Observed at 400X, locations of 0- and 90-degree fiber/matrix separation tended to divide the surface into roughly rectangular areas of matrix fracture. Examining these areas reveals both distinct river markings and subtle conditions of resin microflow. It is particularly interesting to note that in this fracture, river mark branching appears to be associated with areas of partially buried or exposed fibers, suggesting that local disruption of the fracture plane results in crack-plane divergence and initiation of multiple-crack microplanes. Viewed at high magnification, the direction of coalescence of these microplanes and the general texture of microflow coincides with the direction of crack propagation. These findings indicate that such features can be used to identify the direction of crack propagation fractographically.

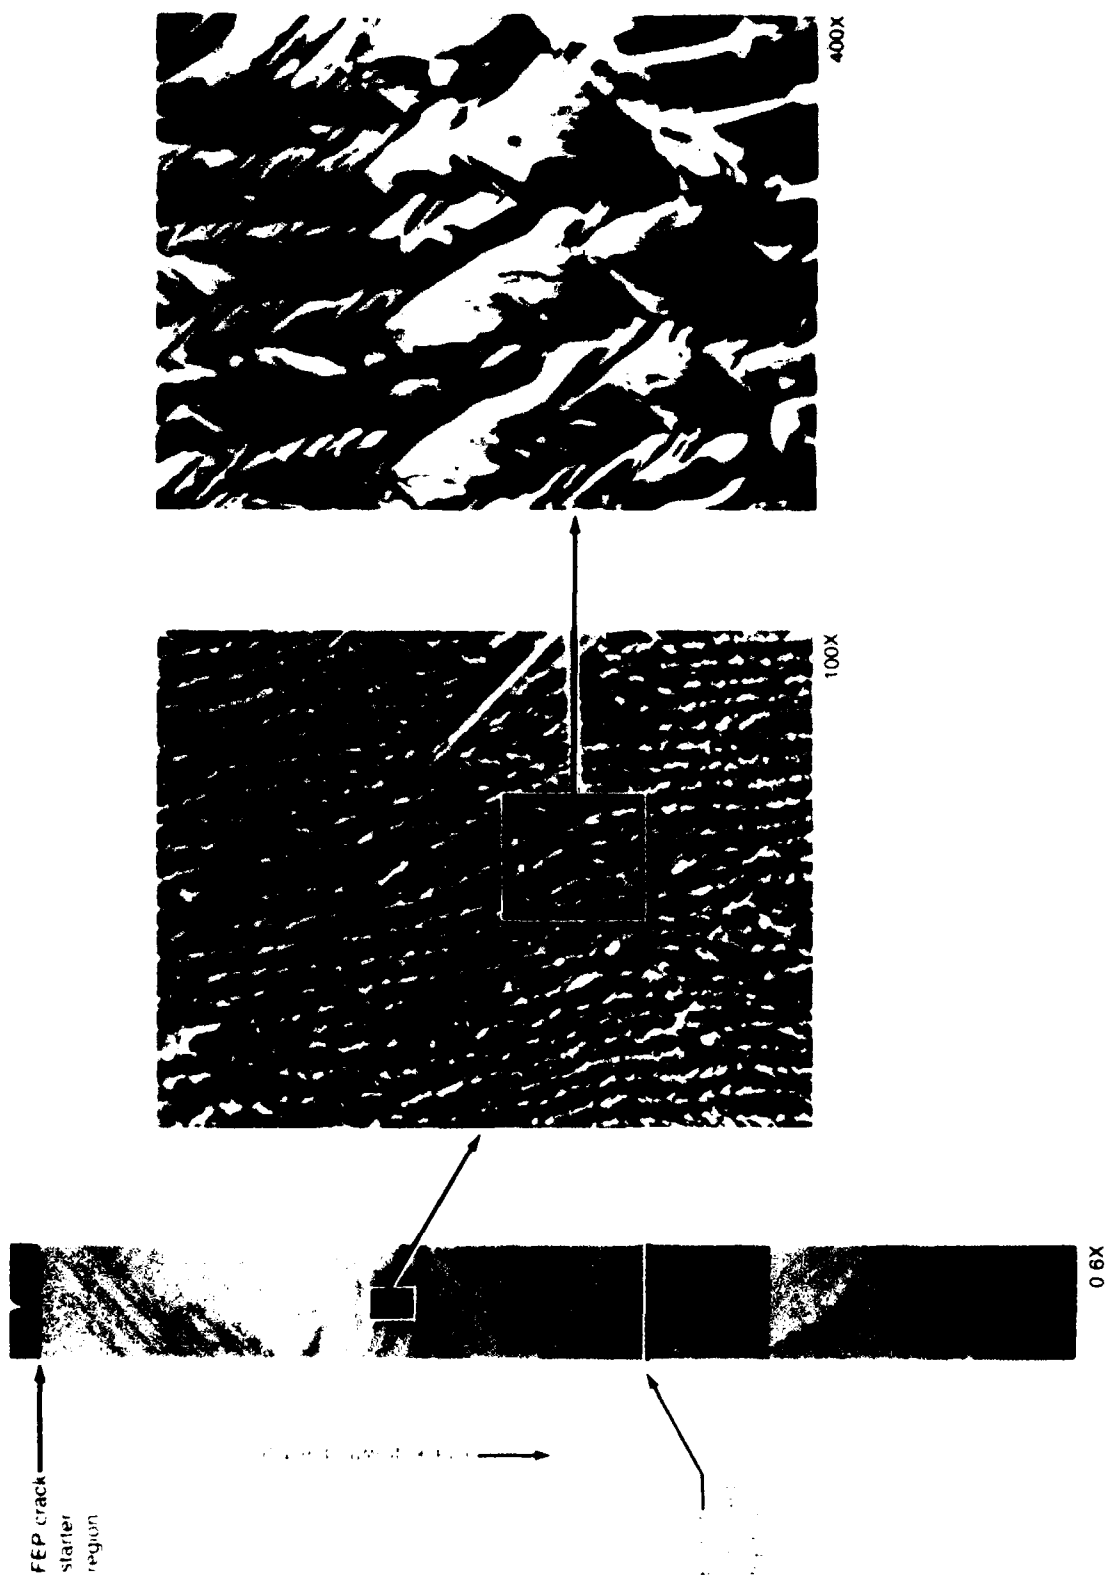
Figure 7-6. Optical Photomicrographs of Intended Fracture Plane Between +45 5-Degree Plies, DCB 21°C (70°F) Specimen

The appearance of fracture surfaces produced by interlaminar tension between +45 and -45-degree ply interfaces are illustrated in Figure 7-6 (optical) and 7-7 (SEM). In Figure 7-6, the fracture occurred between the intended interfaces, with limited amounts of intraply wandering into either of the 45-degree plies. Further visual examination revealed numerous beach mark features similar to those noted previously for other fracture interface conditions. The general shape of these beach marks indicates that fracture began at the FEP insert and progressed towards the opposite end of the specimen as intended. The particularly curved contours of the beach marks indicates that significant crack deflection occurred adjacent to the specimen edge, altering the local direction of propagation by as much as 60-degrees (Figure 7-8). As noted earlier, such divergent

Inspecting the fracture surface at increasing magnifications revealed a relatively rough topography consisting of numerous longitudinal rows of fan-shaped resin fracture zones intersected by the underlying 45-degree oriented fibers. For the optical photomicrograph (Figure 7-6), the strong light/dark contrast of the fracture surface is due to the tilt of fan-shaped zones with respect to the incident coaxial light source. Relatively reflective areas have shallow tilt angles, whereas darker, less reflective regions have relatively large tilt angles. Further SEM examination of the fan-shaped resin fracture areas revealed river markings associated with zones of fiber/matrix separation, and subtle conditions of textured resin microflow (Figure 7-7). The direction of river mark coalescence and microflow progression often deviate from the direction of induced crack propagation; this condition can be attributed to local rotation of the direction of crack propagation toward adjacent microscopic fracture zones. For this layup, deviations in the direction of crack propagation tended to be the most pronounced in small areas of resin fractures. However, these local variations average together, so that the overall direction of river mark branching and resin microflow correspond well with the direction of induced fracture. This finding indicates that the direction of crack propagation may be determined by examining the larger areas of resin fracture or by averaging the detailed crack directions of both large and small areas of resin fracture. The first of these two methods appears attractive in that it requires less effort and produces less data scatter; however, this approach ignores a portion of the actual fracture behavior and may be more susceptible to errors caused by spurious or secondary crack growth. The method choice should be predicated upon both the degree of accuracy desired and the time available for analysis.

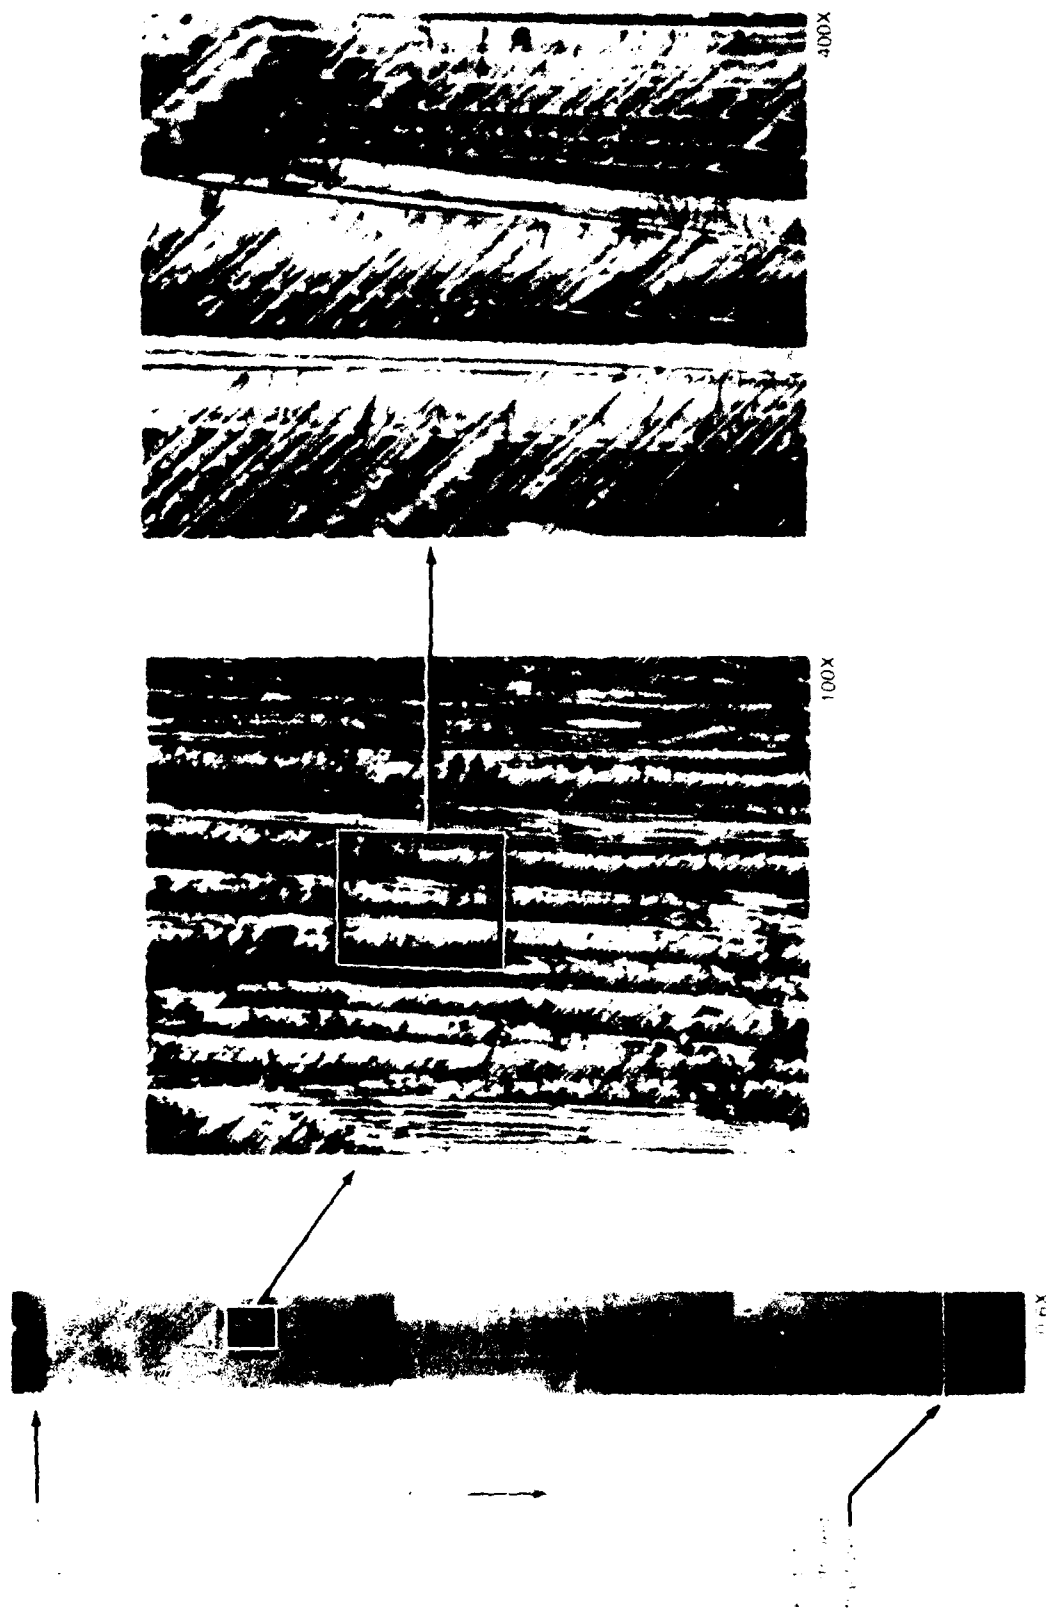
Figure 7-9. Optical Photomicrographs of Intended Fracture Plane Between 0/45-Degree Plies, DCB 21°C (70°F)

The interlaminar tension fractures produced between 0- and 45-degree-oriented plies are illustrated in Figure 7-9 (optical) and 7-10 (SEM). The overall optical macrograph (Figure 7-9), shows that fracture occurred between the desired ply orientations with some limited intraply fracture of the 45-degree ply. As with other orientations described previously, arced bands were apparent running transverse to the specimen length. The contour of

these bands indicate that crack propagation occurred along the specimen length and away from the FEP insert as intended. Additionally, some rotation of the crack direction toward the specimen edge is apparent. Further analyses concentrated on those central fracture regions where the contour of beach markings indicated that the direction of crack propagation coincides with the specimen's longitudinal axis.

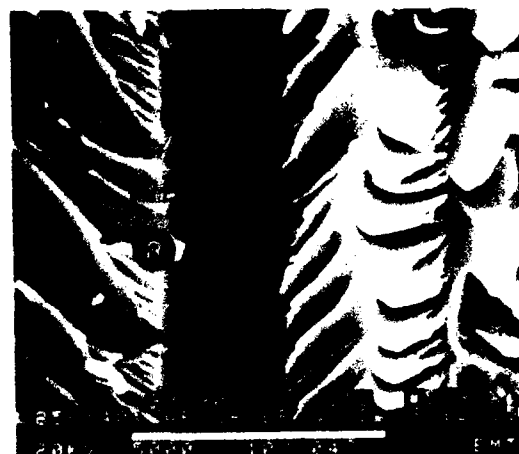
SEM analysis at 2000X indicated the presence of two types of cohesive resin fracture morphology. In one type, areas of resin fracture appear relatively flat, similar to those noted in the mode I fracture interface conditions. In the other type, several rougher areas of resin fracture exist that appear to be made up of numerous platelets of fractured epoxy inclined at a shallow angle to the plane of fracture. Both the tilted platelets and flat areas of resin fracture exhibit branched river markings adjacent to areas of fiber/matrix separation. In contrast to the other ply orientation fractures, the direction of river mark coalescence was both coincident with, and opposite to, the direction of

**Figure 7-12. SEM Fractographs Illustrating the Fracture Topography of Mode 1 Delamination Between Adjacent 90-Degree Plies**

crack propagation. This finding is of particular concern, since for the other interfacial fracture conditions, the direction of river mark coalescence appeared to be a reliable indicator of the overall direction of crack propagation.

In an attempt to understand this condition, the fracture surface illustrated in Figure 7-12 was examined in detail at several tilt orientations. Figure 7-13 shows that increasing the tilt of this fracture surface to approximately 66 degrees revealed:

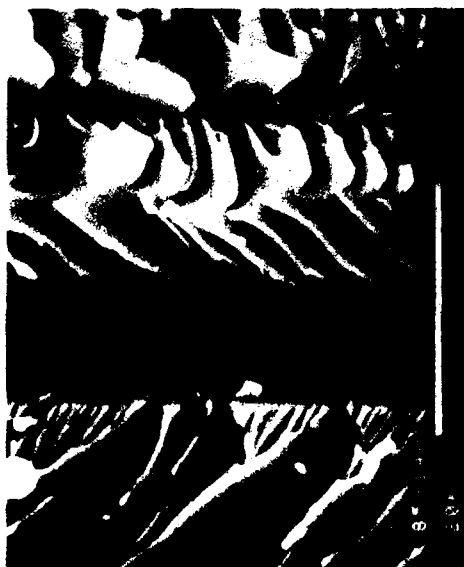
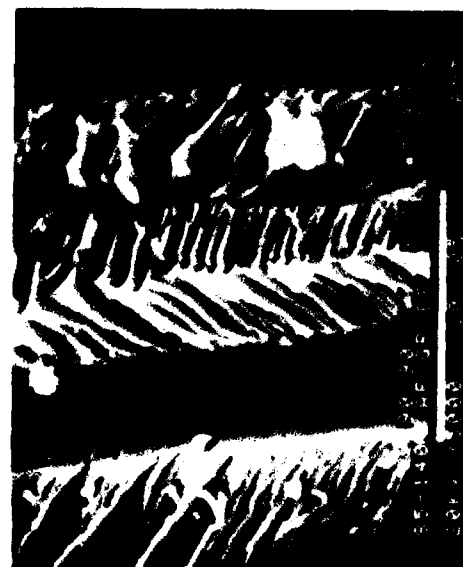
Figure 7-13. SEM Fractographs of Mode I Delamination Between Adjacent 90-Degree Plies Illustrating the Effect of Tilt Angle

- o Areas exhibiting river mark coalescence opposite to the direction of induced crack propagation are generally oriented at steep vertical angles to the plane of fracture
- o Resin fracture areas lying roughly in the plane of fracture tend to exhibit river pattern coalescence coincident with the direction of induced crack growth
- o Examinations at higher angles of tilt tend to increase the serrated appearance of all resin fracture areas, both flat and serrated.

These observations suggest that the direction of crack growth may be determined by considering both the direction of river mark coalescence and the relative plane of resin fracture. A relatively good correlation appears to exist between the direction of river mark coalescence and induced crack growth as long as examinations are limited to those areas lying roughly in the plane of fracture. Areas inclined out of the plane of delamination may not exhibit this correlation for several reasons. First, areas of vertical fracture may arise from bridged fibers being pulled out from behind the main crack tip. Alternatively, steep fracture areas may occur through the secondary joining of displaced fracture planes. In either case, the generation of inclined areas occurs as a secondary event after propagation of the main crack front. Because of their secondary nature, both fiber pullout and fracture plane coalescence may give rise to locally spurious crack propagation directions.

Figure 7-13 shows that increasing the tilt of the fracture surface significantly altered the appearance of both specific surface features and the overall morphology. This finding emphasizes the importance of having investigators document the viewing angle, examine features at several angles to understand their actual morphology, and use photographic stereo pairs where possible. The actual fracture morphology in Figure 7-13 is best described by examining both tilt angles. The relatively flat area of fracture on the left actually consists of several localized fracture planes inclined at about 5 to 10 degrees. In many cases, the edges of these planes sweep upward giving them a steeper appearance. The heavily serrated areas on the right consist of fracture planes inclined at between 20 and 30 degrees. In contrast to the area on the left, the overlapping fracture planes on the right tend to be thicker and more undercut. These resin fracture areas exhibit both thicker fracture plates and significant undercutting of adjacent fracture areas. The appearance of this plate structure and its formation is not well understood at present.

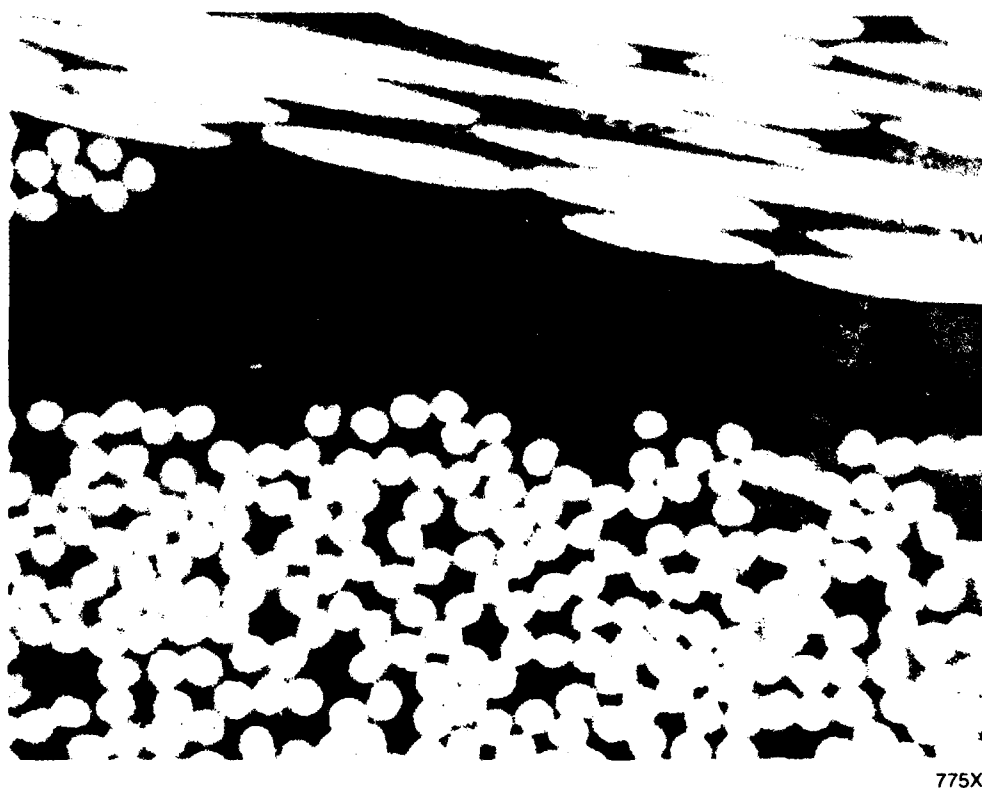
**Figure 7-16. Microstructure of Cracks Found in Short Beam Shear Specimen Tested at 132°C (270°F)**

shear and approximately normal to the resolved tension component of applied shear. This finding suggests that hackle and microcrack formations occur under locally resolved tension conditions. Based on these observations, the orientation of applied interlaminar shear (clockwise or counterclockwise) can be determined by examining the tilt of hackles with respect to the plane of fracture.

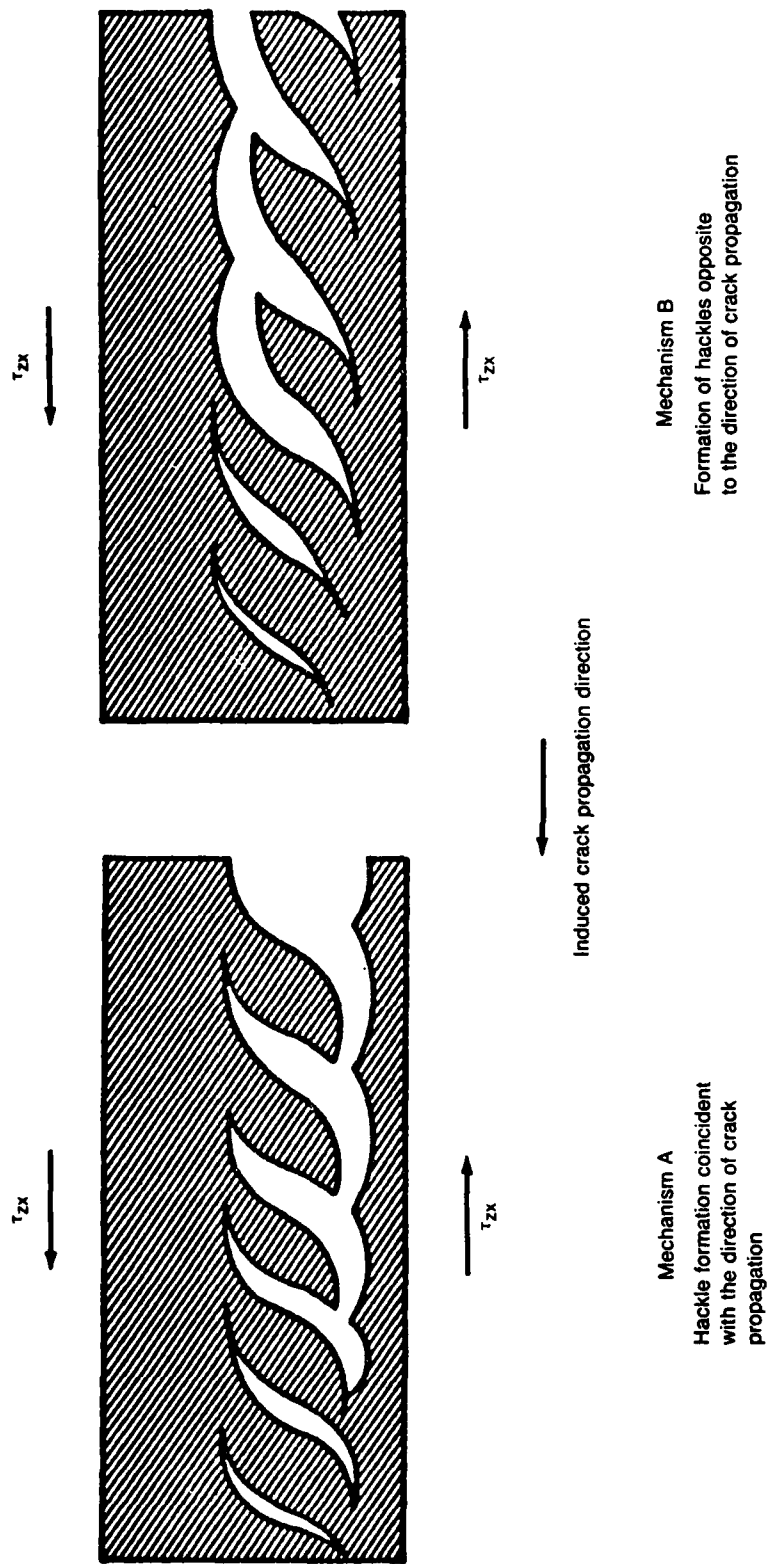
**Figure 7-18. Possible Hackle Separation Mechanisms**

Hackles are tilted normal to the local direction of resolved tension and occur almost exclusively on one side of the fracture surface, with scallops on the opposite side (Figure 7-22). In Figure 7-18, the hackles are tilted coincident with the direction of crack propagation, indicating separation by mechanism A. In contrast to the 0/0-degree ply condition, this observation indicates a positive correlation between hackle tilt and the direction of crack propagation for the 0/90-degree cross-ply condition. However, further studies should determine if the mechanism of hackle separation depends on conditions such as specimen geometry, layup, or degree of mixed-mode loading.

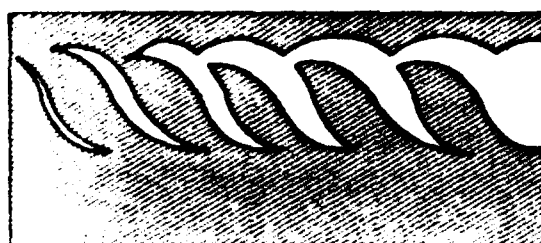
**Figure 7-25. Fractographs of Mating Fracture Surfaces Produced Under Mode 2 Between +45/-45-Degree Plies. (Hackle Separation Occurs by Mechanism A, in Which Hackles (H) Are Retained on One Side, Tilted Coincident With the Direction of Crack Growth)**

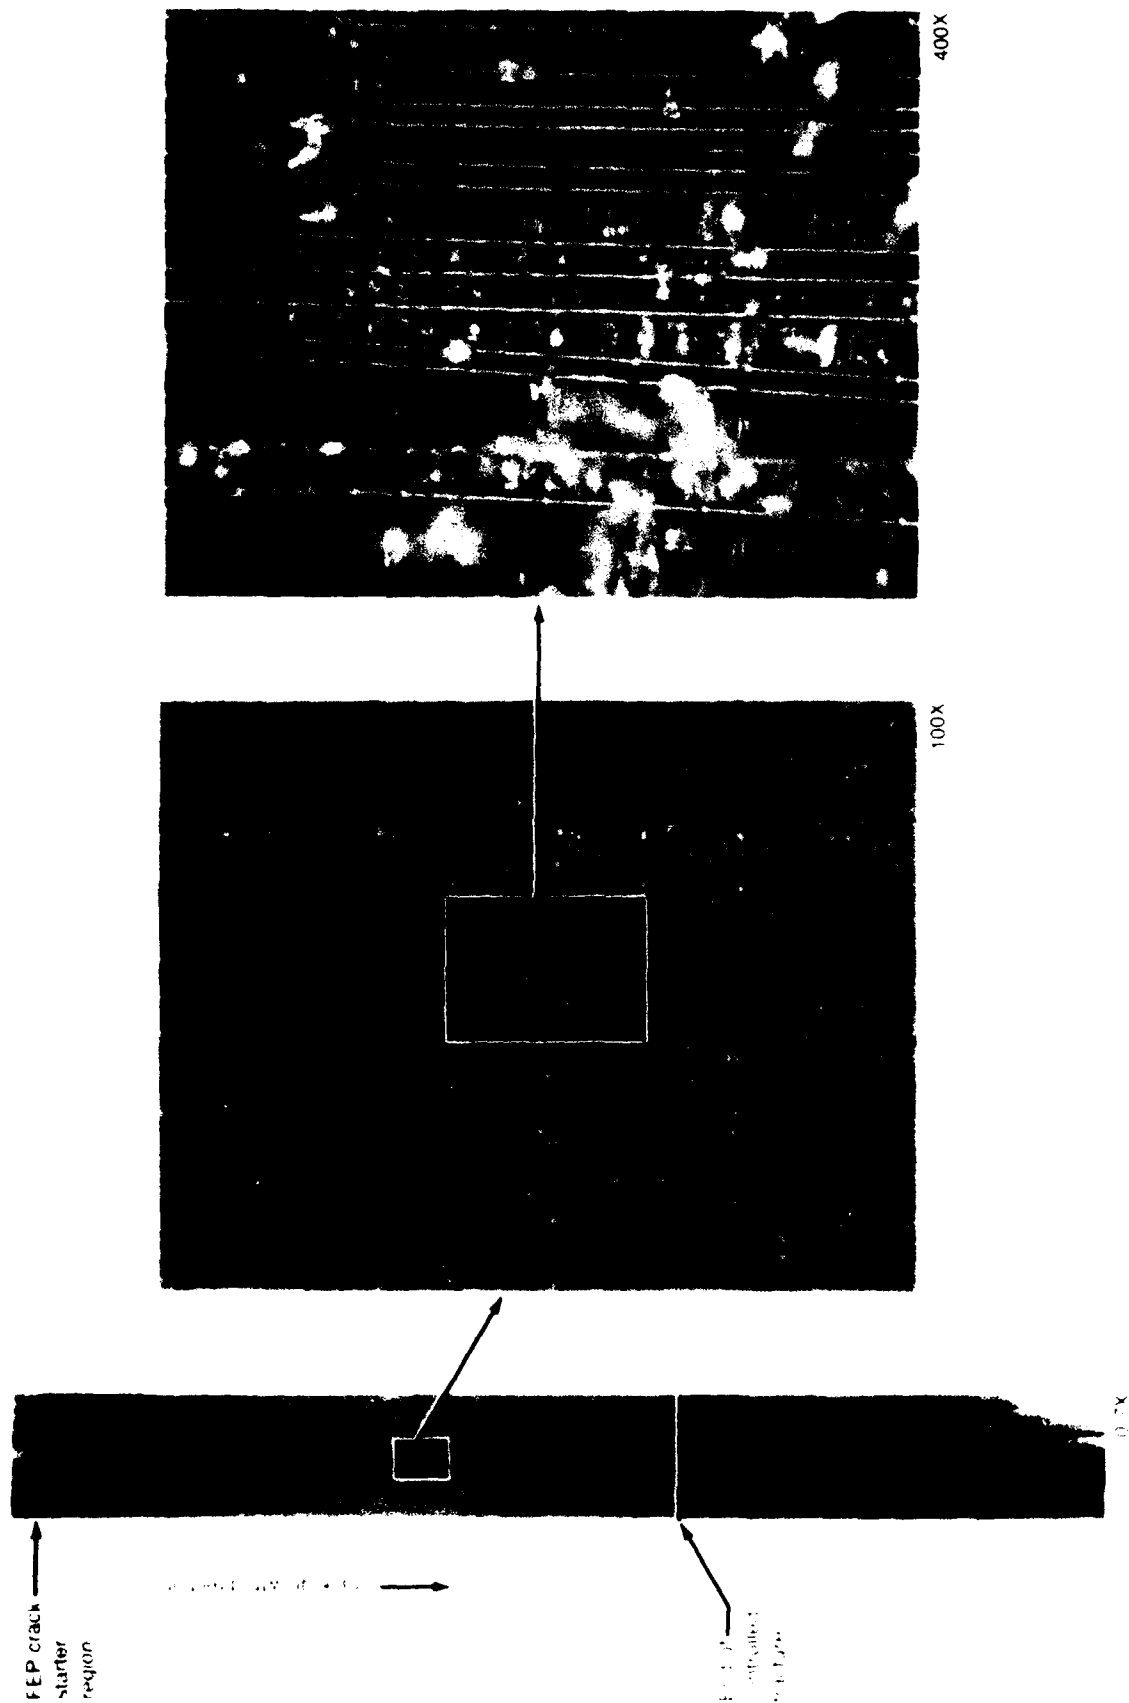
Macroscopic and microscopic examination of these specimens revealed that fracture did not occur on the intended interface between the 90/90-degree plies. Rather, the crack

diverged into the adjacent 0/90-degree interface and remained in this plane throughout the entire specimen length. The typical fracture surface features are presented in Figures 7-28 (optical) and 7-29 (SEM), and are identical to those found in the 0/90-degree specimens.

Figure 7-28. Optical Photomicrographs of Intended Fracture Plane Between 0/90-Degree Plies, ENF 210C (700F) Specimen

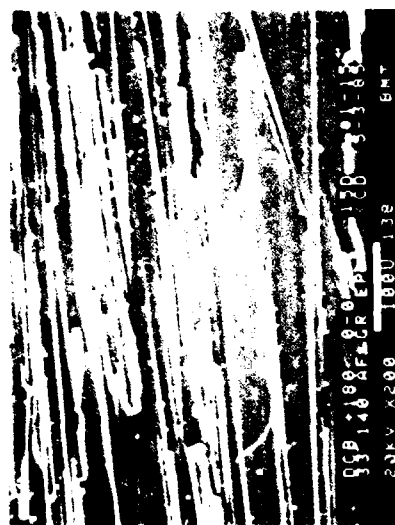
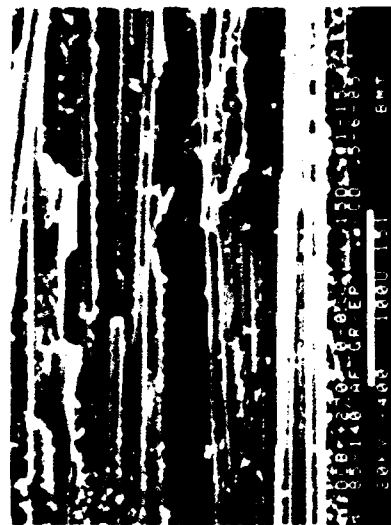
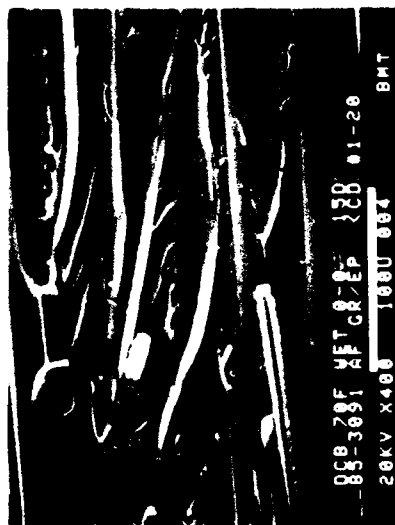
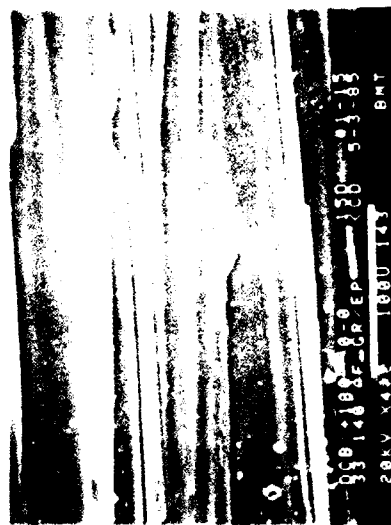
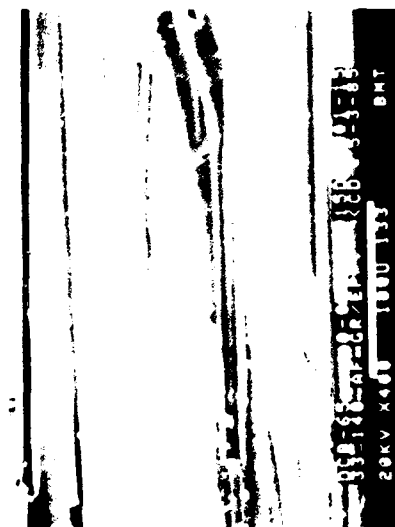
trend is illustrated in Figures 7-30 and 7-31, in which the effects of environment are listed for fractures produced between adjacent 0-degree plies. The fracture topographies characteristic of -54°C (-65°F) dry and 21°C (70°F) wet appear similar to one another and similar to the 21°C (70°F) dry results presented in Section 7.3.1. All exhibit large amounts of flat resin fracture divided into relatively large longitudinal areas by zones of fiber/matrix separation. The 82°C (180°F) dry/wet specimens are also similar to the lower temperature specimens, with a slightly greater amount of exposed fibers. Microscopic examinations of 132°C (270°F) dry and wet specimens indicated that these elevated temperature fractures are similar to one another, although quite different from the -54°C (-65°F) dry and 21°C (70°F) fractures. All 132°C (270°F) fracture topographies are characterized by significantly larger amounts of exposed fiber/matrix separation. Consequently, a corresponding decrease in the size and amount of flat-resin matrix-fracture zones is evident. Fractures at 132°C (270°F), dry and wet, result in large amounts of randomly oriented fibers, apparently pulled out from the surrounding matrix, scattered over the fracture surface. Macroscopically, the 132°C (270°F) fracture surfaces appear distinctly different than those generated at -54°C (-65°F) and 21°C (70°F) because of these easily visible pulled-out fibers.

Figure 7-30. Low Magnification Series of Characteristic 0/0-Degree Interface Mode 1 Fractures at Each Environmental Condition

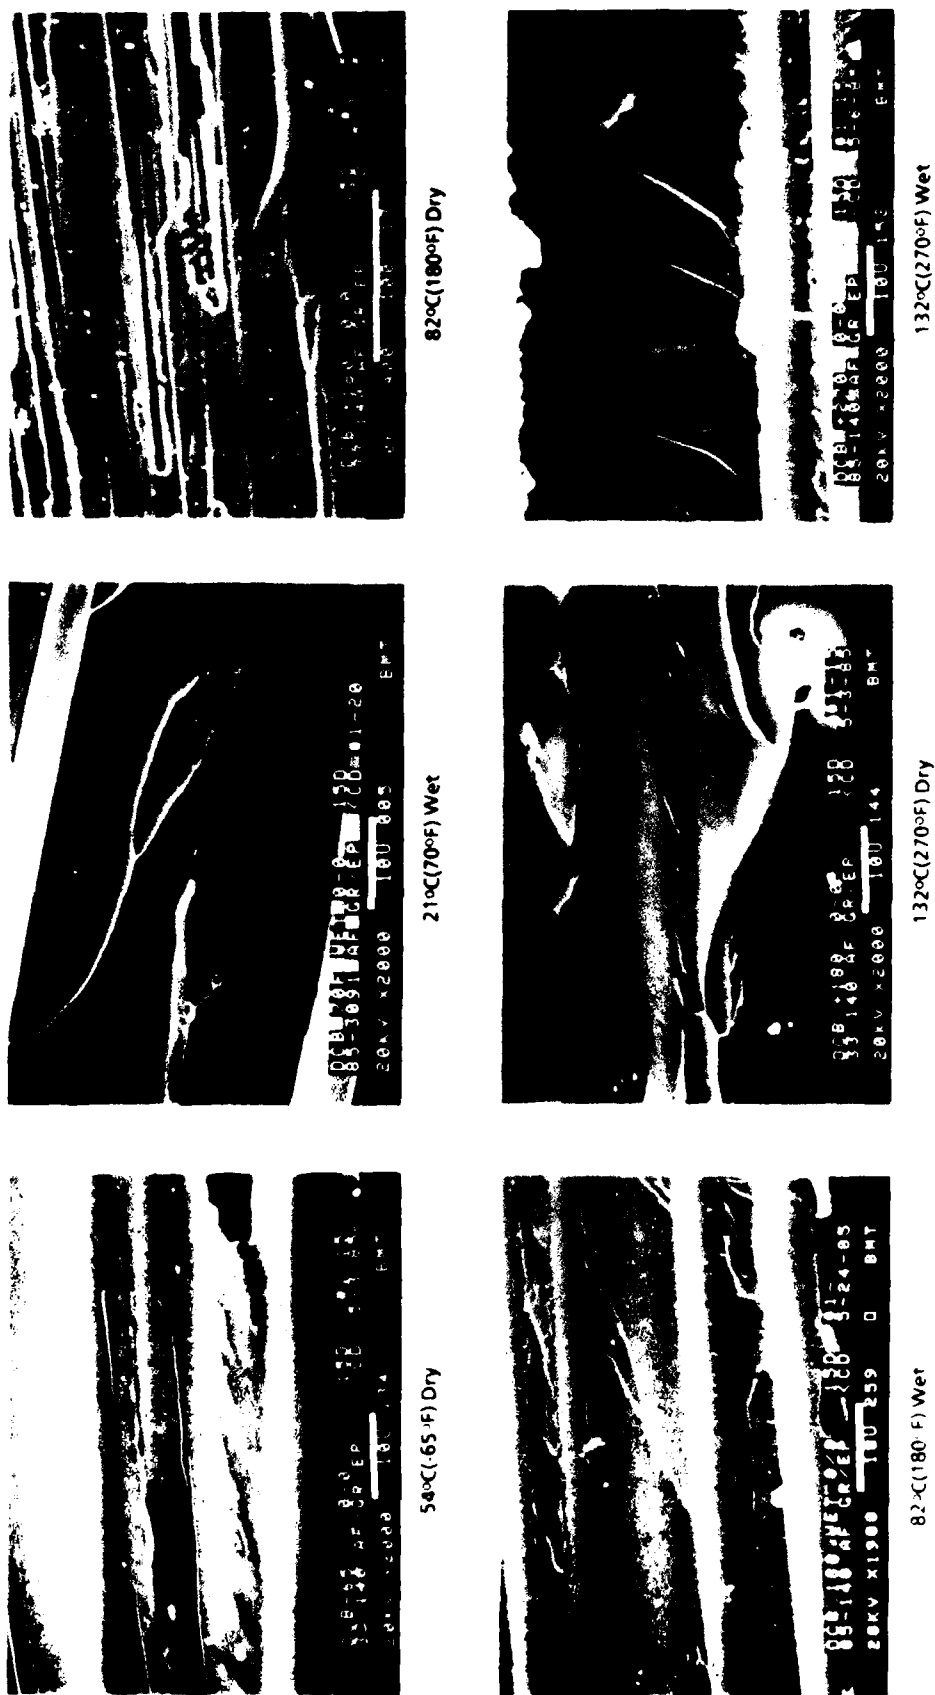
Figure 7-31. Higher Magnification Series of 0/0-Degree Interface Mode 1 Fractures Presented in Figure 7-30 Showing Features of Fiber/Matrix (F) Separation and River Markings (R)

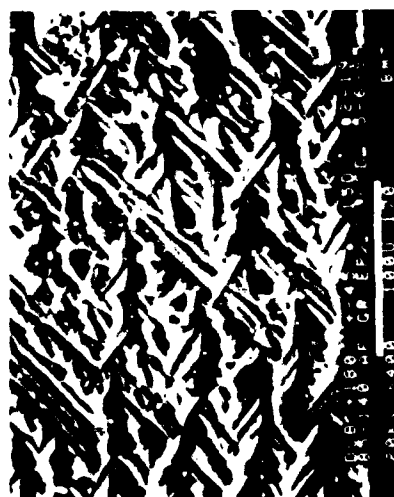
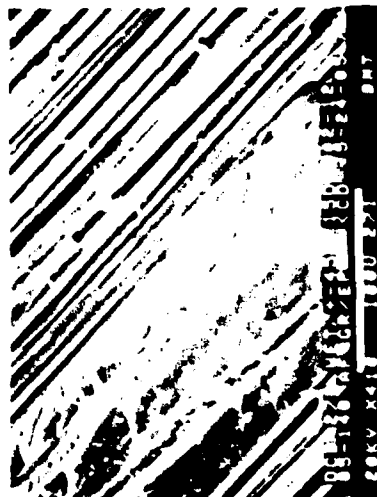
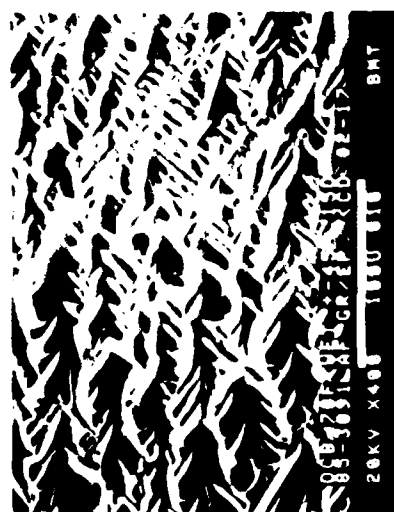
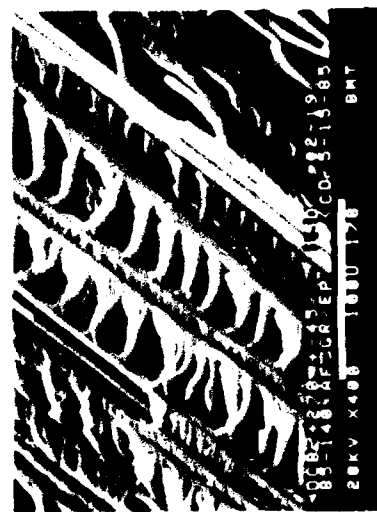
Similar to the 0/0-degree interfaces, interlaminar fractures exhibit increasing amounts of fiber/matrix separation with increasing temperature and absorbed water content. As illustrated in Figures 7-32 through 7-37, the -54°C (-65°F) dry, 21°C (70°F) wet, and 82°C (180°F) dry/wet fracture conditions appear similar. In general, for these lower temperature conditions, regions of cohesive resin fracture appear somewhat smaller than those noted for adjacent 0-degree fractures, and are divided into discrete regions by areas of exposed cross-ply fiber/matrix separation. The fracture surfaces generated at 132°C (270°F) dry and wet conditions for each cross-ply configuration appear distinctly different than those generated at lower temperatures. These figures show that the overall fracture surface topography is dominated by large amounts of fiber/matrix interfacial fracture, with occasional regions of cohesive matrix fracture; randomly pulled-out fibers (similar to the 0/0-degree interface fractures noted above) are visible without magnification.

Figure 7-32. Low Magnification Series of Characteristic +45/-45 -Degree Interface Mode I Fractures at Each Environmental Condition
