## FAILURE ANALYSIS OF COMPOSITE STRUCTURE MATERIALS

Brian Smith  
Ray Grove  
Thomas Munns  
Boeing Military Aircraft Company  
P.O. Box 3707 M/S 73-43  
Seattle, WA 98124

May 1986  
Interim Report for 18 July 1984 to 1 October 1985

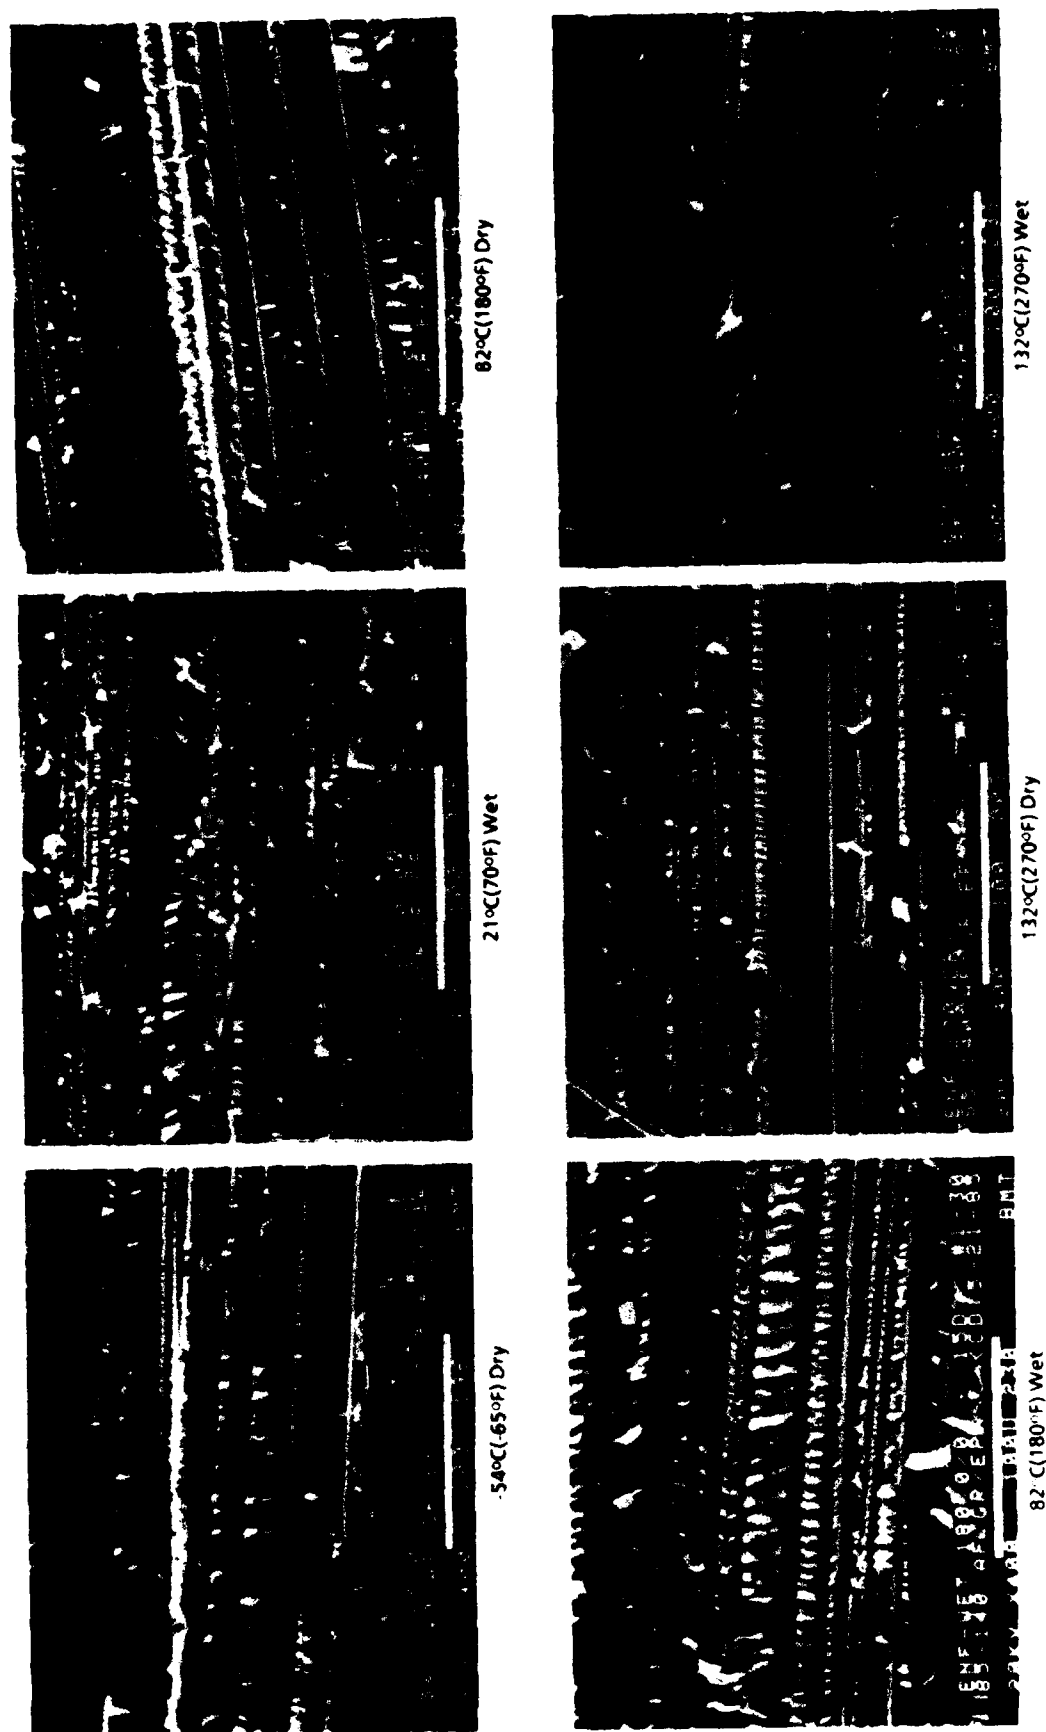
Figure 7-38. Low Magnification SEM Series of Characteristic 0/0-Degree Interface Mode 2 (Shear) Fractures at Each Environmental Condition

Similar to mode 1 (tension), fractures produced under mode 2 (shear) conditions typically exhibit a mixture of fiber/matrix separation and cohesive resin fracture. However, in contrast to the nearly flat matrix topography representative of mode 1, mode 2 cohesive matrix fractures exhibit characteristic hackles. These hackles provide a means to positively differentiate mode 2 from mode 1 fractures for all environmental conditions tested. In general, the effect of high temperature on mode 2 fractures is a pronounced increase in the amount of fiber/matrix separation, similar to that found for mode 1 (tension) fractures. However, such areas were not documented in the interest of recording the appearance of resin-dominated fracture features. The appearance of resin fracture features is illustrated in Figures 7-38 through 7-45, in which controlled fractures were produced between 0/0-, 0/90-, +45/-45-, and 0/45-degree interfaces at -54°C (-65°F) dry, 21°C (70°F) wet, 82°C (180°F) dry/wet and 132°C (270°F) dry/wet. The topographies characteristic of -54°C (-65°F), 21°C (70°F), and 82°C (180°F) fractures appear very similar. These lower temperature delaminations exhibit large amounts of fractured resin, in which long rows of inclined hackles are bounded by zones of fiber/matrix separation. In contrast, fractures produced under 132°C (270°F) dry and wet conditions are characterized by a significantly larger amount of fiber/matrix separation, and a corresponding decrease in the size and amount of resin-hackle features. The hackles are sometimes twisted and deformed, indicative of an increase in matrix ductility at elevated temperatures. As found for interlaminar tension, the 132°C (270°F) conditions result in pulled-out fibers scattered over the fracture surface; while not shown in the figures illustrated, these fibers could be seen at both a macroscopic and microscopic level. For each cross-ply orientation, delamination surfaces exhibit increasing amounts of fiber/matrix separation with increasing temperature and absorbed water content. This phenomenon is particularly evident in the lower magnification photomicrographs in which an overview of the fracture surface morphology can be seen.

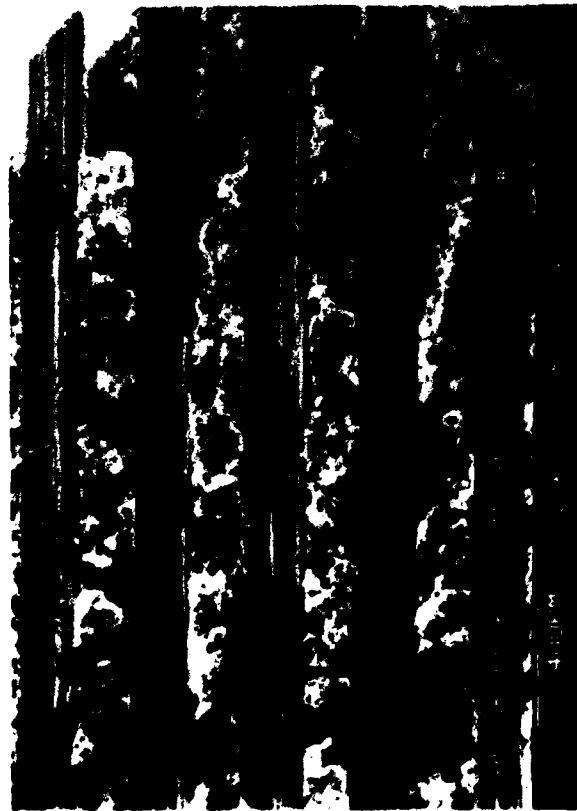
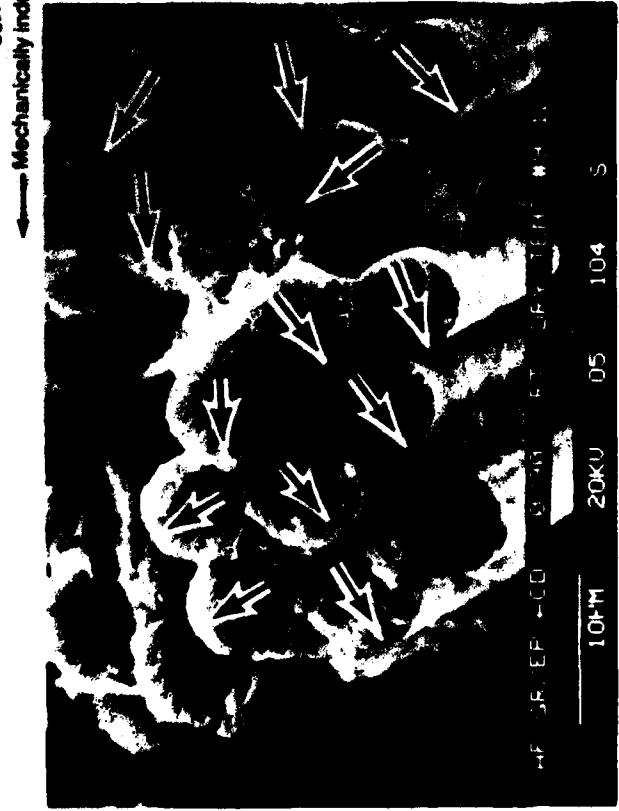
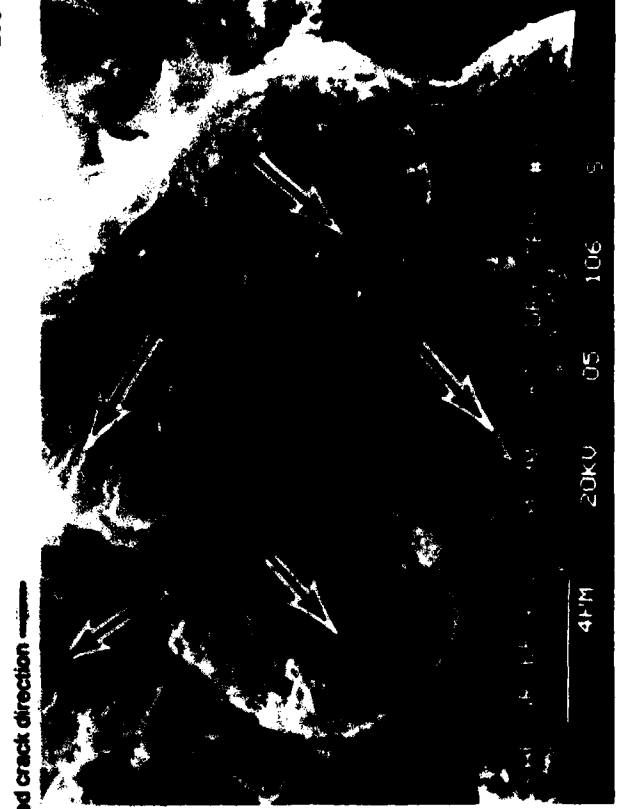
Figure 7-46. Translamellar Tension Fractures; 0/90-Degree Laminate

The typical surface characteristics of translaminar tension fractures generated across the 0/90-degree specimen is illustrated in Figure 7-46. Macroscopic examination of the overall surface revealed that fracture occurred at the intended plane: parallel to the 90-degree fiber orientation. Visual observation during testing revealed that cracking initiated at the specimen notch tip and progressed toward the specimen's opposite side.

SEM examinations were principally focused on the fracture regions in which fiber bundles, pullout, and end-fracture features were evident (see Figure 7-46). 0-degree fibers tend to fracture in bundles or tiers, with each bundle having a relatively flat, common fracture zone. Fibers within the bundles, as well as individual pulled-out fibers, were found to have significant amounts of adhering matrix resin, indicative of good fiber/matrix adhesion and adhesive fracture. Detailed inspection of this adhering matrix resin revealed the presence of hackles, associated with mode 2 shear fracture. Examinations of the fractured end of each fiber revealed a radial morphology—axially diverging lines emanating from a single point. The radial morphology is analogous to the chevron patterns commonly recognized in brittle metals—particularly for fractured bar or rod forms. The appearance of chevrons in metals is associated with microscopic variations in the plane of fracture, aligned in the direction of local crack propagation, and diverging from the point of initiation. Based on this interpretation, the localized direction of crack propagation for each individual fiber fracture can be determined by examining the radial morphology. The initiation points—origins—were primarily located at flaws or notches in the crenulated fiber surfaces, although isolated origins were found at internal flaws such as voids. Crack propagation along the fiber ends did not progress by the development and motion of a well-defined crack front. This was evidenced by the variety of directions of radials within a given bundle, even to the point of opposite directions for adjacent fibers. However, through overall mapping of the fracture growth direction for the individual 0-degree fiber ends, it was determined that the direction of radial features coincided with the direction of induced fracture. As illustrated in the lower photomicrographs of Figure 7-46, the induced crack direction coincides with the general direction of fiber-end fracture (note arrows on fiber ends indicating individual fracture direction).

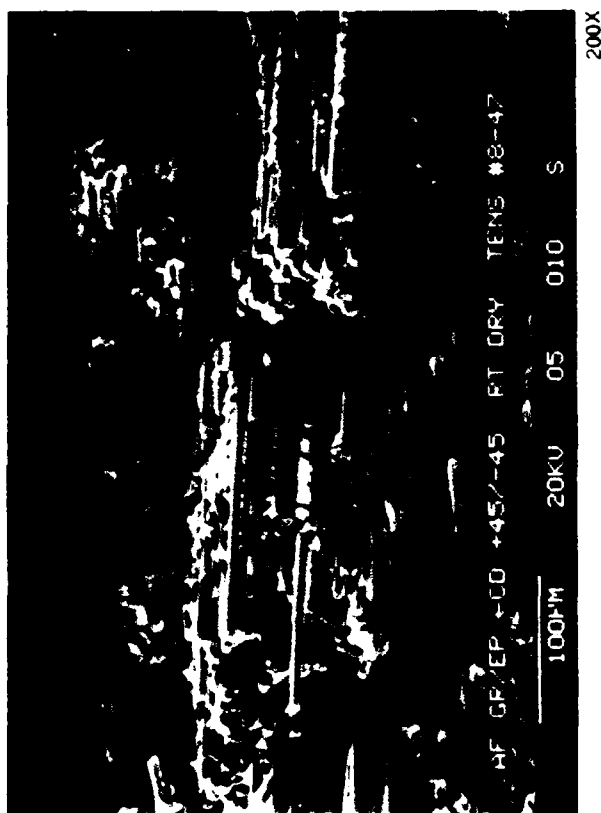
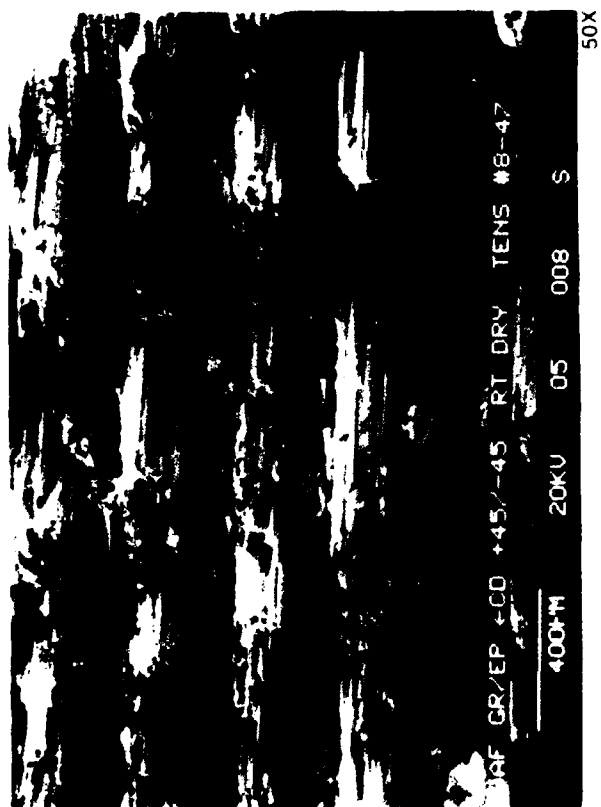
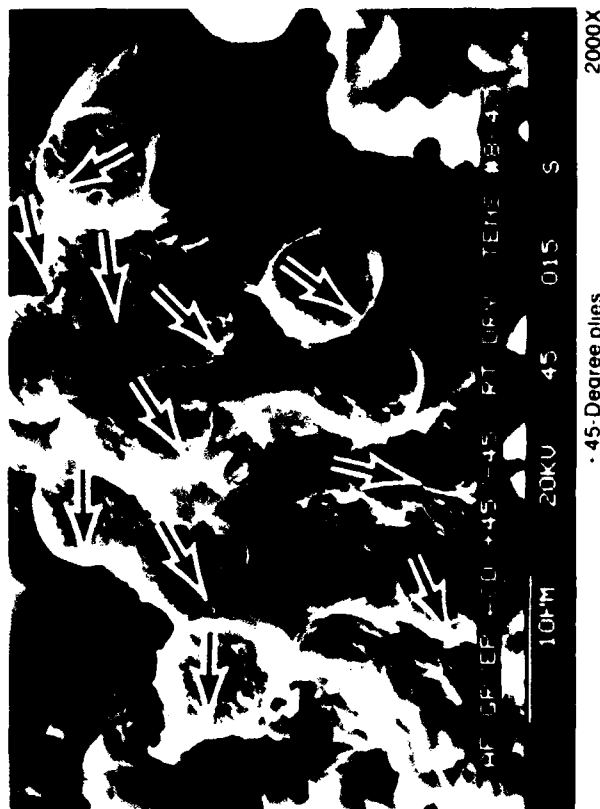
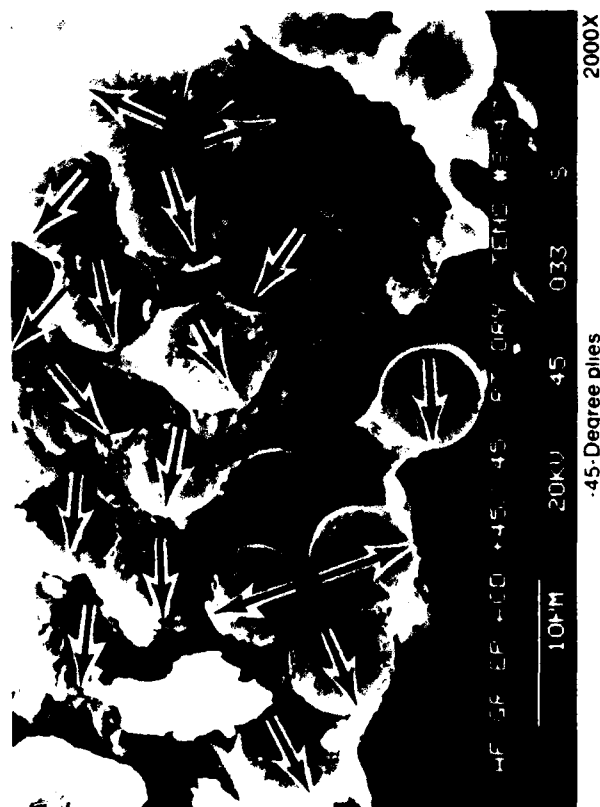
Figure 7-47. Translamellar Tension Fractures; +45/-45-Degree Laminate

The typical surface characteristics of translaminar tension fractures generated in +45/-45-degree specimens are illustrated in Figure 7-47. Macroscopic examination of the overall surface indicated that fracture occurs at the intended plane, parallel to the 90-degree orientation. High-magnification optical and SEM analysis concentrated on the tensile-dominated initiation zone.

The SEM photographs in Figure 7-47 show that the fracture surface consists primarily of large bundles of fibers which have a common, rather flat fracture plane. Each bundle of the +45/-45-degree laminates contained between 10 and 100 fibers, more fibers than were found in the 0/90-degree laminate. However, the fracture surface exhibited fewer single, standalone, pulled-out fibers than the 0/90-degree laminate. Most fibers had a significant amount of matrix resin adhering to them, indicating a good fiber/matrix adhesion and cohesive resin fracture. Examination of the fractured end of each fiber (for both the +45- and -45-degree bundles) revealed a radial morphology, and the average individual crack direction coincided with the direction of induced fracture (see bottom photomicrographs in Figure 7-47).

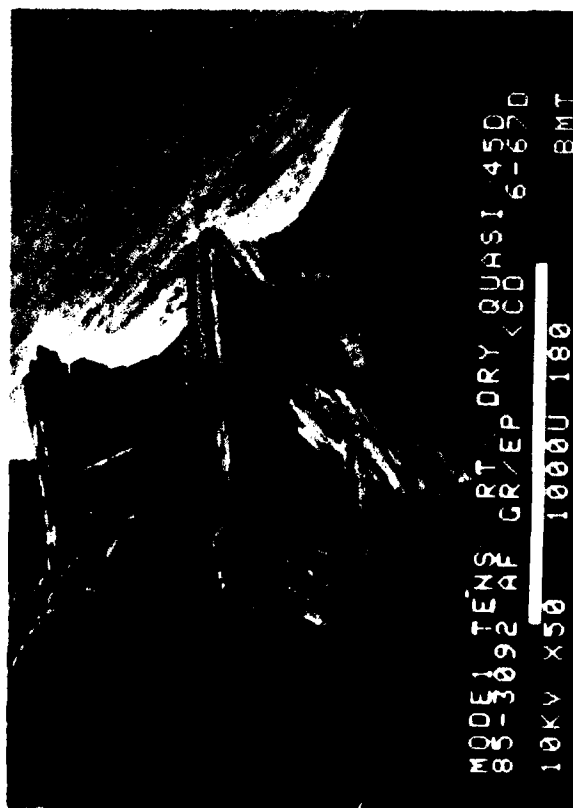
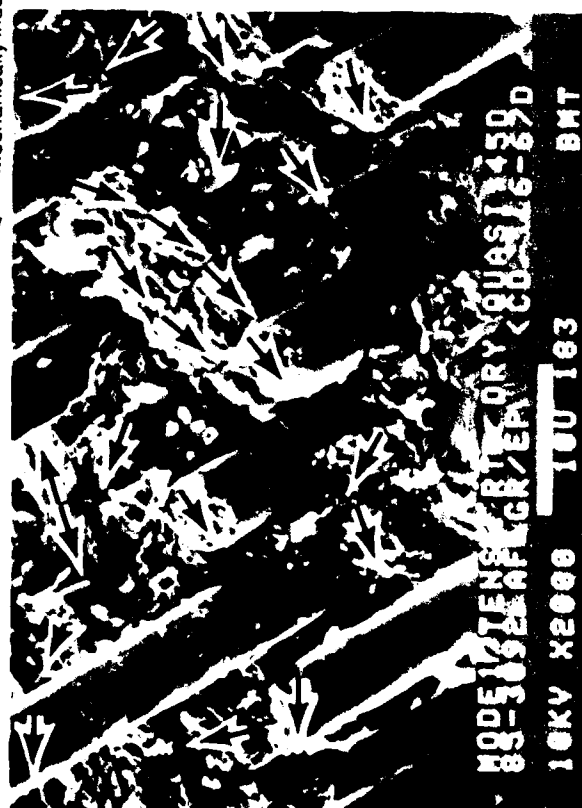
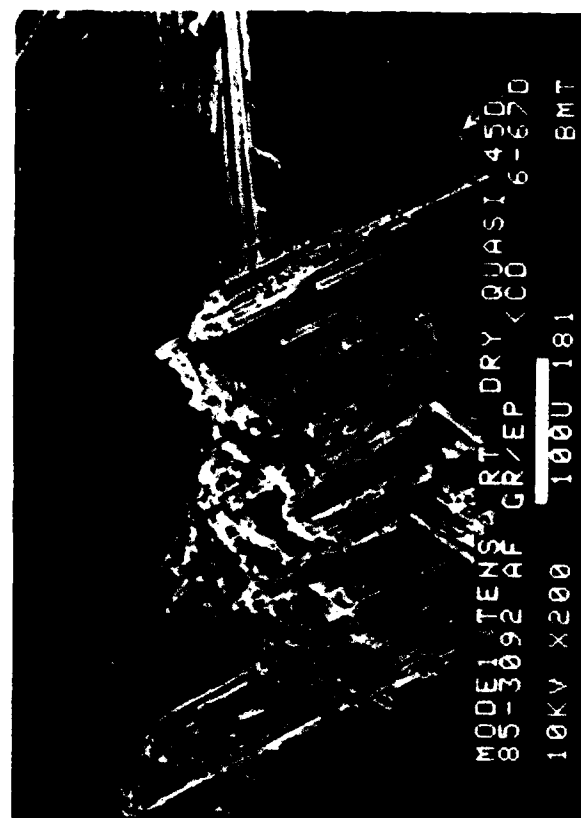
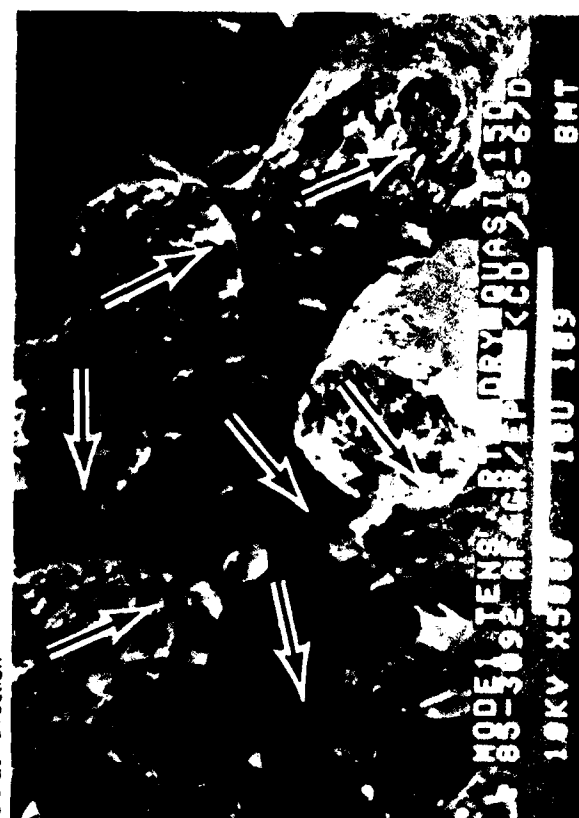
Figure 7-48. Translamellar Tension Fractures: Quasi-Isotropic Laminate

The typical fracture surface characteristics of translaminar tension fractures generated in the quasi-isotropic specimens are illustrated in Figure 7-48. Similar to the other two laminates discussed previously, macroscopic examination verified that cracking occurs parallel to the 90-degree plies.

Examination of the fiber ends for both 0- and 45-degree oriented fibers revealed a radial fracture morphology, as shown in the lower photomicrographs in Figure 7-48. In these photos, the fiber ends of a 45-degree bundle are illustrated. After thorough analysis of the fiber-end fractures, it was concluded that the average of the individual crack directions coincided with the direction of induced fracture. The findings presented above indicate that optical and/or SEM analysis can be used to identify river marks and radial features which define the overall direction of crack growth for quasi-isotropic translaminar fractures.

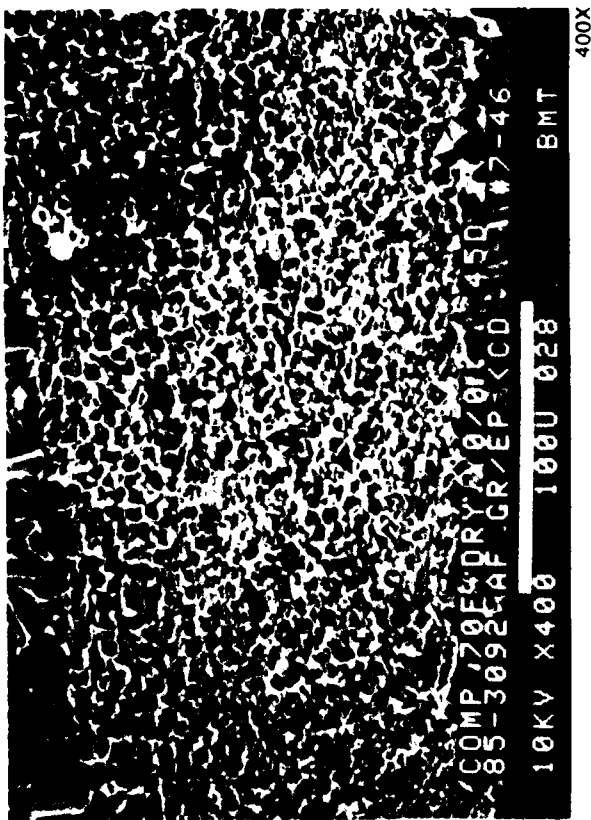
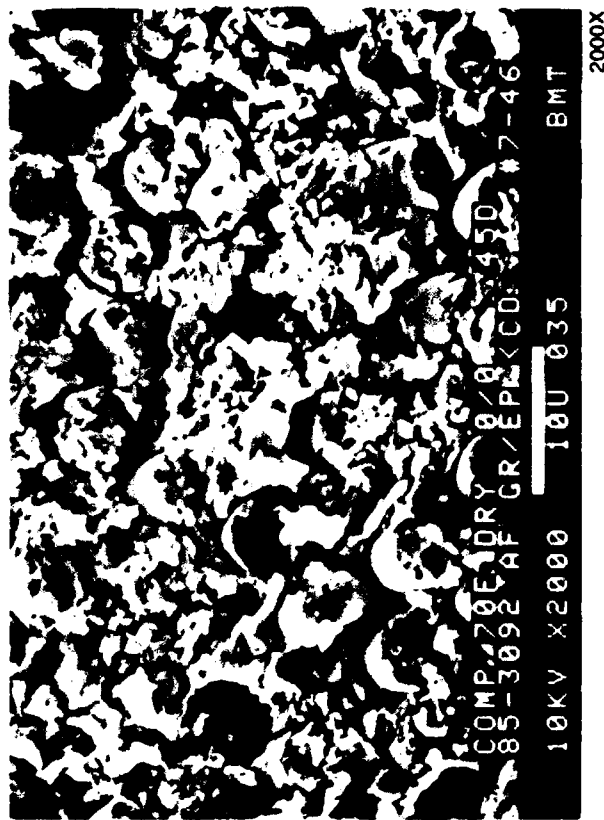
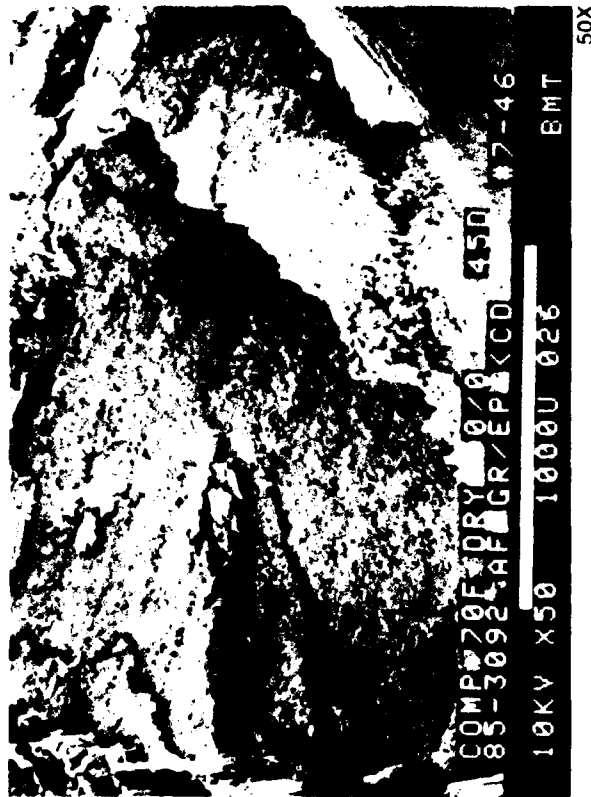
Figure 7-49. Translaminar Compression Fractures; Unidirectional 0-Degree Laminate

Macroscopic and optical microscopic examinations revealed a distinct, flat fracture that occurred on the intended plane. The surface was much flatter than those of translaminar tension fractures, and was virtually devoid of pulled-out fibers. This flat fracture morphology can be seen in the upper left photomicrographs of Figures 7-49 through 7-52, and is most visible in Figure 7-49 of the unidirectional laminate. SEM examination

revealed a combination of fiber buckling, fiber-end fracture, resin-matrix fracture, and postfailure damaged regions. In the upper and lower right photomicrographs in each series, extensive fiber-end damage and many fractured resin particles can be seen. This obliteration of fracture surface features was attributed to postfailure abrasion between mating fracture surfaces.
